# National Transportation Safety Board

## Railroad Accident Brief

### Union Pacific Railroad Derailment with Hazardous Materials Release and Subsequent Fire

Fort Worth, Texas

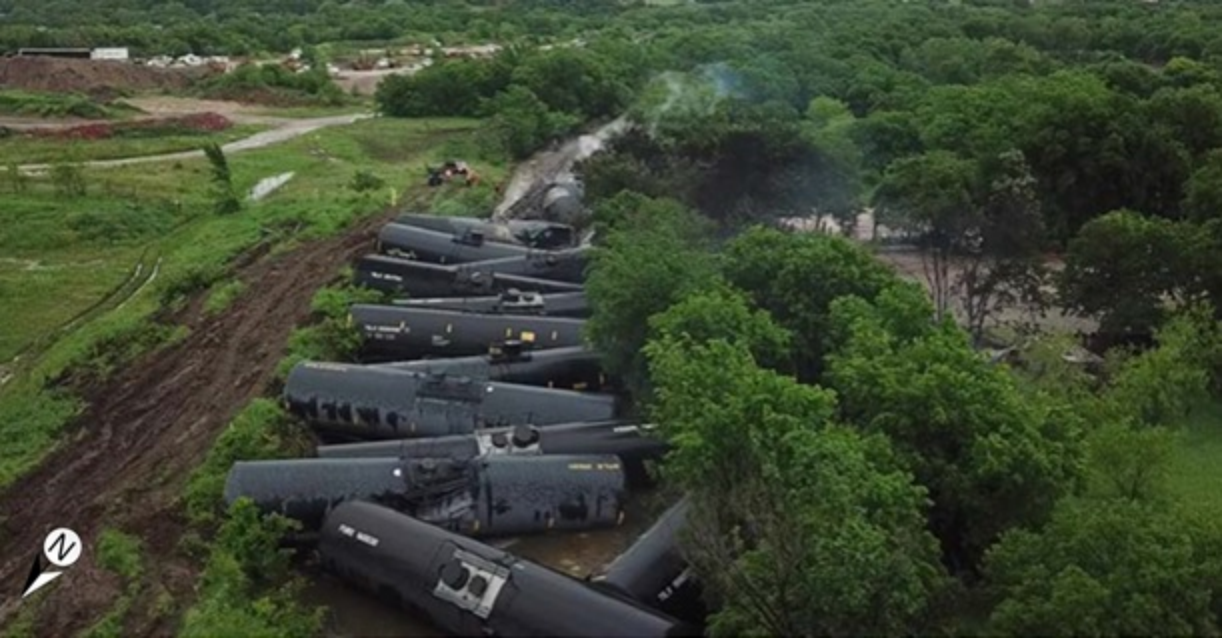
On April 24, 2019, at 12:33 a.m. local time, a southbound Union Pacific Railroad (UP) high-hazard flammable key train, UEBLTG20, carrying denatured ethanol (UN1987), derailed in Fort Worth, Texas.<sup>1</sup> (See figure 1.) The train was 6,122 feet long, weighed 13,230 tons and consisted of three locomotives, two buffer cars, and 96 loaded tank cars.<sup>2</sup> Twenty-six tank cars derailed and three tank cars were breached, leaking 65,270 gallons of denatured ethanol.<sup>3</sup> Several cars caught fire. The released denatured ethanol ignited and formed pool fires and some product entered a tributary of the Trinity River. The train was traveling 26 mph and it was raining at the time of the derailment. UP estimated the damages to be \$6,313,217.<sup>4</sup>

**Figure 1.** Aerial view of derailed UP train UEBLTG20.

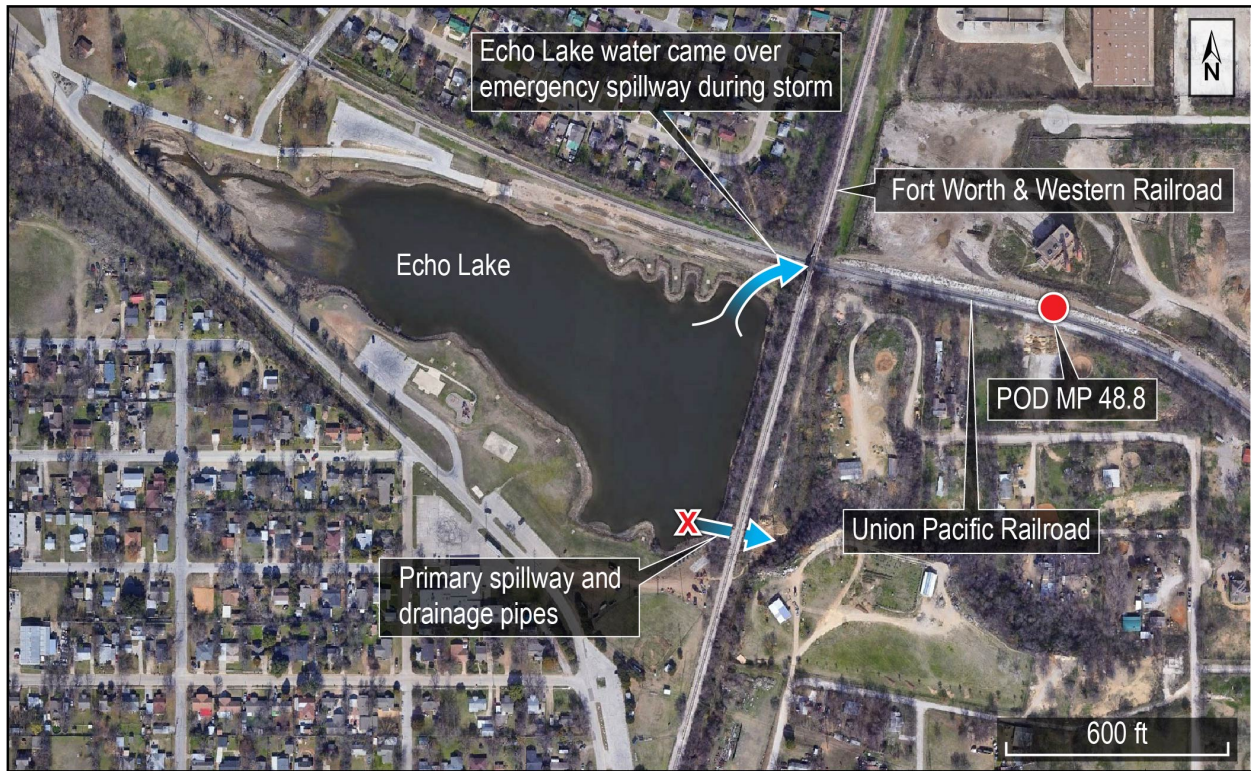
The drainage system at Echo Lake was designed with a primary spillway and emergency spillway. The primary spillway includes three drainage pipes. At the time of the accident, one of the three drainage pipes was functional, one had been intentionally plugged due to pipe damage,

and the third had been blocked by debris. An emergency spillway for the lake was located along the UP right-of-way. (See figure 2.)

**Figure 2.** Aerial view of accident site depicting the primary spill way and drainage pipes and point of derailment at MP 48.8.

The National Transportation Safety Board determines that the probable cause of the accident is the derailment of Union Pacific Railroad train UEBLTG20 due to a weakened track structure and wash out resulting from a water overflow event due to rain causing Echo Lake to flood. Contributing factors include deferred maintenance of primary and emergency spillways at Echo Lake, and the absence of dynamic weather reporting criteria at Union Pacific Railroad.

On September 30, 2020, NTSB investigators received an update from the City of Fort Worth Department of Parks and Recreation stating that a contractor for Tarrant County completed the drainage improvement work (per conveyance agreement) at the southeast corner of Echo Lake in June of 2020. Tarrant County and the City of Fort Worth continue to work on transferring the maintenance easements for the spillway drainage system. In addition to the completion of the drainage improvements, the Department of Parks and Recreation is aware that the railroad is pursuing a park conversion along the north boundary of Echo Lake Park, to construct a berm for further flood protection. At this time, there is no schedule for the completion of this work.

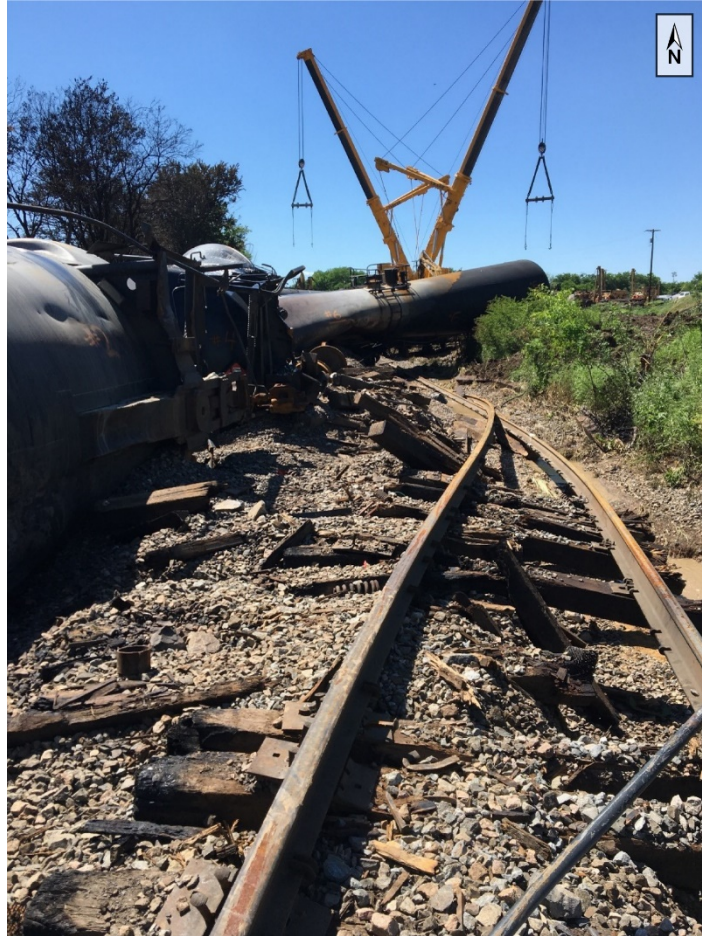
A heavy stream of water flowing south and in a downhill direction had washed away large amounts of subballast, shoulder and crib ballast along the track and several locations along the track had ballast that piled up and over both running rails.<sup>8</sup> At the derailment location, the water had flowed overtop and underneath of the track structure, undercutting and eroding away the tracks supporting ballast foundation, shoulder and crib ballast. The track structure had weakened to a point where it could not support the weight and dynamic loading of the train. NTSB investigators further observed that the track between the two curve transitions was damaged for several feet, due to the track losing support underneath the train as it traversed over that portion of the track. (See figure 3.)

**Figure 3.** Photograph of the destroyed track infrastructure and three damaged tank cars.

UP made a change to operating rule 6.21 (Operating Rule 6.21, Precautions Against Unusual Conditions) for operating under a flash flood warning, emphasizing to train crews that they should "proceed prepared to stop prior to washout or debris on track." This differs from a previous version of the rule where speed would be governed through special instruction.
