Railroad Accident Brief: RAB-21/06

# Southeastern Pennsylvania Transportation Authority Roadway Worker Fatality

Philadelphia, PA  
July 8, 2019

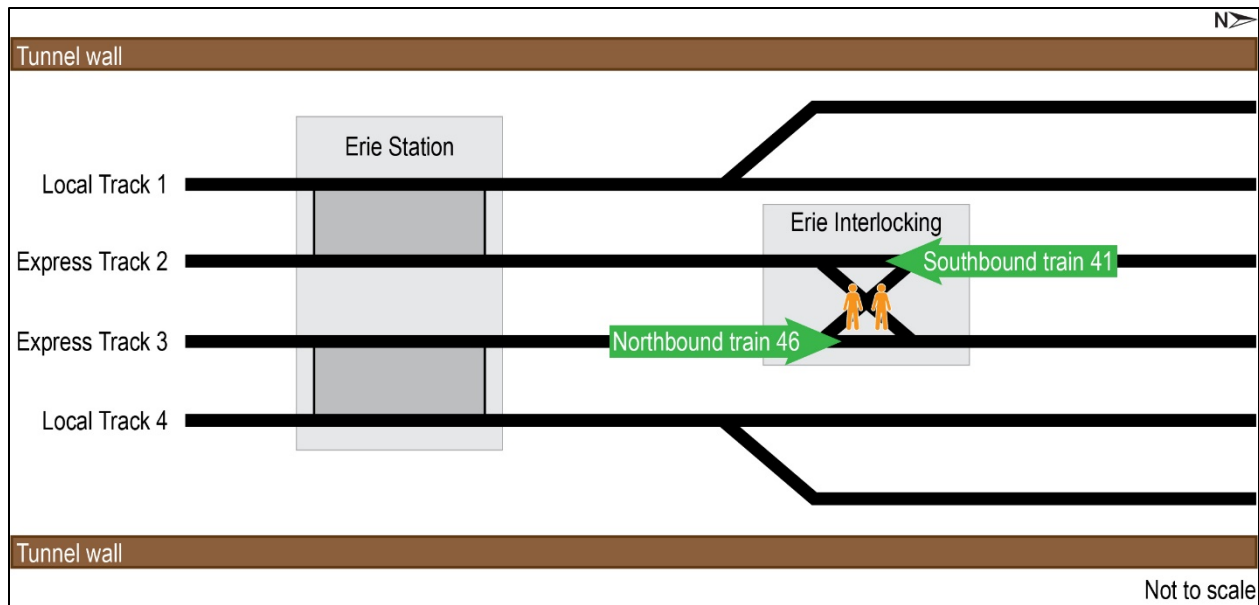
On Monday, July 8, 2019, about 5:21 p.m. local time, northbound Southeastern Pennsylvania Transit Authority (SEPTA) train 46, struck two SEPTA roadway workers on express track 3 (track 3) on SEPTA's Broad Street Subway Line in Philadelphia, Pennsylvania.<sup>1</sup> One worker was killed, and the other was transported to a local hospital with non-life-threatening injuries. Prior to the accident, a southbound SEPTA train (train 41) was operating on express track 2 (track 2) just north of SEPTA's Erie interlocking and passed the workers. Simultaneously, northbound train 46 struck the roadway workers as it departed the Erie Station on track 3. (See figure.)

**Figure.** Diagram of accident location on Broad Street Subway Line.

Note: This diagram shows tracks 1, 2, 3, and 4 running through the Erie Station to the south. Train 41 is headed south through the Erie interlocking on track 2, and train 46 is headed north through the Erie interlocking on track 3. The accident site and the two roadway workers who were hit are shown in the Erie interlocking between tracks 2 and 3.
