Amtrak Roadway Worker Fatality
Bowie, Maryland
April 24, 2018

Accident Report

NTSB/RAR-21/02
PB2021-100935

Railroad Accident Report

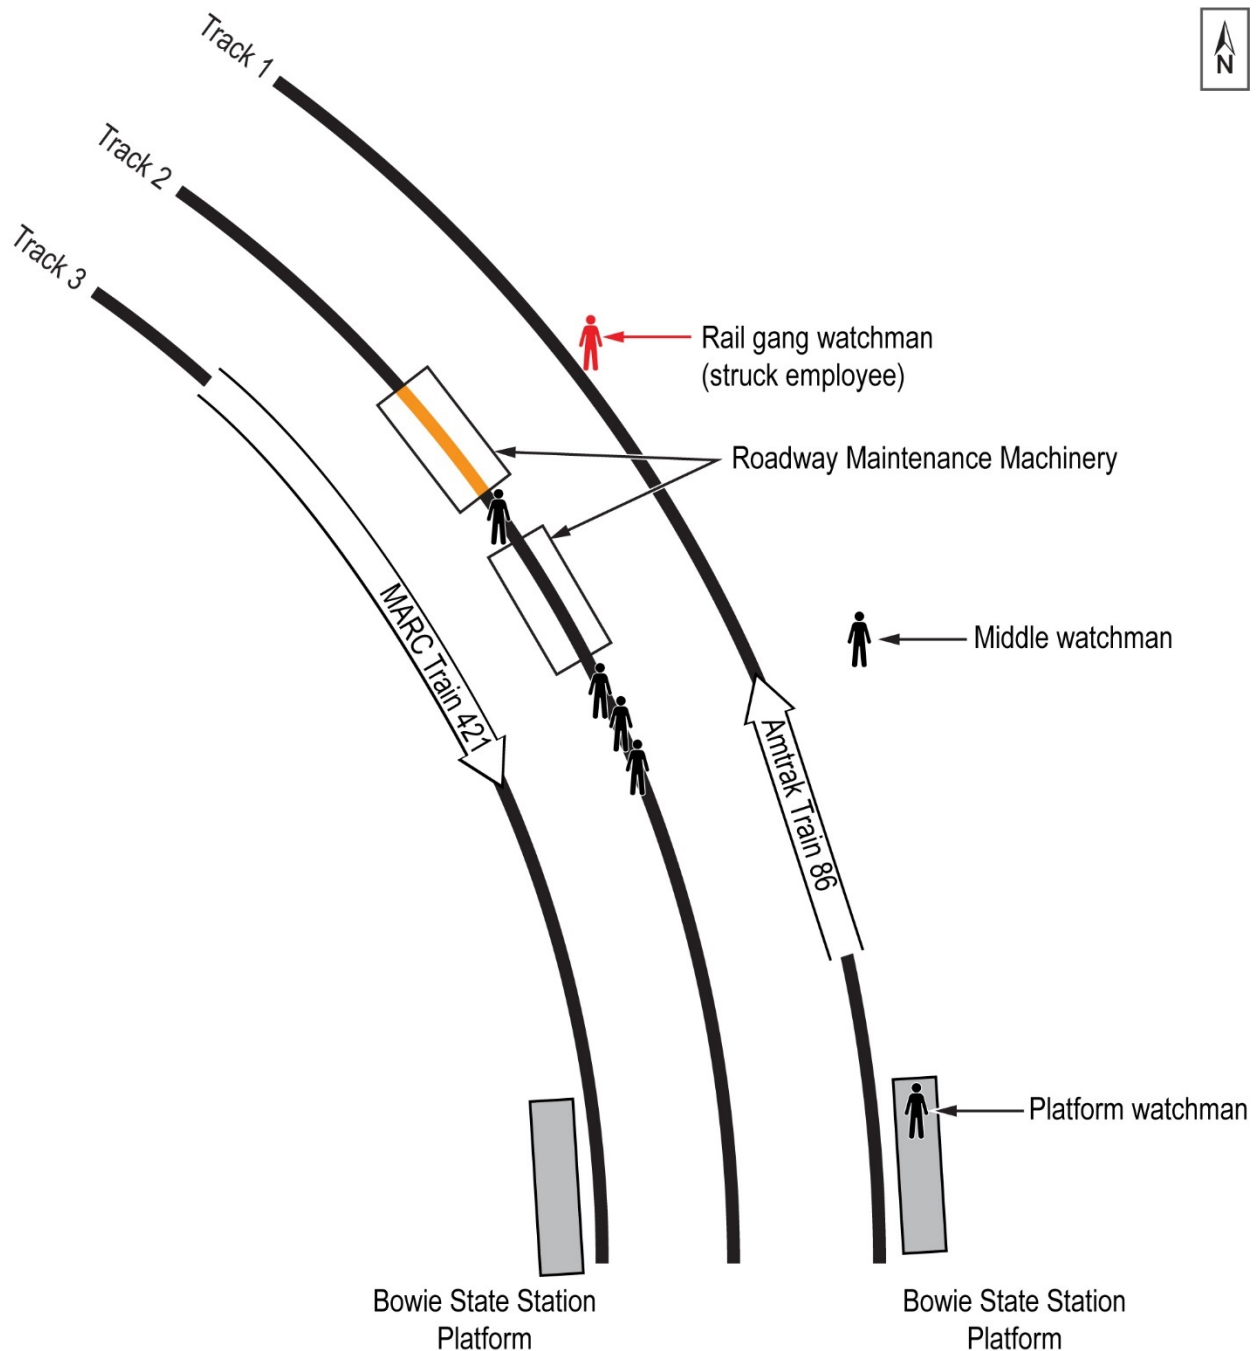
Figure 1. Graphic of accident site.

to the equipment and the watchman would be in a better position to get the attention of the welders.⁶ At this location he was about 660 feet north of the middle watchman.

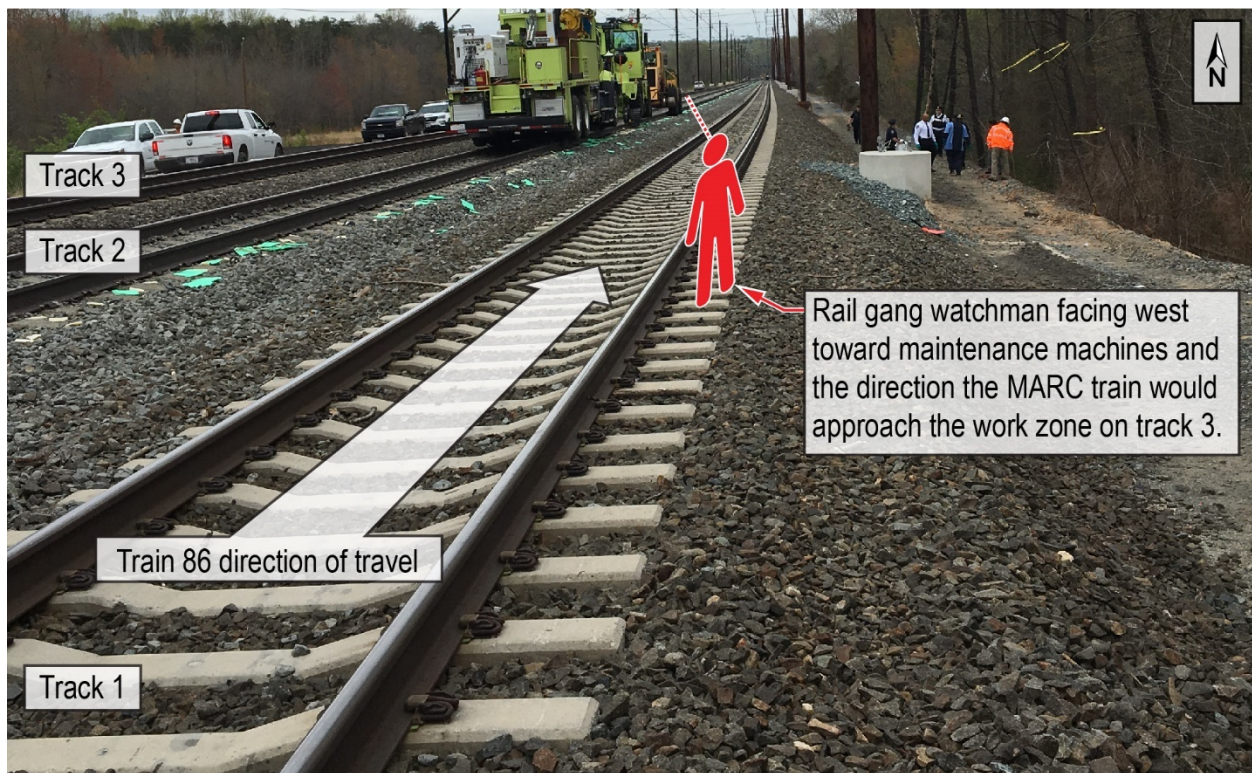
Figure 2. Photograph of the accident area, facing north.

During an examination of the accident scene, the NTSB noted that the ballast shoulder was steep at the location where the rail gang watchman was posted and did not provide stable footing.¹⁷ Figure 2 shows the work environment. The NTSB asked the platform watchman about the rail gang watchman's position on the steep ballast. The platform watchman indicated that, in general, it was difficult to find stable footing anywhere along the steep ballast shoulder throughout the work zone.

The middle watchman indicated that the steep ballast shoulder was uncomfortable to stand on while watching for trains. The slope was steep enough that standing on the rocks that made up the ballast caused unstable footing.

because the steep ballast slope made it too difficult to safely stand and properly watch for trains. He also suggested to the NTSB that watchman platforms be built to reduce the safety hazards of unstable footing. Another employee stated that when watching for trains, he often found it necessary to move and pack the ballast around with his feet to make “step like” indentations in the steep ballast slope. He stated that when a train approached, he usually would go behind a catenary pole for added protection due to the flying debris and dust that the train kicked up.¹⁸
