Aviation Investigation Final Report

Location:	Hurricane, Utah	Accident Number:	WPR16FA036
Date & Time:	December 10, 2015, 13:47 Local	Registration:	N307AB
Aircraft:	BARNETT ALLEN S RV7	Aircraft Damage:	Substantial
Defining Event:	Aircraft structural failure	Injuries:	2 Fatal
Flight Conducted Under:	Part 91: General aviation - Personal

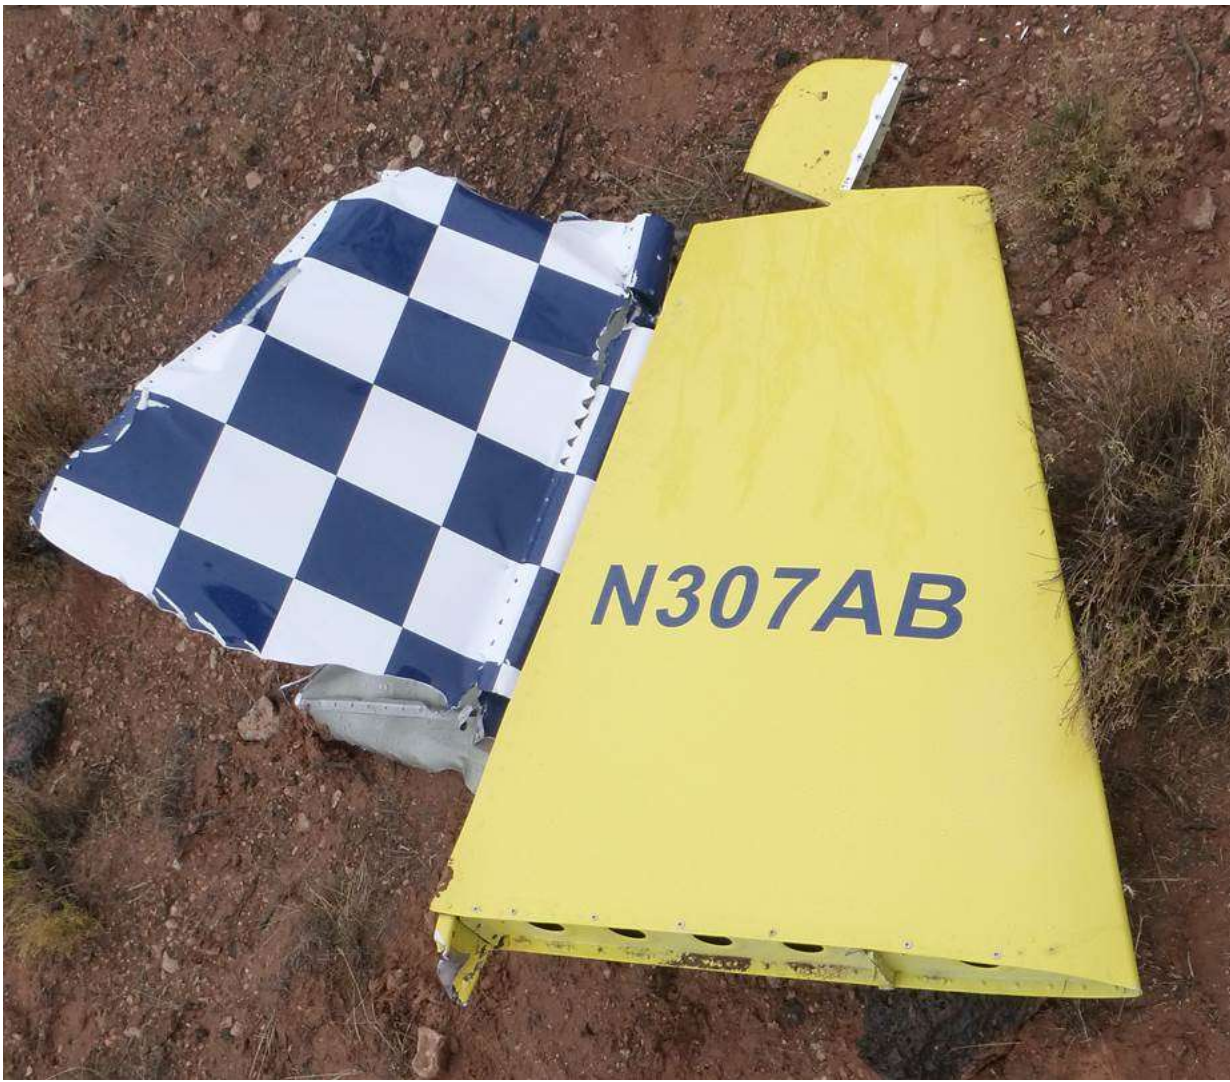
Postaccident examination of the airplane revealed that the vertical stabilizer, with about half the upper rudder still attached, separated from the airplane and was recovered mostly intact farthest from the main wreckage. The vertical stabilizer separated in a leading-edge-left direction in overload. The damage to the horizontal stabilizers and elevators that was consistent with a downward failure in positive overload. The damage observed on the wings was consistent with a downward failure in negative overload. Additionally, there were no indications of any pre-existing cracks in or anomalies with the vertical stabilizer, horizontal stabilizers, elevators, or wing structures, and no pre-accident anomalies were observed that would have precluded normal control of the airplane. The loads required to fail the horizontal stabilizers and elevators cannot be generated from normal flight or control movements. Such failures would have required an abrupt pull back on the stick and corresponding movement of the elevator to a trailing-edge-up position, at speeds greater than the airplane's maneuvering speed. Failure of the horizontal tail first would have caused the airplane to pitch down rapidly, producing air loads on the upper surface of the wing that were sufficient to fail them in negative overload.

The recovered photographic information showed the pilot performed a split-S maneuver that likely caused the airplane's speed to increase rapidly. The speed increased above V_{NE} and excited the rudder flutter mode, causing the vertical stabilizer to separate due to overload. The photographs confirmed the vertical stabilizer separation as the airplane

[The vertical stabilizer separated mostly intact from the airplane during the accident sequence and had the upper portion of the rudder attached. The forward spar was fractured just above its attachment to the horizontal stabilizer front spar. The rear spar was fractured and twisted just above the stabilizer shelf, consistent with the vertical stabilizer separating leading edge left. Most of the upper half of the rudder remained attached at the upper and center hinge points. ~~and~~ The lower half remained attached to the empennage. The rudder trailing edge was splayed open, and the trailing edge strip remained attached to the left rudder skin on both halves. There was evidence of sealant between the rudder skins and trailing edge strip. The rudder was fractured spanwise just below the center hinge. The rudder counterweight was separated from the upper end of the rudder just above the upper skin stiffeners \(see figure\).](#)

Figure. Vertical stabilizer and attached rudder.

All the fractures exhibited a dull, grainy appearance consistent with overstress separation. There was no evidence of progressive or pre-existing fractures on any of the parts.
