Railroad Investigation Report: RIR-22/10

BNSF Railway Employee Fatality

Louisiana, Missouri
April 7, 2021

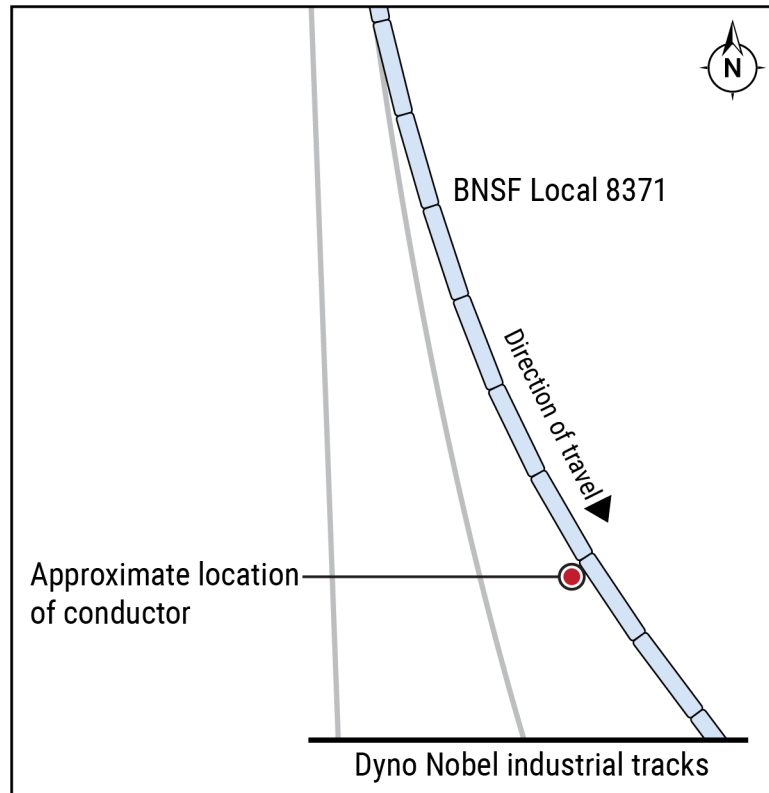
Figure 1. Overhead illustration of the accident location.

On April 7, 2021, about 3:25 p.m. local time, a conductor of BNSF Railway (BNSF) Local 8371 was killed while dropping off and picking up railcars near the Dyno Nobel, Inc. (Dyno Nobel) industrial facility in Louisiana, Missouri.¹ Immediately before the accident, event recorder data indicated the engineer was moving the train southeast on Dyno Nobel industrial track at less than 9 mph with the conductor controlling a shoving movement (by radio communication with the engineer) from the ground.² There were no witnesses, and surveillance video recordings from the facility did not capture the accident. It was daylight and the weather was overcast, with a temperature of 73°F and southeast winds at 3.8 mph. Figure 1 provides an illustration of the accident location.

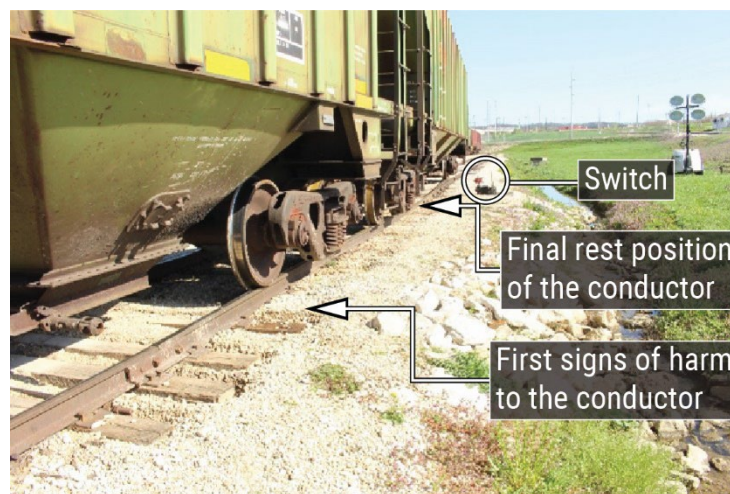
The brakeman announced “emergency” over the handheld radio, and the engineer dialed 911 on the locomotive radio. Shortly after the call to 911, emergency responders arrived on-scene and the conductor was pronounced deceased. While on-scene, the responders identified the first signs of harm to the conductor in the ballast on a walking space adjacent to the tracks near the accident location.⁶ (See figure 2.)

Figure 2. Area where the conductor was found.

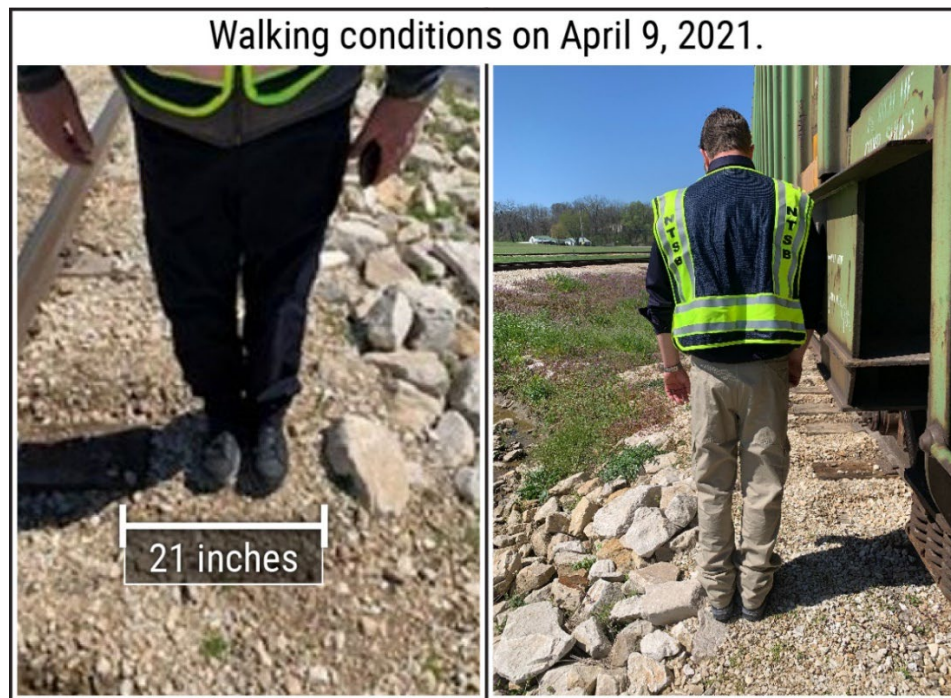
The track at the accident location was maintained by Dyno Nobel. On April 9, 2021, NTSB investigators inspected the area of the accident and took measurements of the walking space. At the time of this measurement, there was only 21 inches of walking space between the end of the crosstie and the large rocks. (See figure 3, left.) Further, during these inspections, investigators noted insufficient walking space; large rocks were located on the south side of the track near a decline leading to a drainage ditch. (See figure 3, right.)

Figure 3. Measurement of the walking space near the accident location.

While there were no witnesses, and surveillance video footage did not capture the accident, the responders identified the first signs of harm to the conductor in the ballast near the accident location with insufficient walking space. Further, NTSB investigators found the walking space where the conductor was likely protecting the train movement from the ground to be challenging terrain consisting of a narrow walkway with a steep, rocky drop-off into a drainage ditch.

The National Transportation Safety Board determines that the probable cause of the employee fatality at the Dyno Nobel facility was a result of the conductor being impacted by the moving railcars during a shoving movement while located in an area with insufficient walking space available for the employee to perform trackside duties.

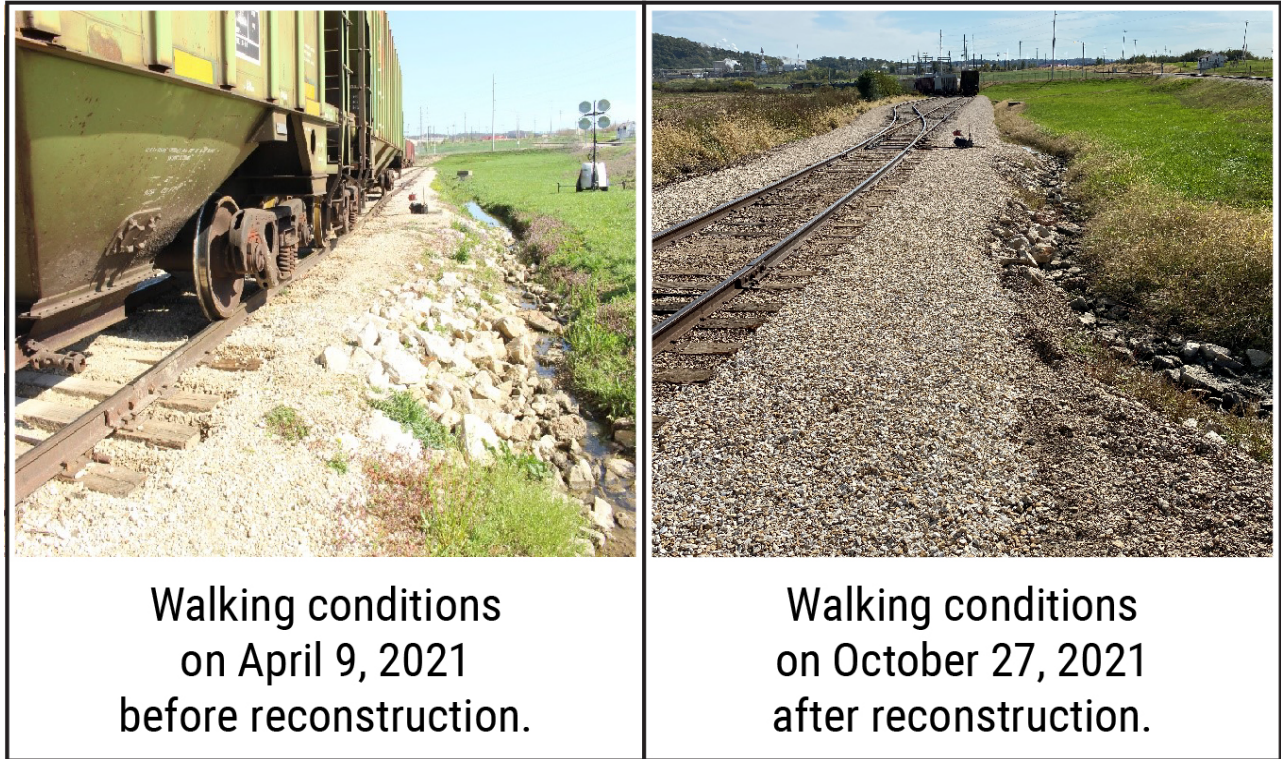
The NTSB requested that the Missouri Department of Transportation (MoDOT) conduct a postaccident inspection of the walking space at the accident location. Upon inspection, the MoDOT inspector found that the walking space located in the area of the accident did not meet the requirements of Missouri Code of State Regulations, which state:

Figure 4. Walking conditions at the time of the accident (*left*) and walking conditions after reconstruction (*right*).

The MoDOT required Dyno Nobel to complete remedial action within 30 days. In response, Dyno Nobel reconstructed all walking spaces along trackage within the facility to be 9 feet from the center of the track, which is 6 inches wider than the state minimum requirements. (See figure 4.)

Upon the NTSB's request, the MoDOT inspected the walking space at the accident location and found that it did not meet Missouri Code of State regulations. In response, Dyno Nobel reconstructed all walking spaces along trackage within the facility to be 9 feet from the center of the track, making the walkways 6 inches wider than the state minimum requirements.
