NTSB/RIR-22/06

Norfolk Southern Corporation Employee Fatality

Baltimore, Maryland

February 7, 2019

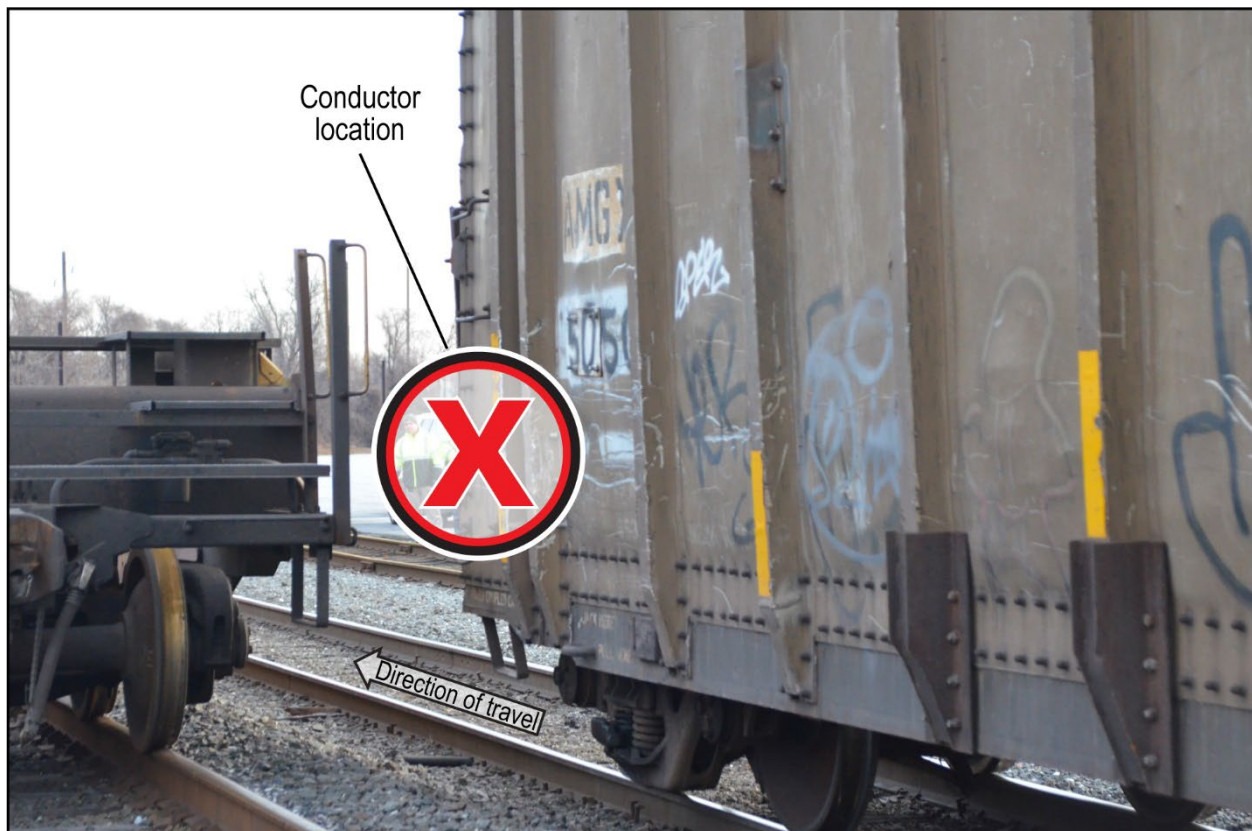
Figure 1. Accident railcar with the stationary railcar on adjacent track. (Photo courtesy of the Federal Railroad Administration (FRA).)

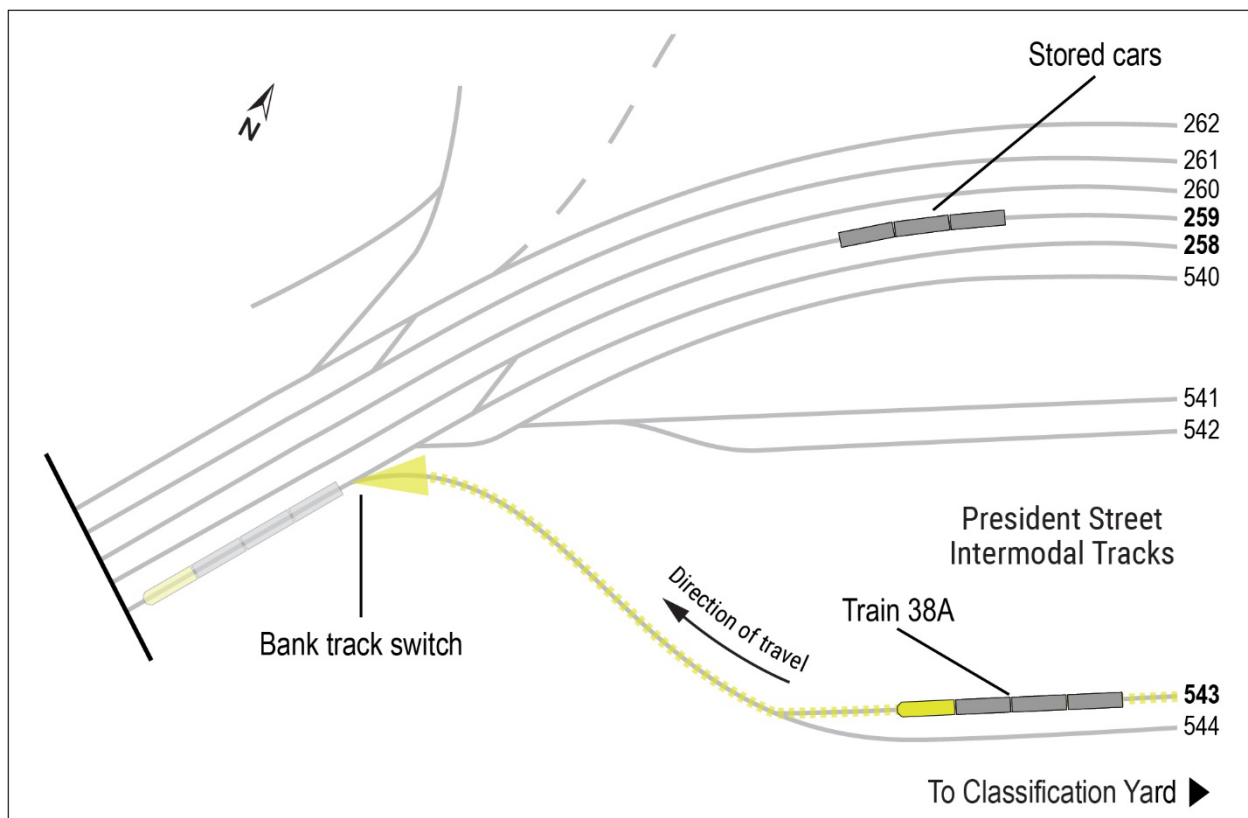
Figure 2. Train 38A movement south through President Street intermodal tracks.

Note: The yellow line and arrow at the bottom of the graphic show the movement of train 38A south after it aligned with track 543 and headed toward the Bank track switch to drop off four railcars and continue south.

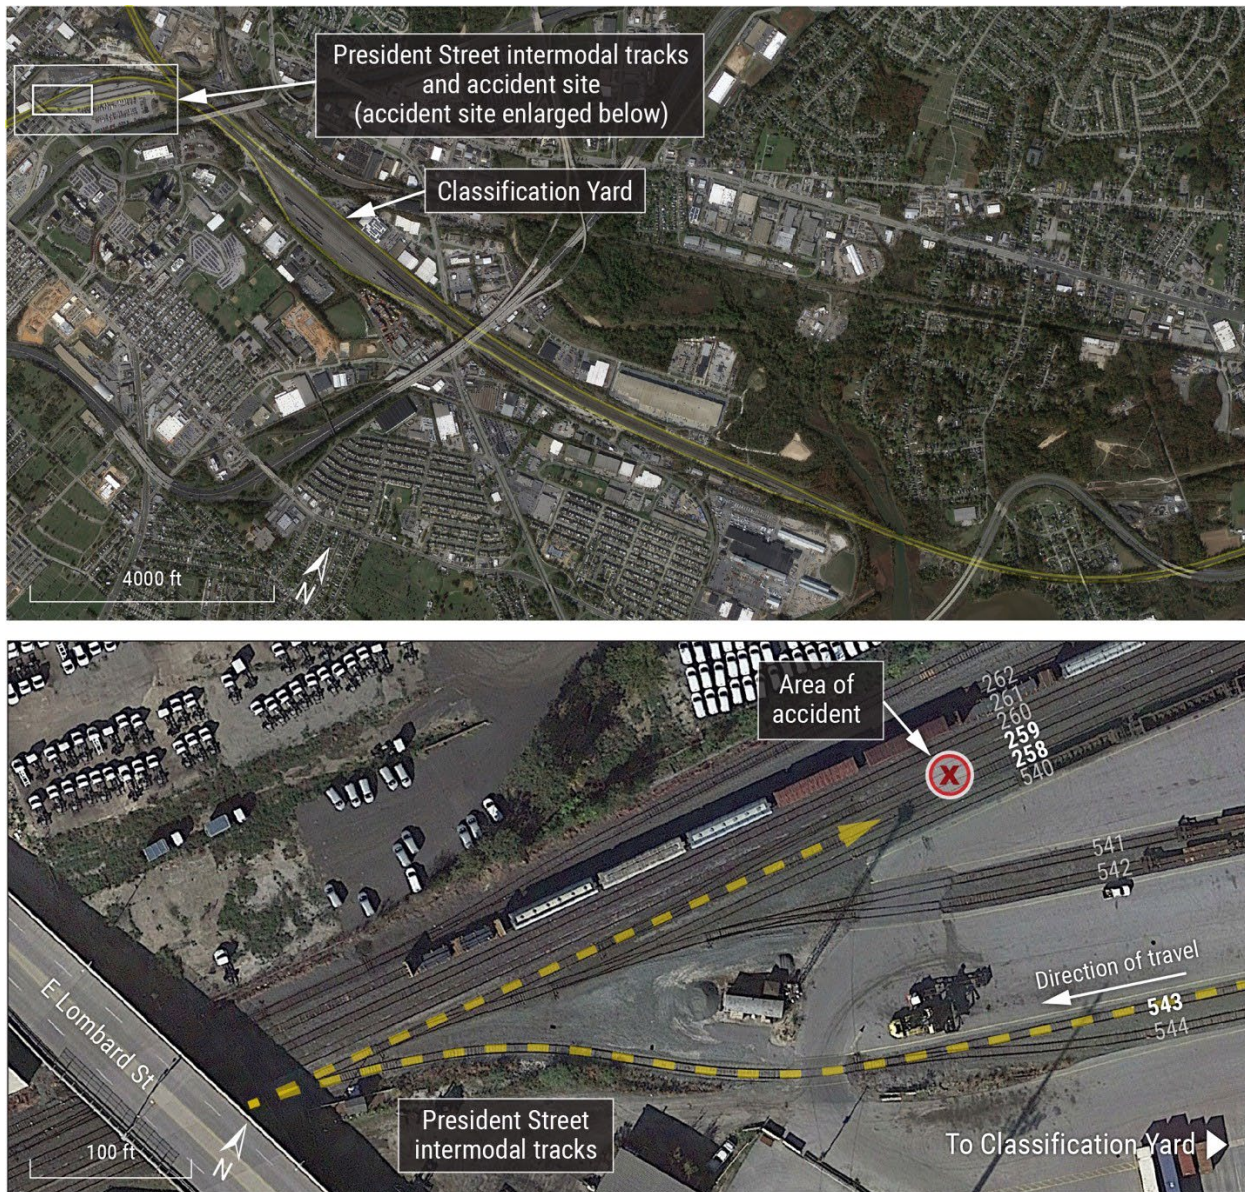
Figure 4. Google satellite photographs of Bayview Yard.

Note: The upper graphic is a map showing the President Street intermodal tracks, accident site, and the Classification Yard within the Bayview Yard. The lower map provides a yellow line and directional arrows showing train 38A's movement before the accident. The red X shows the accident location between tracks 258 and 259.
