Issued: December 8, 2022

Railroad Investigation Report: RIR-22/14

Canadian Pacific Railway Raking Collision and Impact with Standing Train

St. Paul, Minnesota
August 25, 2021

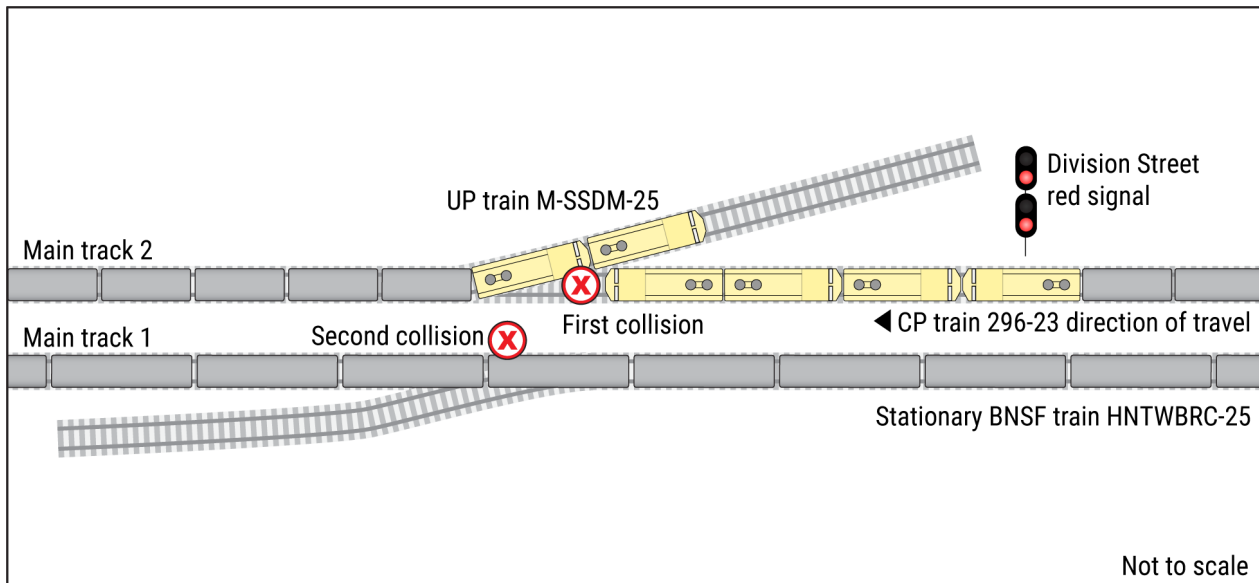
Figure 1. Diagram of collision.

released the brakes and started to descend the grade with the throttle in the idle position, moving toward control point Division Street, which displayed a red signal.³ (See figure 1.) The distance between the two control points was about 3,560 feet.

CP train 296-23 was traveling to St. Paul, Minnesota, on BNSF tracks. The train passed a red (stop) signal at control point Division Street at a speed of about 19 mph and collided with a standing UP train on the same main track, derailing one CP locomotive and two UP locomotives. The derailed CP locomotive then collided with a railcar of a BNSF train that was stopped on the adjacent main track.
