CSX Transportation Freight Train and Southeastern Pennsylvania Transportation Authority Trolley Collision

Darby, Pennsylvania
December 9, 2021

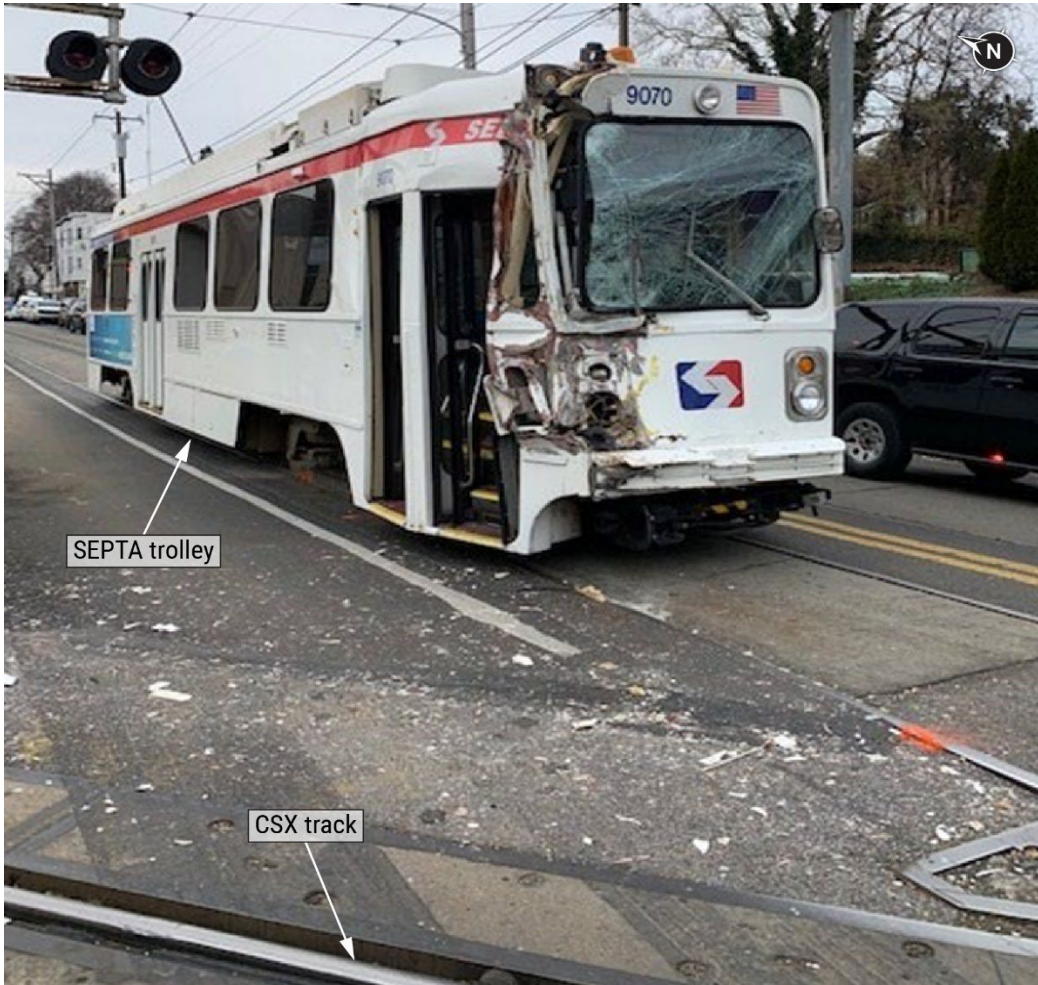
collided with the trolley at 8:25:38 a.m. at a speed of 22 mph. The train struck the right front and side of the trolley, pushing it backwards (west) but not derailing it.⁵ (See figure 2.)

Figure 2. Damaged trolley and CSX track.
