Railroad Investigation Report RIR-24-06

# Norfolk Southern Railway Employee Fatality

Cleveland, Ohio

March 7, 2023

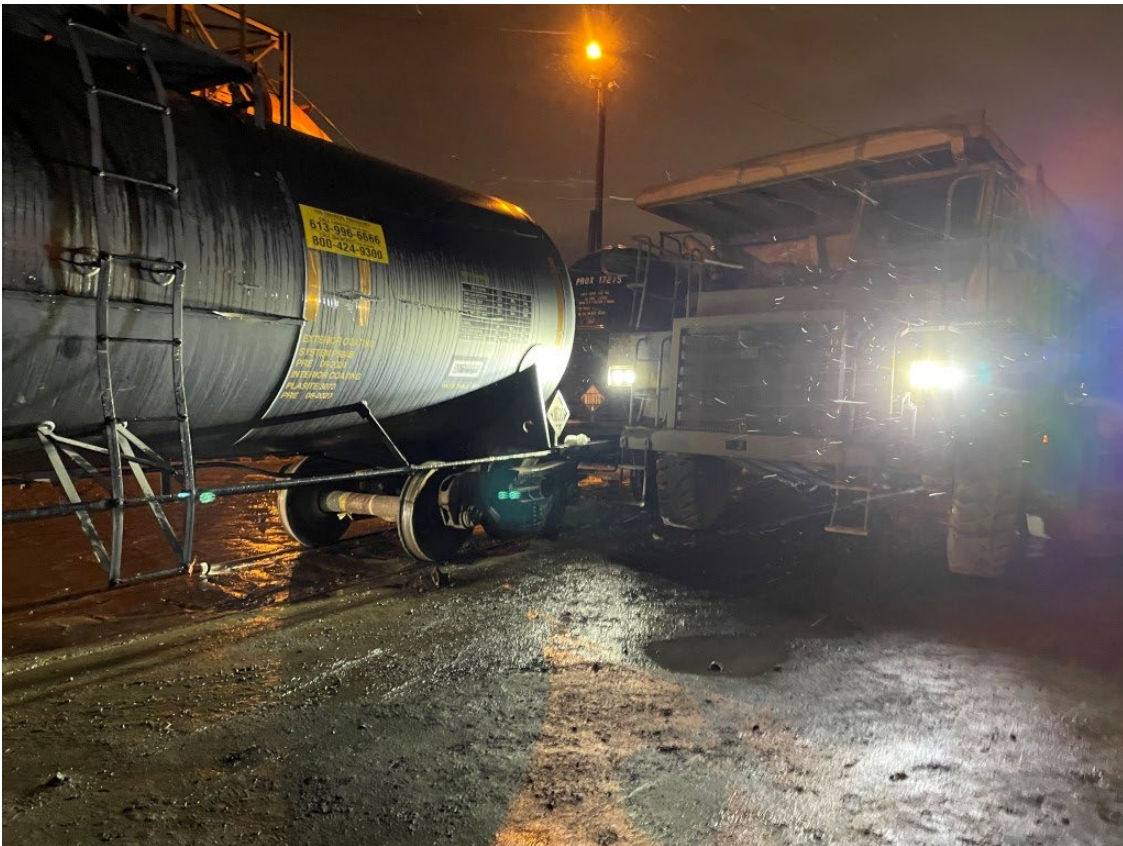
The dump truck was driven by a Stein LLC employee and was hauling limestone at the time of the collision. Cleveland-Cliffs surveillance camera data reviewed by NTSB investigators showed the dump truck traveling south through the steel plant, approaching the private grade crossing. The dump truck stopped at the stop sign at 1:08:29 a.m. Then, at 1:08:32 a.m., the dump truck began moving toward the crossing. The driver applied the brakes upon seeing the approaching train, but the dump truck was already in the crossing. At 1:08:35 a.m., the train and dump truck collided within the crossing. (See figure 2.) During interviews with NTSB investigators, the driver stated that he did not see the train while stopped at the stop sign because of the angle of the crossing and the lack of lighting.

**Figure 2.** The final resting place of the dump truck and train. (Source: Federal Railroad Administration [FRA].)
