# Chicago Transit Authority Yellow Line Train Collision with Snow Removal Machine

Chicago, Illinois  
November 16, 2023

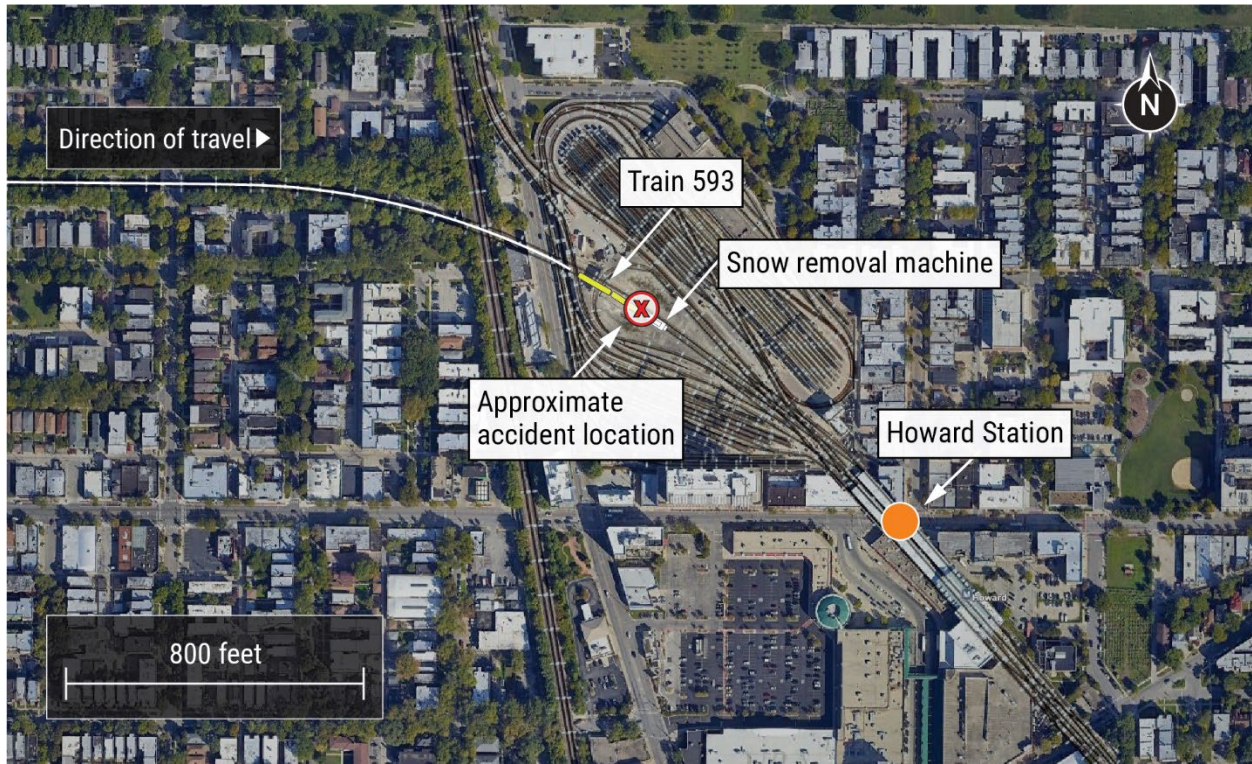
On November 16, 2023, about 10:30 a.m. local time, southbound Chicago Transit Authority (CTA) Yellow Line passenger train (train 593) collided with a stationary CTA snow removal machine (S-500) on south Skokie track 1 near Howard Yard and derailed.<sup>1</sup> (See figure 1.) The train was carrying 1 operator and 30 passengers; there were 6 CTA employees on board the snow removal machine. Sixteen people were transported to a hospital, treated, and released. Three people were critically injured, including the operator. There were no fatalities. The train remained upright following the collision. CTA estimated damages to equipment to be about \$8.7 million. At the time of the accident, visibility conditions were daylight and clear; the weather was 61°F with no precipitation.

**Figure 1.** Overview of the accident site. (Courtesy of Google Earth.)

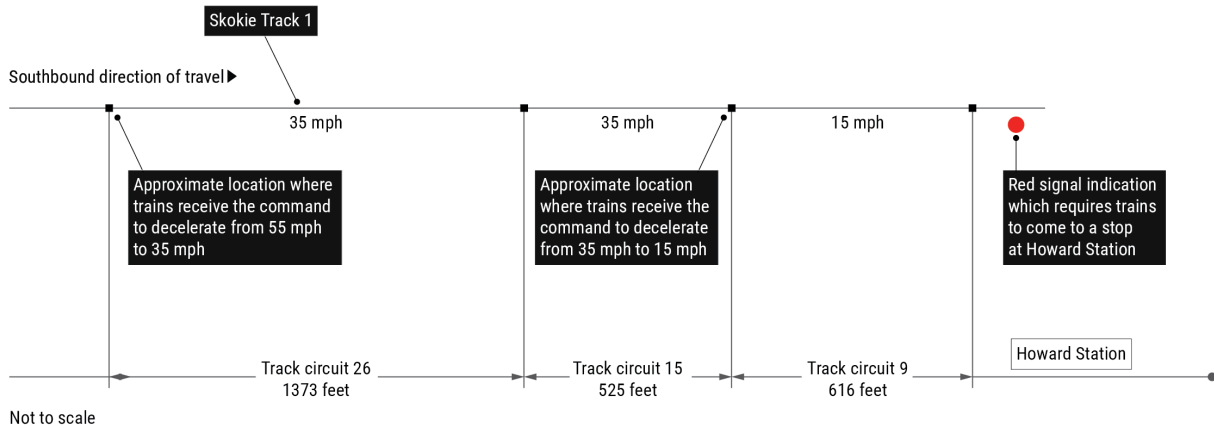
Train movement on the Yellow Line were authorized by wayside and in-cab signal indications from an ATC system and coordinated from a rail operations control center. The ATC system used track circuits and signal blocks to detect trains on the track.<sup>4</sup> A Yellow Line southbound train approaching Howard Station would traverse through track circuit 26 (about 1373 feet long), track circuit 15 (about 525 feet long), and track circuit 9 (about 616 feet long) to reach Howard Station. The signal block at the accident site extended from the beginning of track circuit 26 to the end of track circuit 9. The ATC system was configured to allow only one train or rail equipment in a signal block. A train entering track circuit 26 would automatically get a zero-speed command from the ATC system if there was another train or rail equipment within the signal block and would stop within a distance of 1,780 feet or less in ideal conditions.<sup>5</sup> The maximum authorized speed for trains on the Yellow Line were set by CTA at 55 mph. Under normal operating conditions and when there were no other trains or rail equipment within the signal block, the operator of a southbound train entering track circuit 26 would receive a command to decelerate from 55 mph to 35 mph. As the train entered track circuit 9, the operator would receive another command to decelerate further to 15 mph. The operator would then manually reduce the train's speed while approaching the red signal indication at the entrance to Howard Station and stop the train at the station.<sup>6</sup> (See figure 2.)

**Figure 2.** Movement of Trains on Skokie Track 1 during normal operations. (Courtesy of CTA).

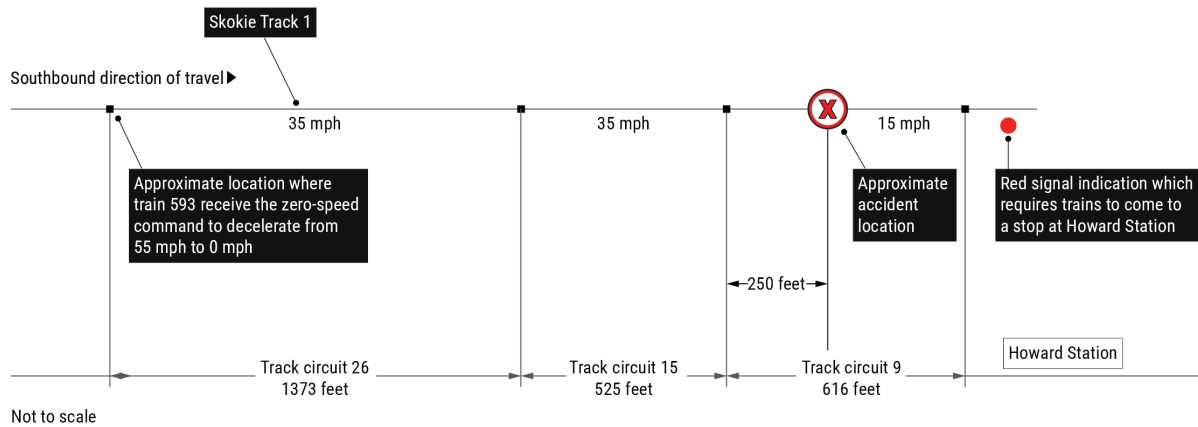
Shortly before the collision, during a southbound movement, the snow removal machine had stopped in track circuit 9 about 370 feet north of a red signal indication before entering Howard Station. At this time, train 593 was traveling southbound toward Howard Station about 54 mph on the same track. At 10:30:22 a.m., as the train entered track circuit 26, the operator received an in-cab zero-speed command from the ATC system, because the snow removal machine was already present within the signal block.<sup>7</sup> The train received the zero-speed command about 2,150 feet from the stopped snow removal machine. The train operator initiated a full-service braking application about

1 second later.<sup>8</sup> When interviewed by the NTSB, the operator said that he noticed that the train had started sliding and was not slowing down as much as it should have. The NTSB’s subsequent review of event recorder data showed that the train’s wheel slide protection system activated during the full-service braking application and modulated the train’s dynamic and friction brakes. The operator saw the snow removal machine and initiated an emergency braking application at 10:30:41 a.m., which activated the train’s dynamic, friction, and track brakes.<sup>9</sup> The train decelerated to about 23 mph before striking the snow removal machine at 10:30:50 a.m. (See figure 3 and figure 4.)

**Figure 3.** Movement of Train 593 on Skokie Track 1 on November 16, 2023. (Courtesy of CTA).

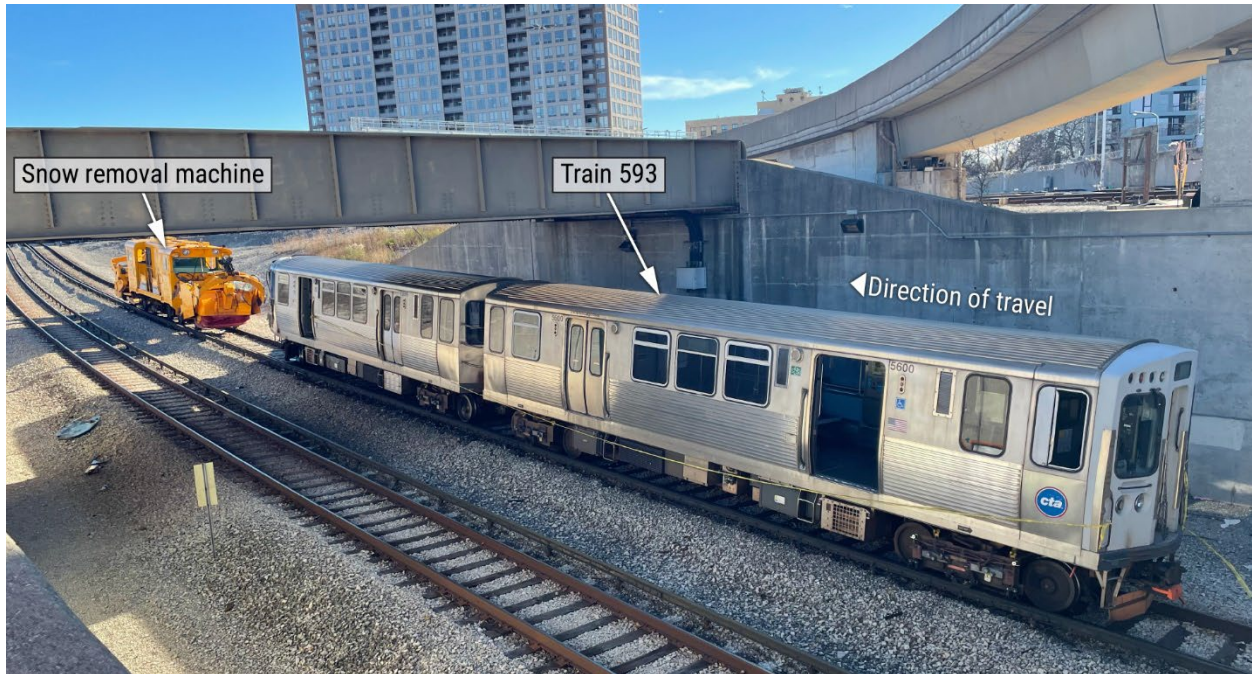
**Figure 4.** Train 593 and the snow removal machine on the Yellow Line after the accident.
