Railroad Investigation Report RIR-23-13

# Watco Dock and Rail, L.L.C.

## Employee Fatality

Houston, Texas

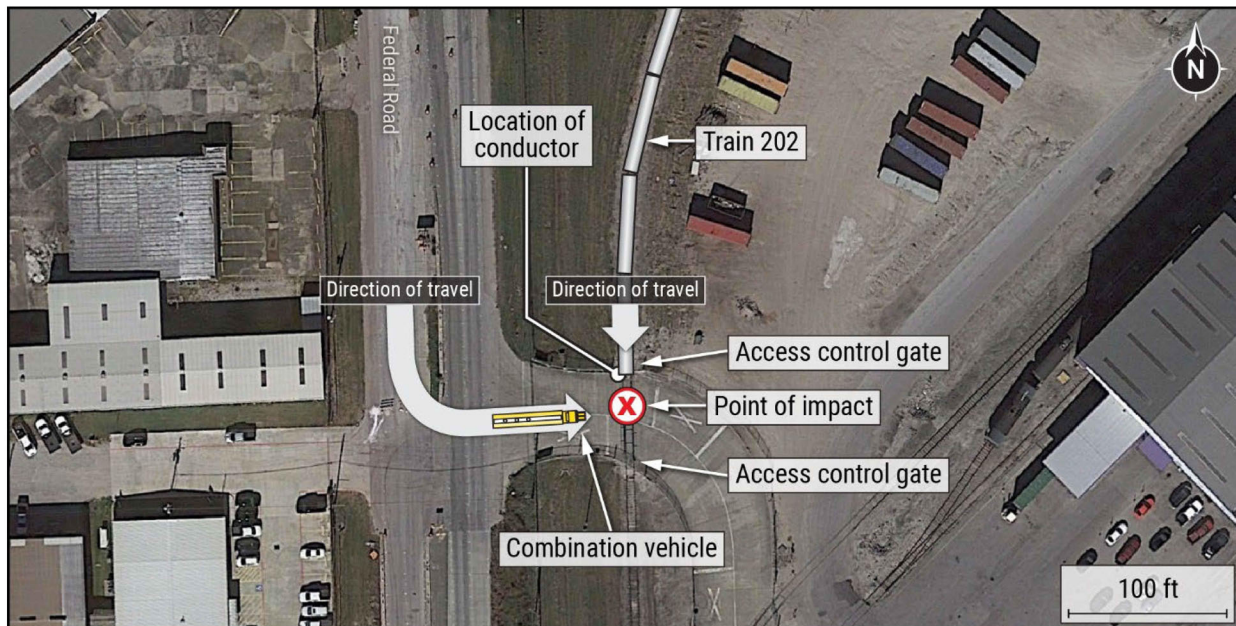
**Figure 1.** Overhead photograph of accident location. (Source: Google Earth.)

On the day of the accident, at 3:58:22 a.m., the crew began shoving the 2 locomotives and 25 tank cars about 30 to 40 railcar lengths southward from the lead track to switching track 905. The engineer was operating the locomotive, and the accident conductor was positioned on the west side of the last car's platform to protect the shoving movement. The other conductor was on the ground next to tank cars south of the crossing.<sup>3</sup> The combination vehicle was traveling on Federal Road parallel to the tracks in the same direction as train 202.

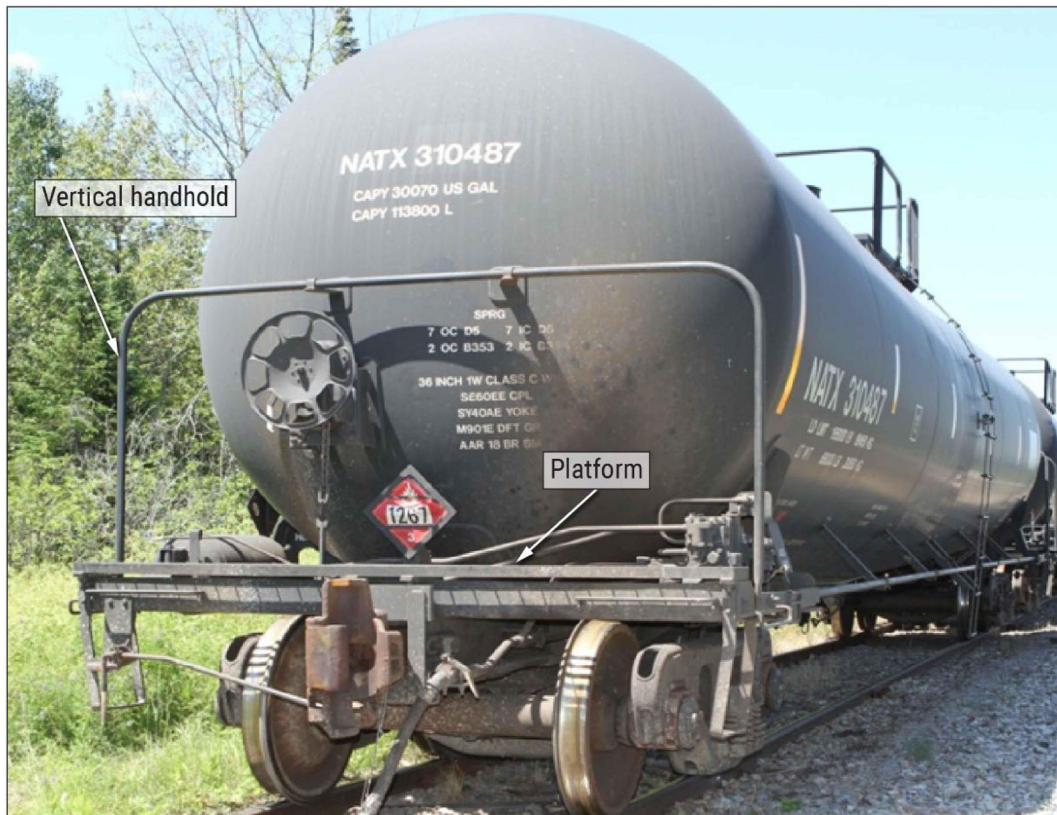
the tank car as required by WDRL's Transportation Safety Rule T-17, Riding In or On Moving Equipment, with three points of contact (two feet on the platform and one hand on a vertical handhold). (See figure 2.) The accident conductor held onto the vertical handhold with his left hand, so that his body was partially turned away from the side of the highway-railroad grade crossing from which Federal Road traffic approaches. He was holding his lantern in the crook of his right elbow with his right hand on the radio microphone button to communicate with the locomotive engineer.

**Figure 2.** Exemplar tank car depicting the vertical handhold and platform. (Source: Transportation Safety Board of Canada.)

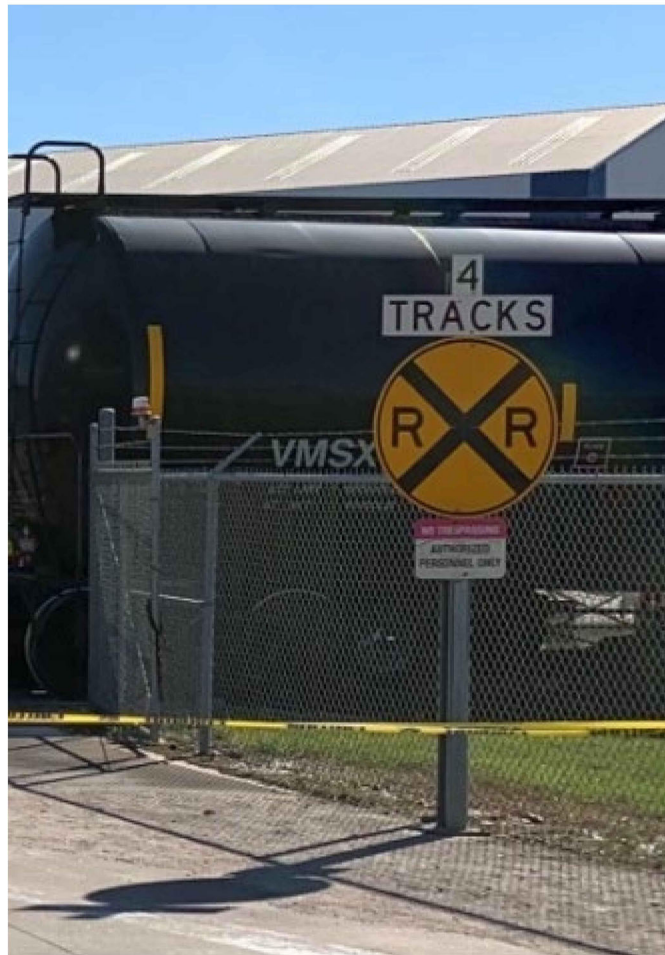
The grade crossing was equipped with passive warning devices including pavement markings and an advance warning sign facing Federal Road. (See figure 3.) The grade crossing was not equipped with active warning devices (such as lights that flash only when a train is approaching or occupying a crossing) or crossing gates, nor was an employee stationed at the crossing to protect it.

**Figure 3.** Highway-railroad grade crossing at Greens Port Industrial Park (Source: Federal Railroad Administration.)

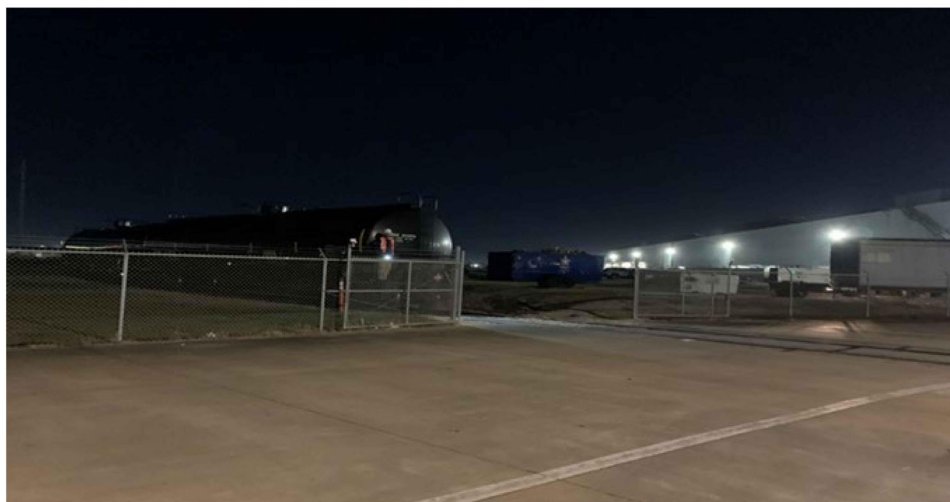
The NTSB conducted a partial re-enactment of the accident at the highway-railroad grade crossing near Greens Port Industrial Park about 4:00 a.m. on October 31, 2021. Multiple Gemini combination vehicles entered and exited the facility during the re-enactment. The NTSB observed that the south side of the driveway crossing the railroad tracks was well-illuminated by a private flood light located south of the highway-railroad grade crossing. (See figure 4.) The north side of the driveway did not have a flood light, and it was dark. Despite the darkness, NTSB personnel could see a person standing on a tank car moving toward the crossing.

**Figure 4.** Flood lights at the industrial park entrance.

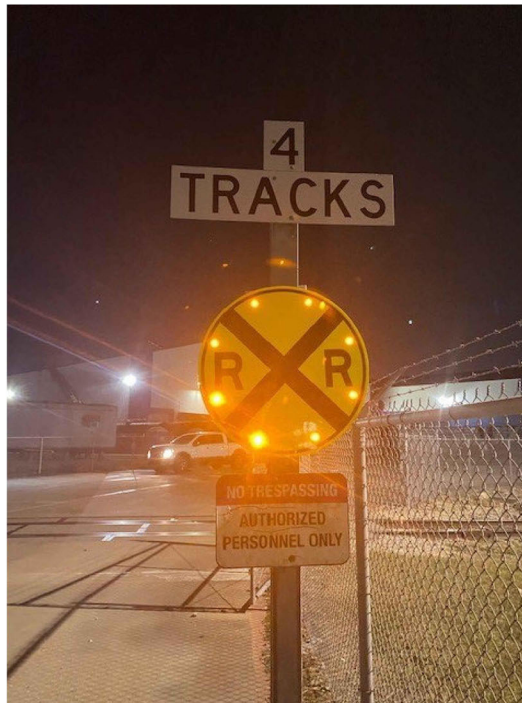
**Figure 5.** Highway-railroad grade crossing signage with LED lights.

WDRL also equipped the private highway-railroad grade crossing's advance warning signage with LED (light-emitting diode) lights. (See figure 5.) The intent was to make the signage more visible to truck drivers who enter the driveway that intersects with the private highway-railroad grade crossing. Further, WDRL conducted assessments to identify other crossings within the Greens Port Industrial Park that could benefit from this added protection.
