Railroad Investigation Report RIR-23-15

Derailment of Washington Metropolitan Area Transit Authority Train Near Rosslyn Station

Arlington, Virginia
October 12, 2021

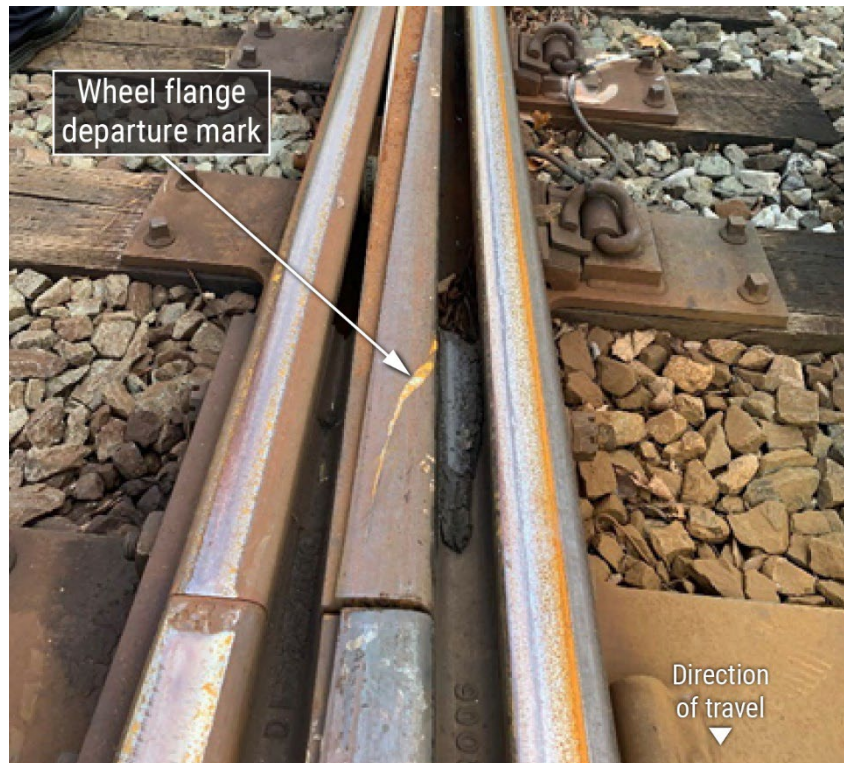
As a result of the investigation into the Rosslyn Station derailment, WMATA employees discovered damage to switches 1A and 3A chain marker 187+25 on main track 1 in a crossover north of Arlington Cemetery Station, including wheel flange departure marks near the switch point (across a switch point guard) of switch 1A.¹² (See Figure 5.) While examining the track between switch 1A and switch 3A, the NTSB noted damage to two switch heel blocks, bolts, ties, and automatic train control

equipment consistent with one or more derailed wheels running along the ground and re-railing as they approached switch 3A. (See figure 6.) WMATA employees also found broken sections of brake disc in this area, which the NTSB matched to the right-side brake disc on wheelset #4 of railcar 7200.¹³

Figure 5. Wheel flange departure mark on the switch point guard near the heel of 1A switch.

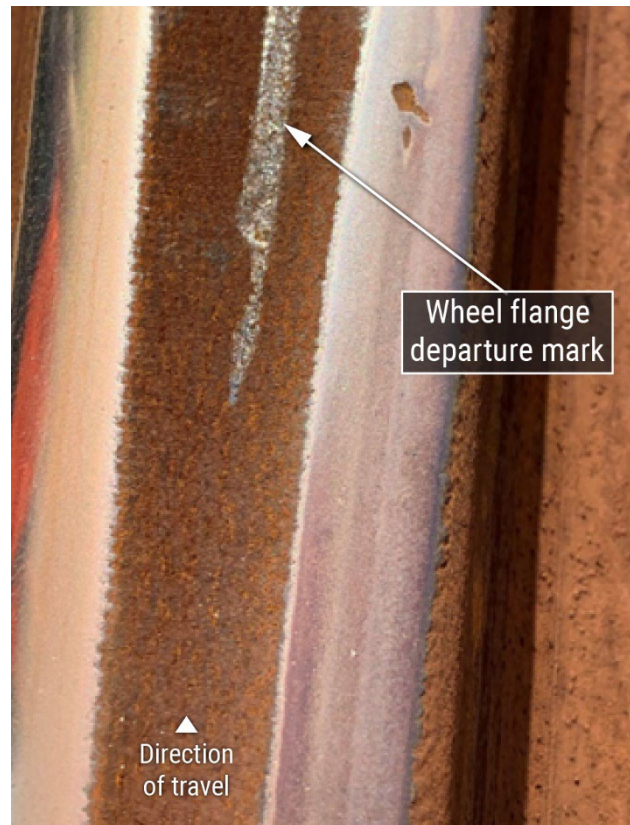
The NTSB also identified wheel flange departure marks on the tread portion of the track (the tread portion carries the wheel tread) on switches 1B and 3B at crossover G05 west of Largo Town Center Station at chain marker 621+98 on main track 2. (See figure 7.) In addition, the NTSB identified wheel marks on the ground, broken ground pads, and damaged automatic train control equipment between switch 1B and switch 3B. The damage was consistent with one or more derailed

wheels running along the ground and re-railing as it neared switch 3B. The NTSB found fragments of brake disc at the crossover.¹⁴

Figure 7. Wheel flange departure mark on the tread portion of a frog point at the 1B switch.

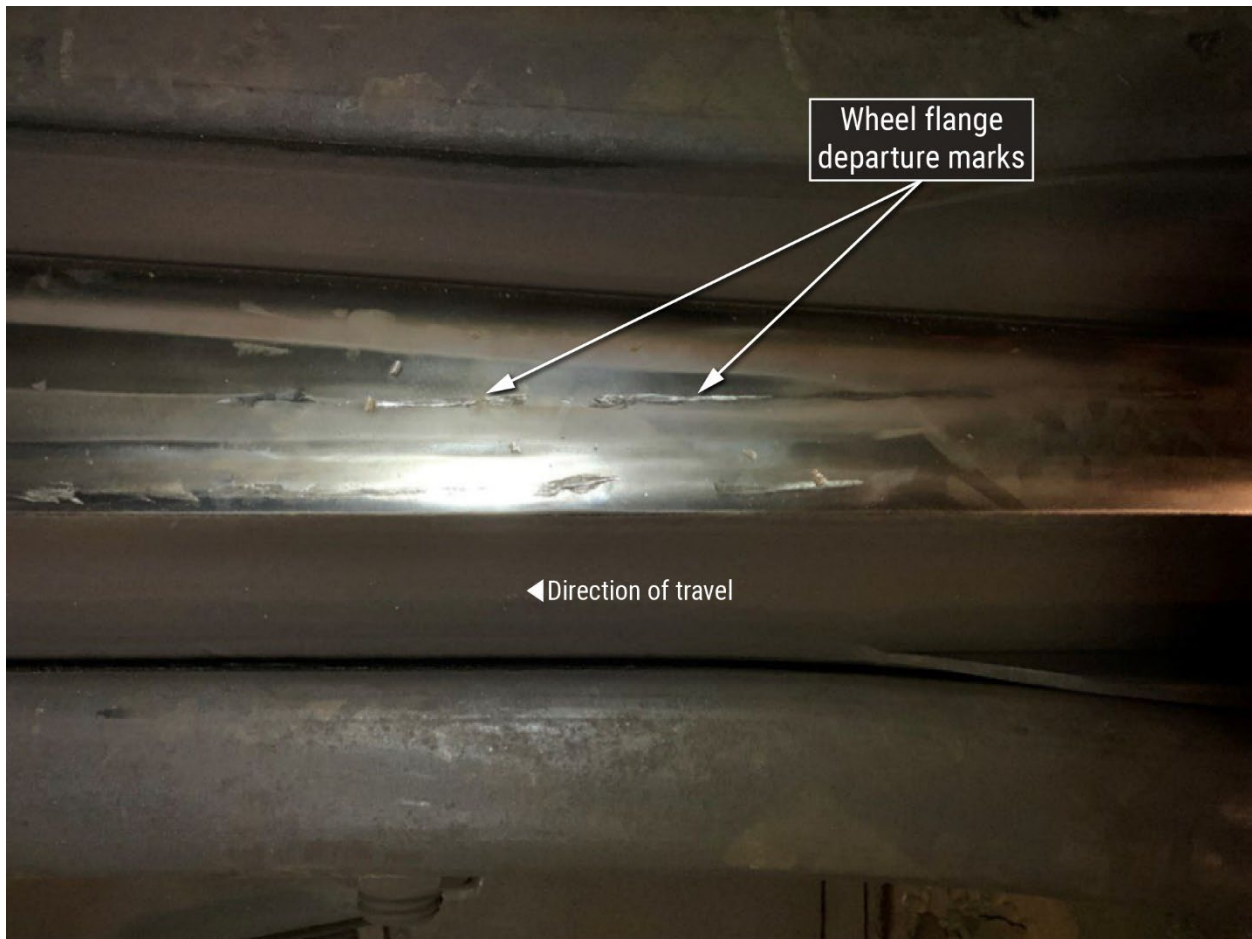
The NTSB identified wheel flange departure marks in the turnout at the frog of the switch in the C05 turnout at chain marker 146+70, about 166 feet south of Rosslyn Station. (See figure 9 and figure 10.) Investigators also found wheel departure marks on other track components nearby. This turnout was the final point of derailment.

Figure 9. Wheel flange departure marks on the tread portion of the frog point at the C05 turnout.

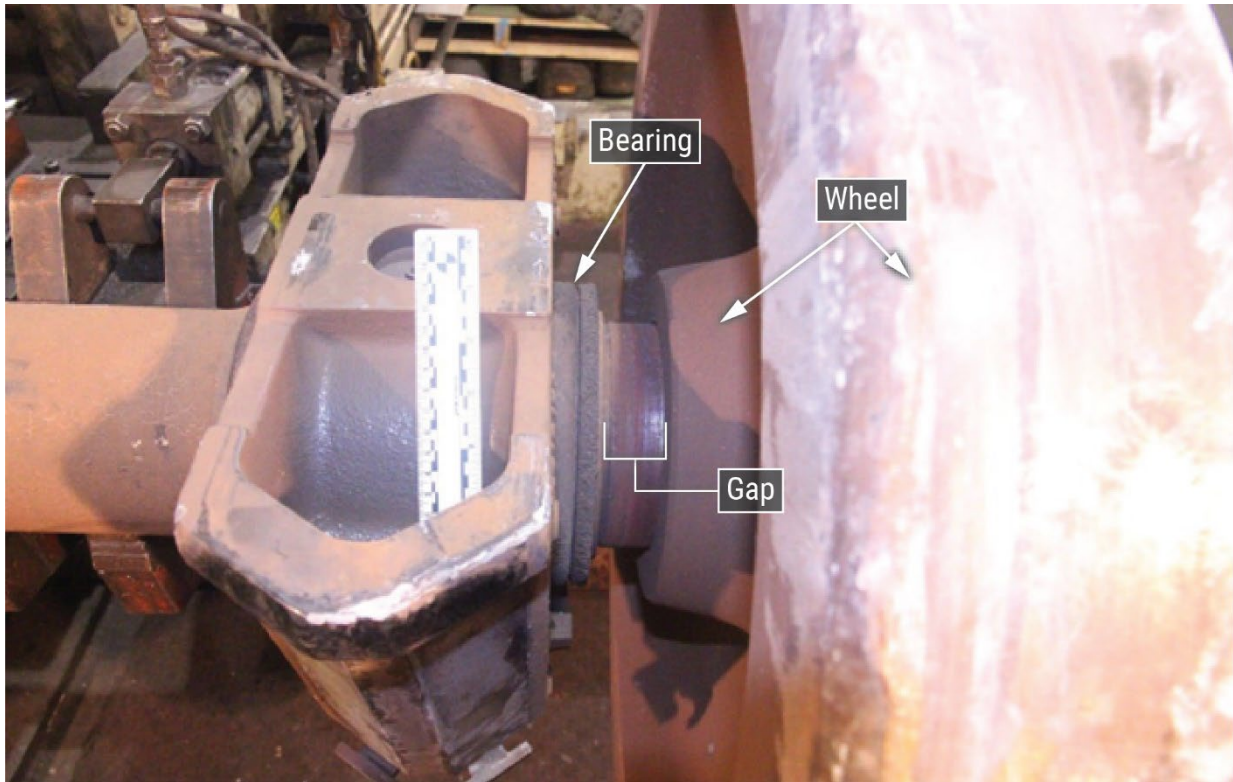
The NTSB observed the inspection and disassembly of wheelset #4 from railcar 7200 at the WMATA Greenbelt maintenance facility on October 20, 2021. In accordance with wheelset design, each wheel should have been flush against its bearing when mounted. Before disassembly, the inspection identified gaps between both wheels and their respective bearings: about 0.63 inches for the right-side wheel and about 1.10 inches for the left-side wheel. (See figure 12 and figure 13.) The back-to-back measurement was about 55.375 inches, or about 2 inches wider than the maximum design specification.²⁰

Figure 12. Gap between the right-side wheel and bearing on wheelset #4.

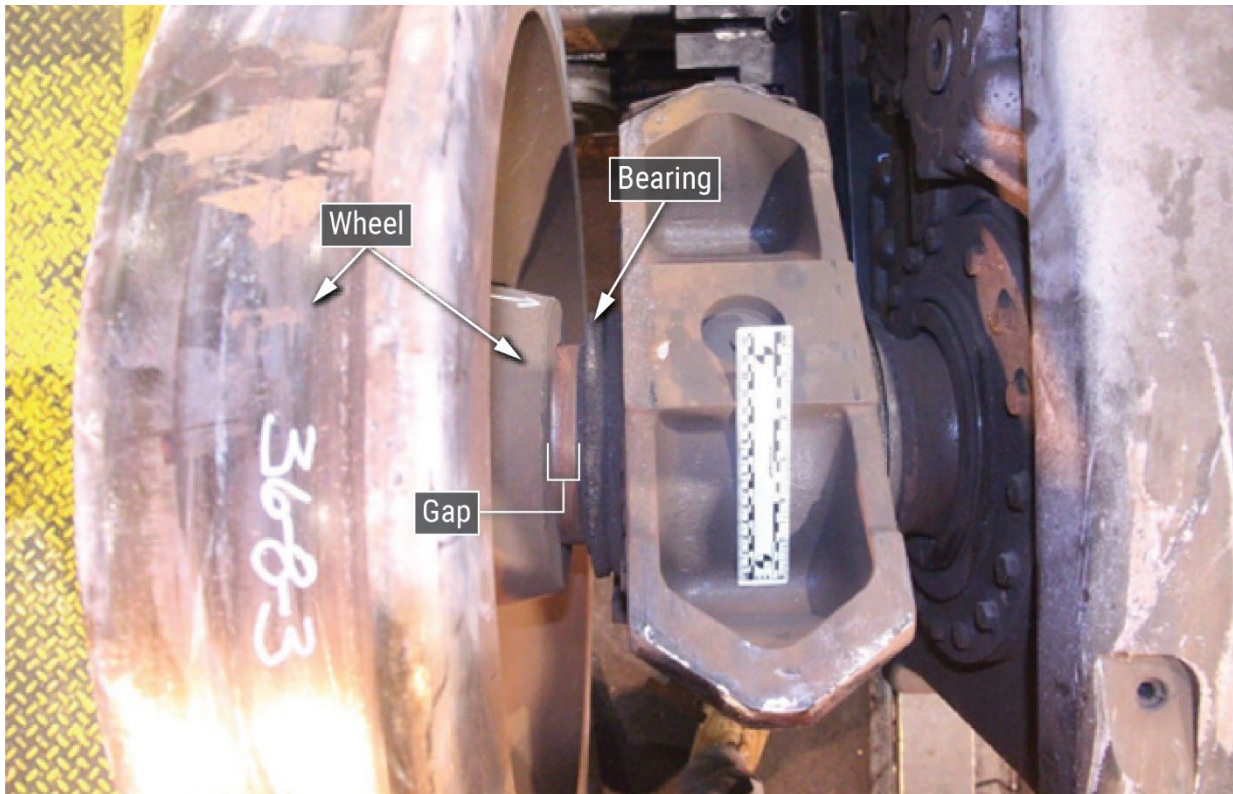
Figure 13. Gap between the left-side wheel and bearing on wheelset #4.

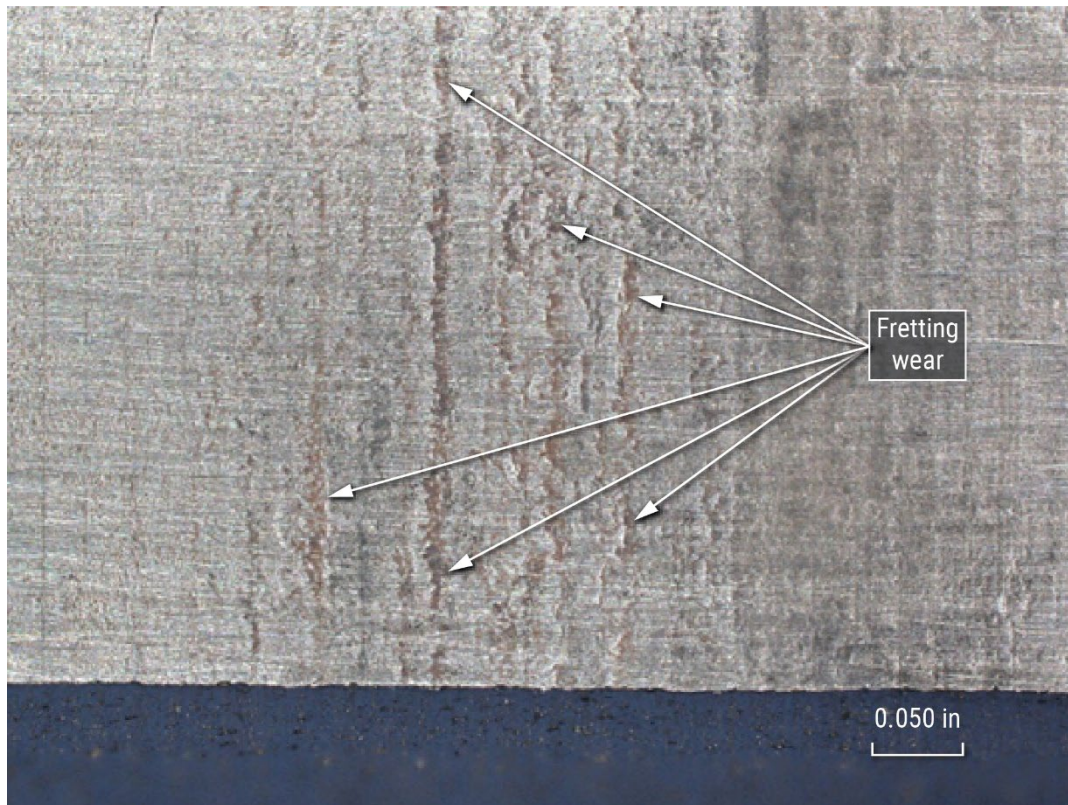
After cleaning the axle to remove obscuring surface oxidation and to allow further examination, the NTSB Materials Laboratory identified circumferential bands consistent with fretting wear on the axle wheel seat surface. Fretting wear results from small oscillations between two bodies in contact. Fretting wear tends to roughen surface finishes, leading to oxidation and reducing the strength of the connection between components. In axles, fretting wear can be a sign of ratcheting extrusion, in which an axle under simultaneous bending and lateral stresses will experience movement between the wheel bore surface and the axle wheel seat (Nishimura, Sakatmoto, and Kawashima 2001).

The most severe observed region of fretting damage, located on the right-side axle wheel seat surface, exhibited parallel wavy and linear features oriented perpendicular to the axle's long axis. The features exhibited a reddish-brown color consistent with oxidation (rust). (See figure 14.)

Figure 14. Close-up of the most severe fretting wear on the right-side axle wheel seat.
