Railroad Investigation Report: RIR-24-02

Norfolk Southern Railway Employee Fatality

Bessemer, Alabama

December 13, 2022

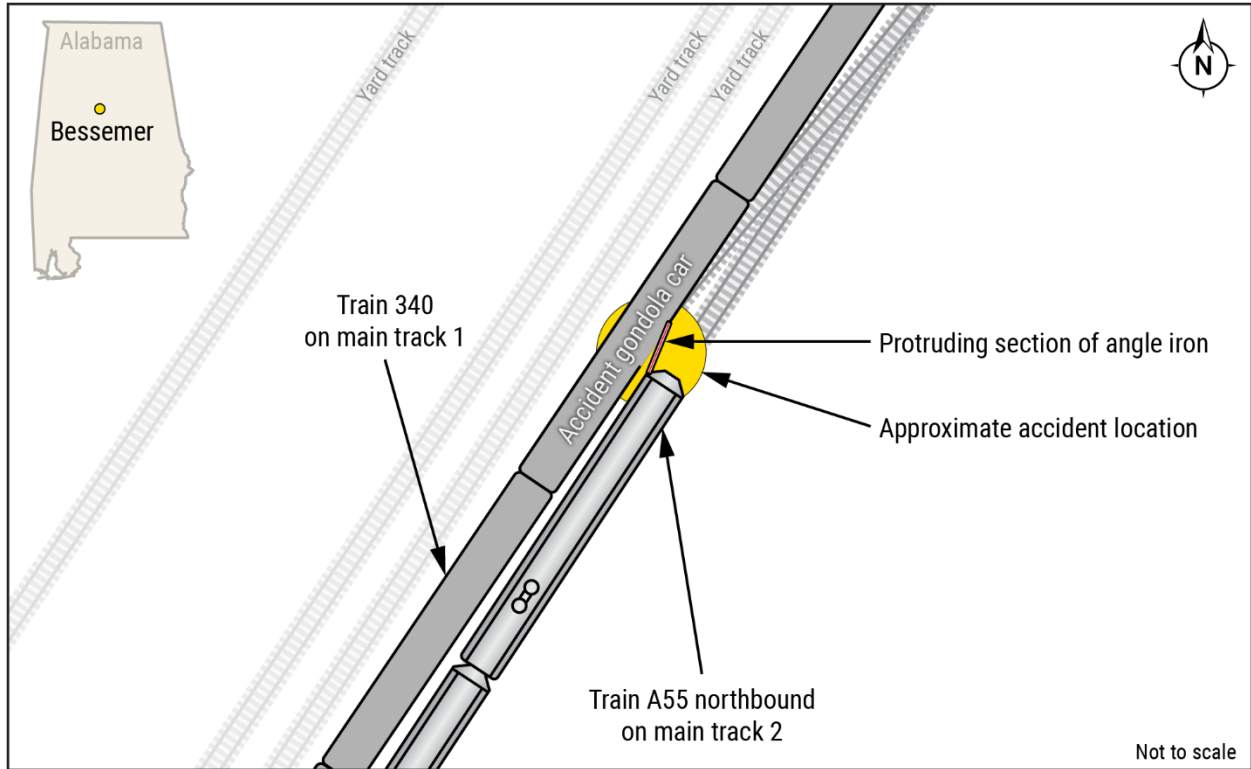
On December 13, 2022, about 12:01 a.m. local time, the lead locomotive of Norfolk Southern Railway (NS) freight train A55-12 (train A55) struck a length of steel angle iron protruding from a gondola car on stationary NS freight train 340-12 (train 340) on the Alabama Great Southern South Subdivision in Bessemer, Alabama.¹ Train A55 was traveling northbound about 54 mph on main track 2; train 340 was stopped on main track 1. The gondola car, SSEX 100843 (hereafter the gondola car), was part of a block of 21 railcars recently added to train 340 from a yard track near a U.S. Pipe recycling facility. The section of angle iron was protruding from the top edge of the gondola car on its east side, fouling main track 2 at milepost 153.5.² (See figure 1.) As the lead locomotive of train A55 passed the gondola car on the adjacent track, the section of angle iron penetrated the locomotive's left-front door window, continued into the operating cab, and struck the conductor trainee. The conductor trainee was killed, and the conductor was transported to a local hospital for minor injuries. Visibility conditions at the time of the accident were dark and clear; the weather was 50°F with no precipitation.

Figure 1. Diagram of accident scene.

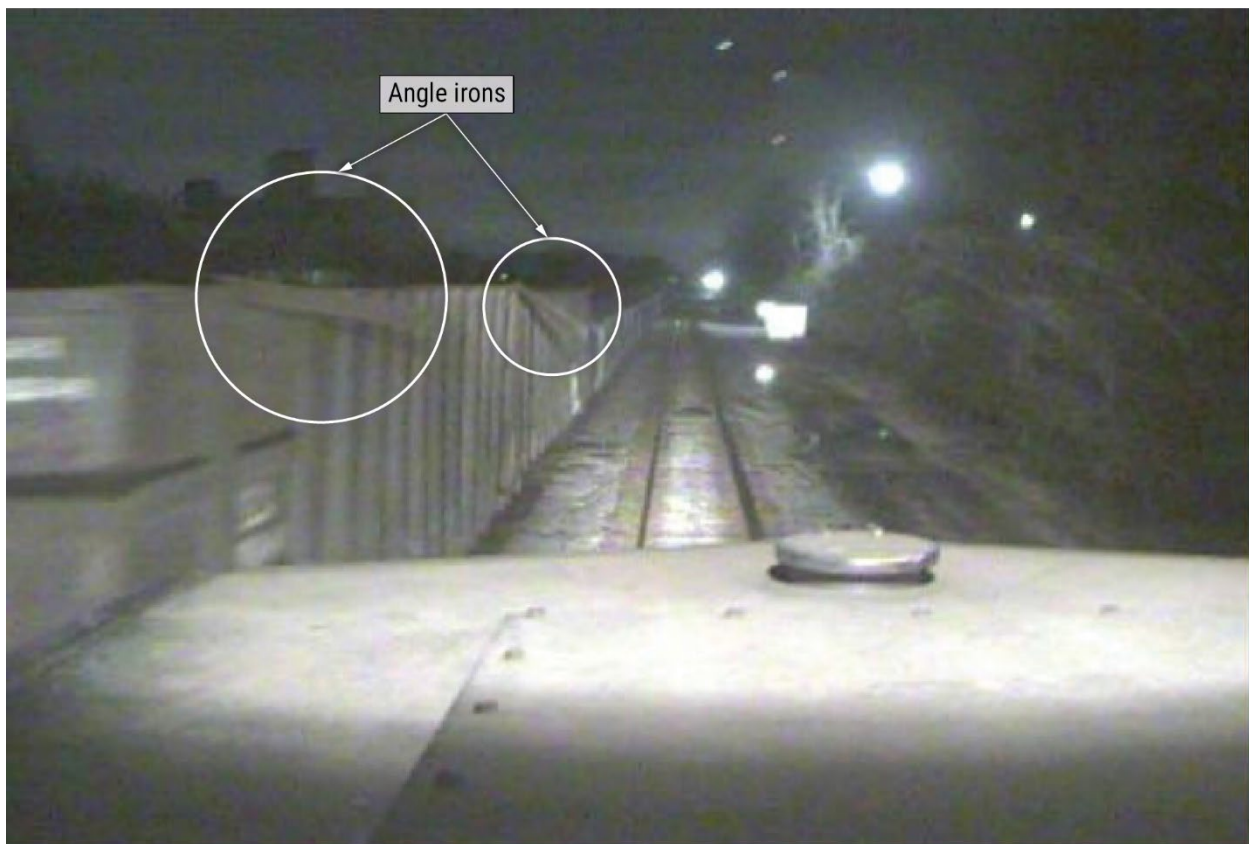
When interviewed by the National Transportation Safety Board (NTSB), the engineer said that train A55 was traveling northbound about 55-60 mph as it approached the stationary train 340 about midnight on the day of the accident. He saw a piece of steel protruding from the side of train 340 immediately before the accident. Images from the lead locomotive's outward-facing image recorder show two sections of

angle iron protruding from the top cord of the gondola car.⁴ (See figure 2.) The section of angle iron that was protruding toward train A55 entered the cab of the locomotive, propelling broken glass into the cab and striking the conductor trainee. Immediately after the section of angle iron struck the locomotive, the engineer initiated an emergency application of the train's brakes and called his dispatcher for assistance. According to event recorder data reviewed by the NTSB, train A55 was traveling 54 mph at the time of the emergency brake application. After bringing the train to a stop, the engineer asked the dispatcher for permission to reverse to a nearby highway-railroad grade crossing to await emergency responders. He repositioned the train so that the lead locomotive occupied the crossing, allowing emergency responders access when they arrived about 12:13 a.m. on December 13, 2022. The conductor trainee died at the scene.

Figure 2. Gondola car and protruding angle iron section immediately before impact. (Source: NS.)

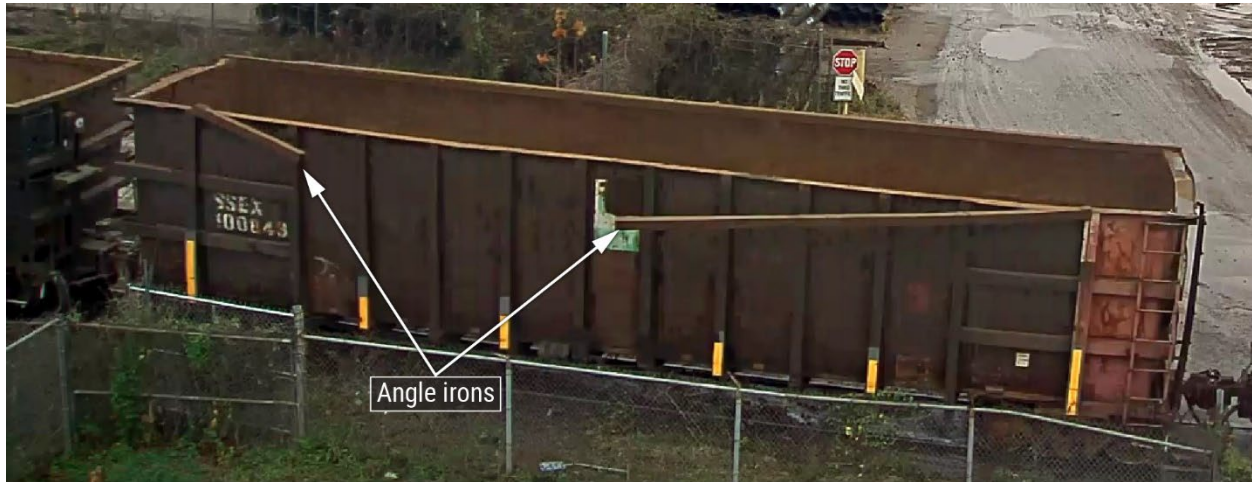
The crew of train A39, which included an engineer, a conductor, and a conductor trainee, went on duty on December 12, 2022, at 9:01 a.m. Train A39 picked up railcars, including the accident gondola car, from the U.S. Pipe facility and positioned them on the “hill track.”⁷ Images from a U.S. Pipe surveillance camera show angle iron sections protruding from the accident gondola car as it departed the U.S. Pipe facility. (See figure

3.) When interviewed by the NTSB, the conductor of train A39 reported inspecting both sides of the railcars before moving them, as required by NS operating rule C-100, and did not report any defects.⁸ When interviewed by the NTSB, the conductor noted the presence of scrap metal on the ground and the need to pay attention to where he was walking to avoid injury; his line of sight was mostly directed downward toward the ground, brake equipment, and wheelsets. The inspection and movement occurred during daylight hours.

Figure 3. Accident gondola car departing U.S. Pipe facility. (Source: U.S. Pipe.)

Investigators observed broken welds at intervals along the top edge of the gondola's east side where the section of angle iron had been attached. The individual welds were small and not part of the gondola’s original construction, consistent with a previous repair. A second angle iron section along the top edge of the east side was partially attached and protruding from the gondola car near its B end (the end with the brake wheel). (See figure 3.)

Based on the NTSB's review of surveillance camera images from the U.S. Pipe facility, the accident gondola car was undamaged when it was delivered to the facility on December 4, 2022. However, images captured on December 7, 2022, after U.S. Pipe employees unloaded the gondola car with a crane, show two angle iron sections protruding from the top edge of one side of the gondola. These images confirm that the gondola was damaged at the U.S. Pipe facility during unloading.

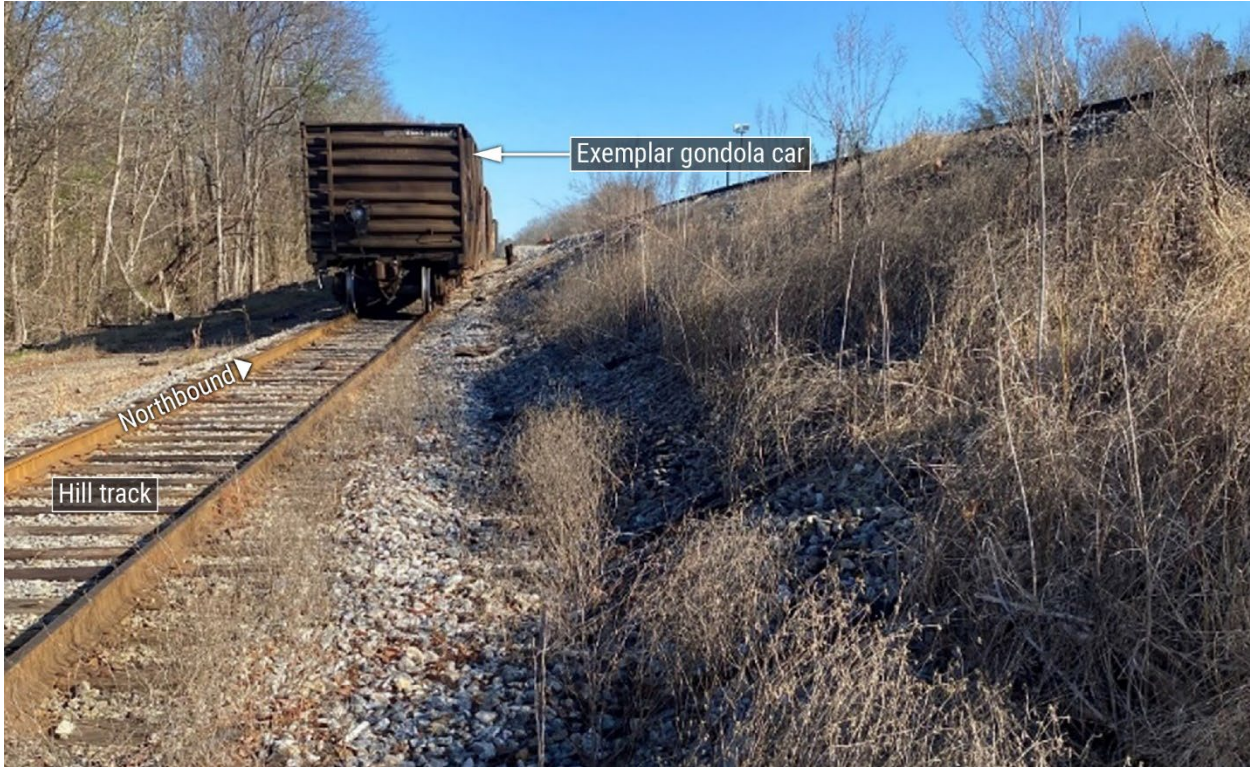
Train 340 approached the NS yard in Bessemer about 11:15 p.m. on December 12, 2022. The crew was assigned to pick up railcars, including the accident gondola car, from the hill track, which was accessible only by main track 1. When interviewed by the NTSB, the conductor said that the crew decided to start the pre-departure inspection in the yard on the west side of the railcars because of unsafe walking conditions on the east side of the hill track, which consisted of an incline slope adjacent the track and what the conductor described as insufficient walking space and “bad footing.” (See figure 4.) The crew planned to complete the remaining pre-departure inspection of the east side of the train on main track 1.⁹

Figure 4. North-facing view of the hill track with exemplar gondola cars. (Source: Federal Railroad Administration (FRA).)
