Railroad Investigation Report: RIR-24-08

# CSX Transportation Employee Fatality

Cumberland, Maryland

August 6, 2023

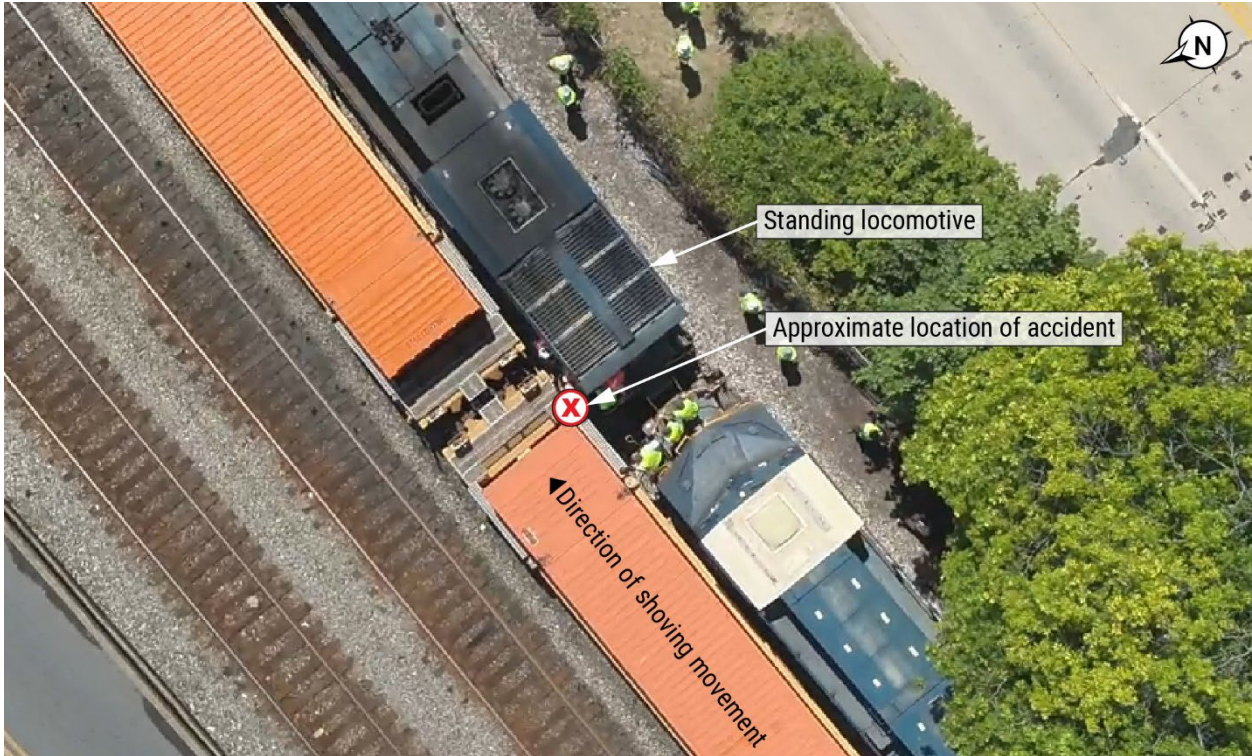
On August 6, 2023, about 11:42 p.m. local time, a CSX Transportation (CSX) conductor trainee was fatally injured during switching operations at the CSX railyard in Cumberland, Maryland.<sup>1</sup> The conductor trainee was riding on the side of a railcar on CSX train I13706 during an eastbound shoving movement when he struck the handrail of a locomotive parked on an adjacent track.<sup>2</sup> (See figure 1.) He was taken to a nearby hospital, where he later died. Visibility conditions at the time of the accident were dark and clear (the yard was illuminated by artificial light), and the temperature was 73°F.

**Figure 1.** Aerial view of the accident scene. (Source: CSX.)

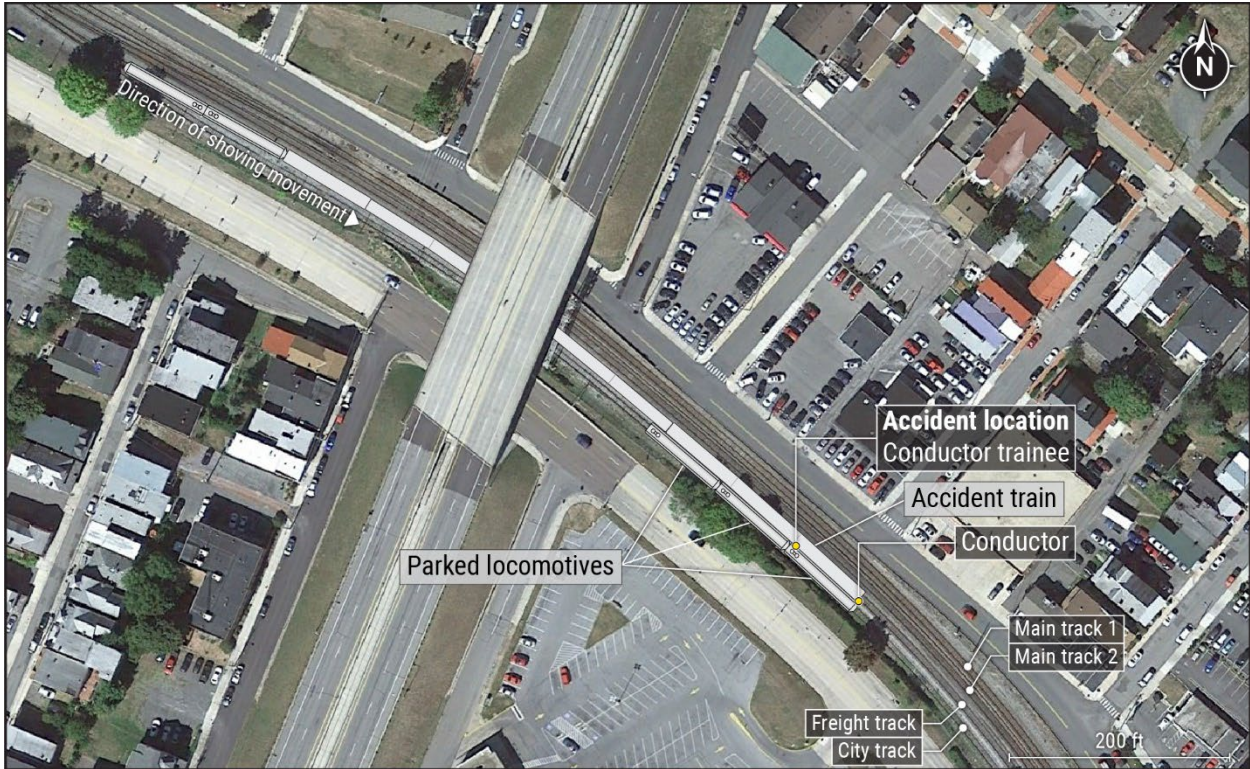
In Cumberland Yard, the crew received instructions to pick up railcars from a yard track, an operation that would involve a shoving movement on the freight track. (See figure 2.) The parked locomotive involved in the accident was one of three positioned on the city track, which was roughly parallel to the main tracks and separated from them by the freight track. None of these locomotives were relevant to the crew's assignment.

**Figure 2.** Expanded overhead view of the accident scene. (Source: Google Earth.)

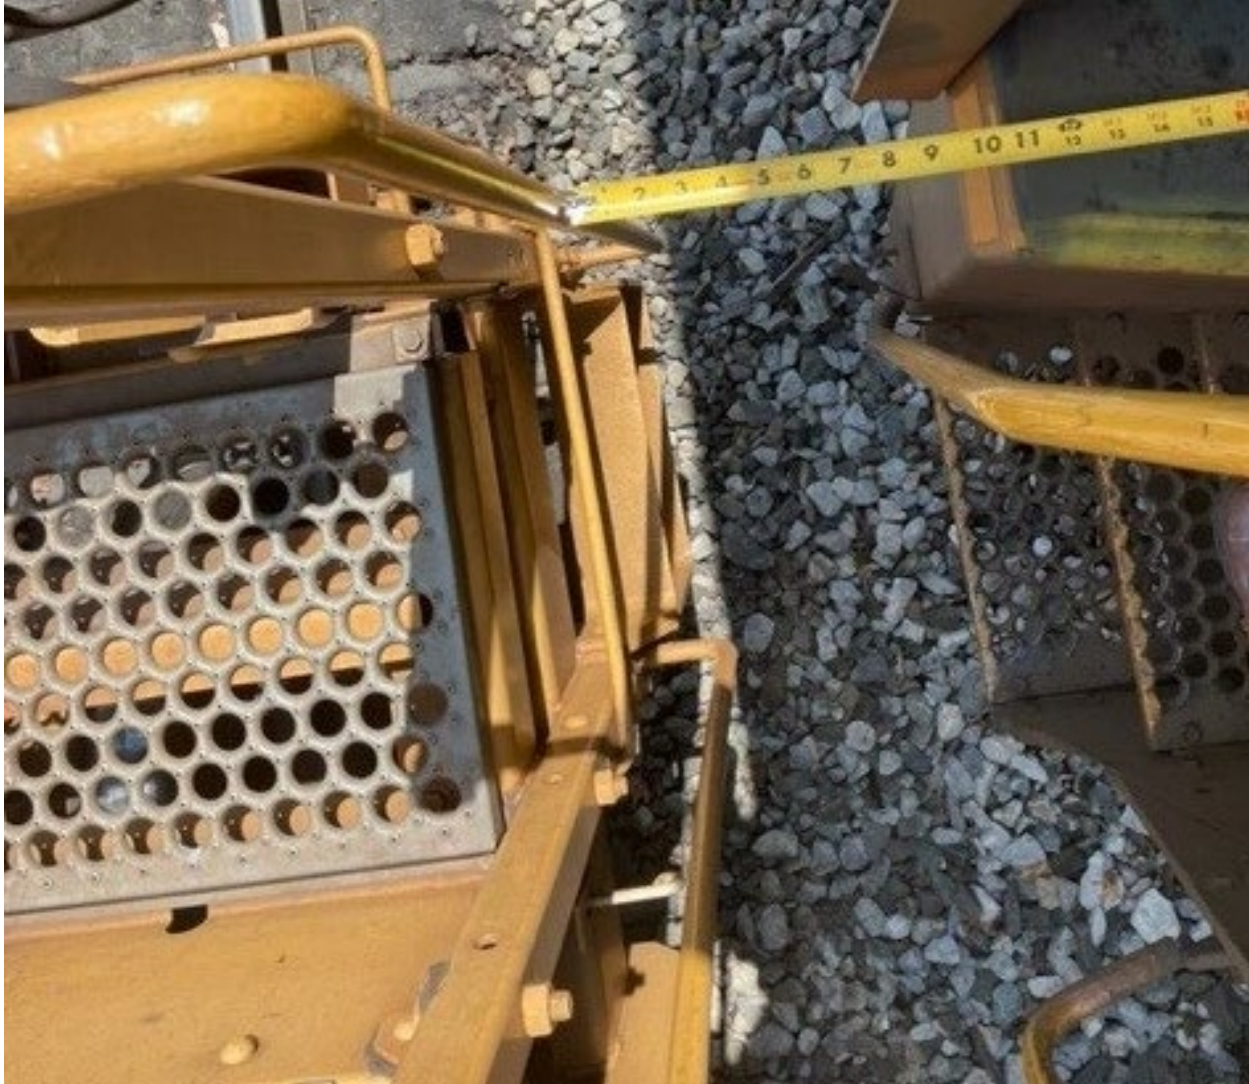
During postaccident examinations, the NTSB measured 7 inches of clearance between the ladder the conductor trainee was riding and the closest point on the eastern locomotive parked on the city track. (See figure 3.) The location was not included in CSX's list of close clearances or marked with signage.

**Figure 3.** Clearance between railcar (left) and parked locomotive (right).

The parked locomotives created a close clearance location because the city track where they were positioned was unusually close to the freight track being used by the accident train. The distance between the track centerlines was slightly more than 11 feet—or 3 feet less than both the current AREMA standard and the CSX standard for new or reconstructed track. Based on NTSB measurements on the scene, an additional 3 feet of clearance would have prevented the accident.

The NTSB determines that the probable cause of the CSX Transportation employee fatality was the accident train's movement through an unidentified and unmitigated close clearance location that resulted in the employee being caught between the side of the railcar he was riding and equipment parked on an adjacent track.

- Removed the city track from service immediately after the accident; as of this report, it remains out of service and is scheduled for removal.
- Issued safety alert with a safety briefing on temporary close clearances on August 10, 2023.
- Revised rules for field training such that when an employee with less than 1 year of service is assigned a trainee, a supervisor must be contacted prior to performing any work.
- Used geographic information system data to identify track centerlines 12 feet 6 inches apart or closer, flagged these tracks, and put in the existing close clearance index.<sup>11</sup>
