RECORD OF CONVERSATION

Date: April 25, 2020
Person Contacted: Gary Hendrickson (Aviation Safety Inspector – Airworthiness)
NTSB Accident Number: WPR20LA130

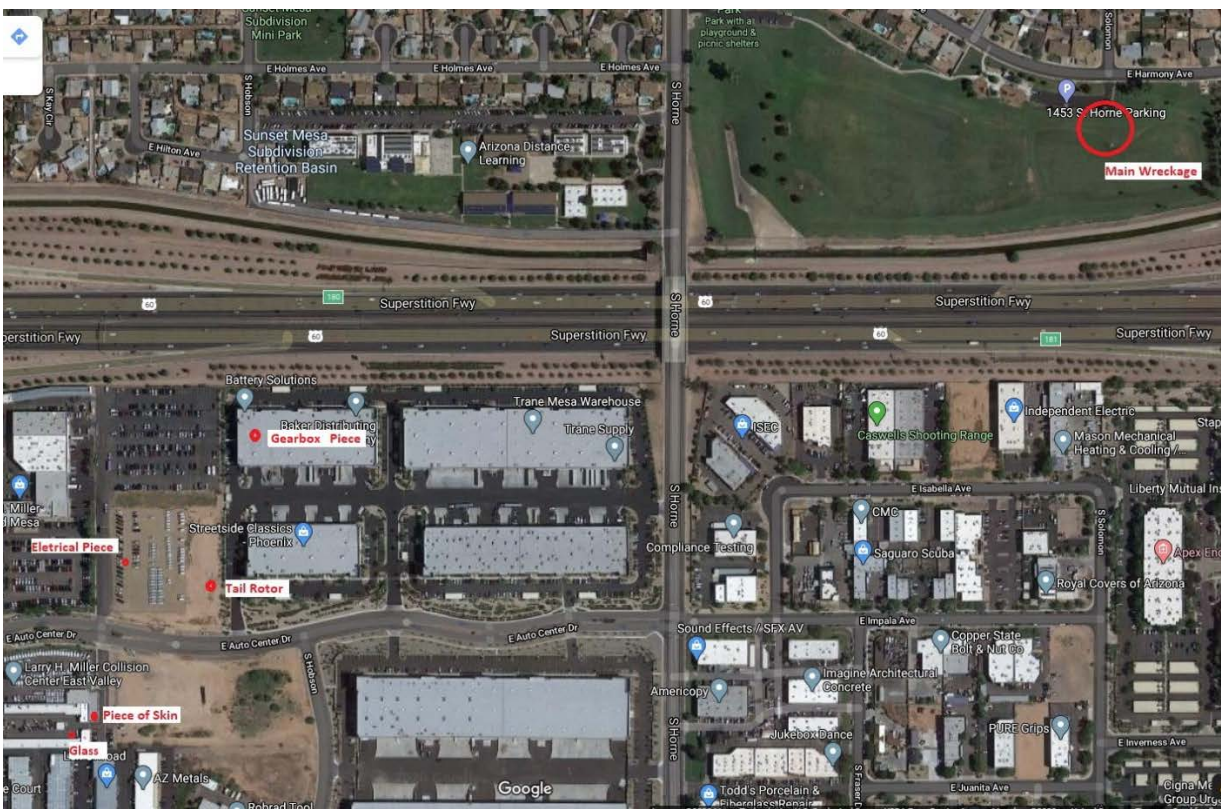
- The debris field was slightly longer than 1/2 mile, extending along a generally northeast direction.
- The first identified piece of debris were fragments of glass, which were consistent with a navigation light on the vertical stabilizer.

Figure 1: Wreckage Debris Field (Google Earth)

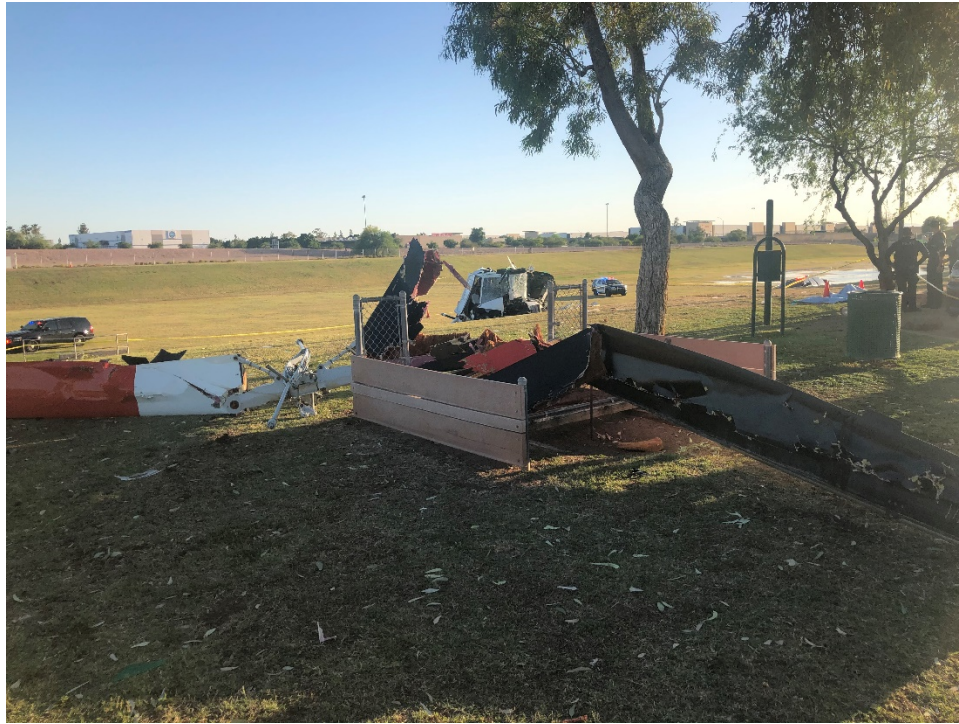
Figure 2: End of Debris Field looking Toward the Beginning

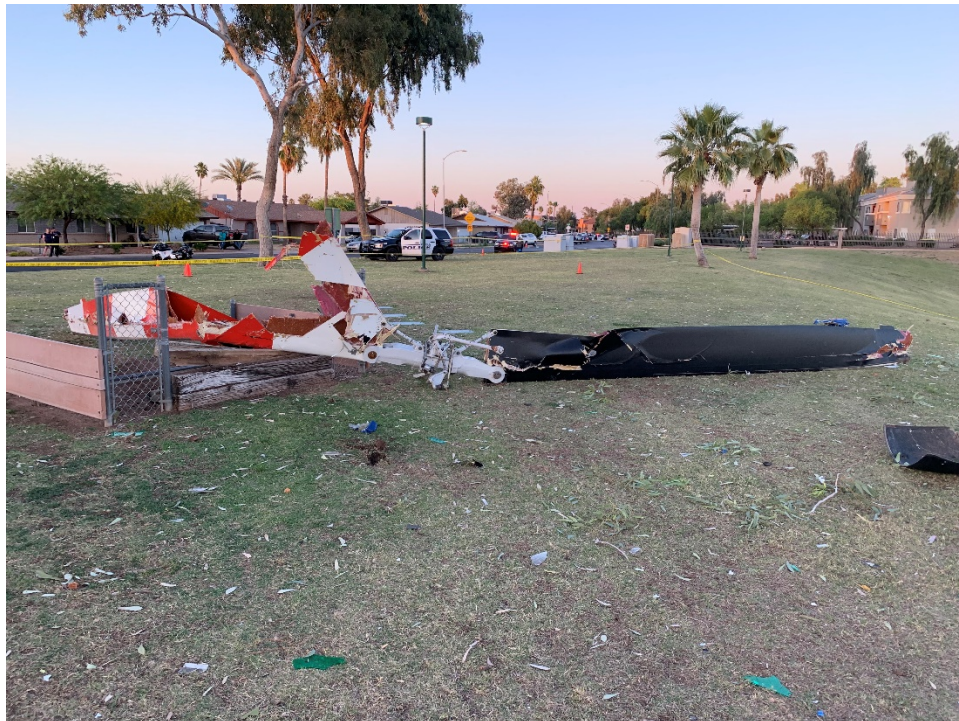
- The main rotor blade assembly was the last major piece of debris located about 20 yards northeast of the main wreckage.
 - Both blades exhibited extensive damage throughout but remained attached at the main rotor hub.

Figure 3: Main Rotor Blade Assembly

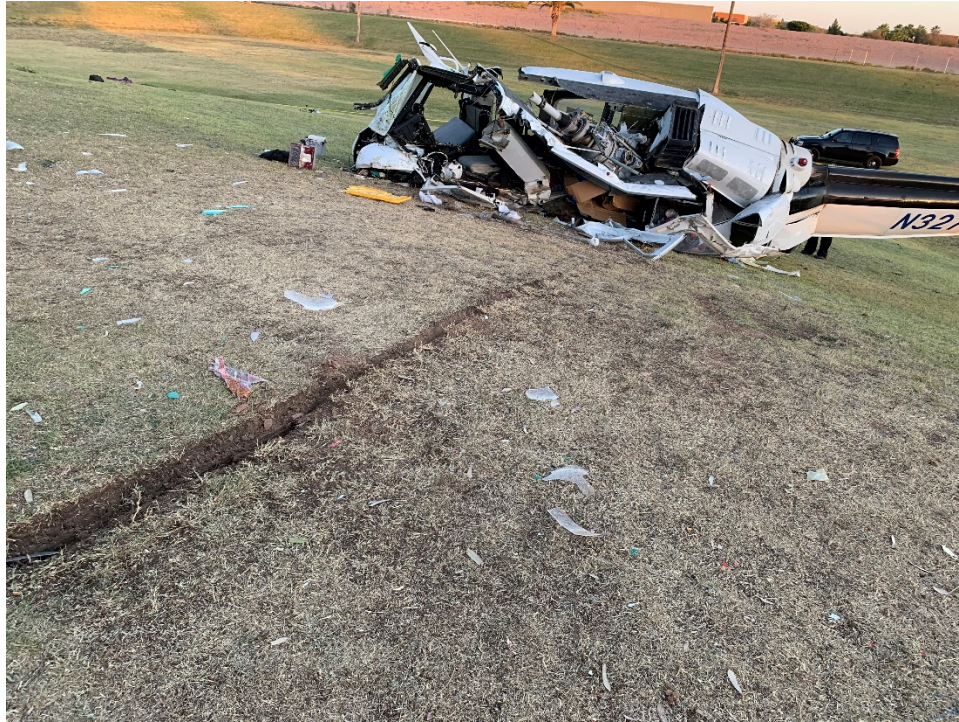
Figure 6: Main Rotor Blade Strike

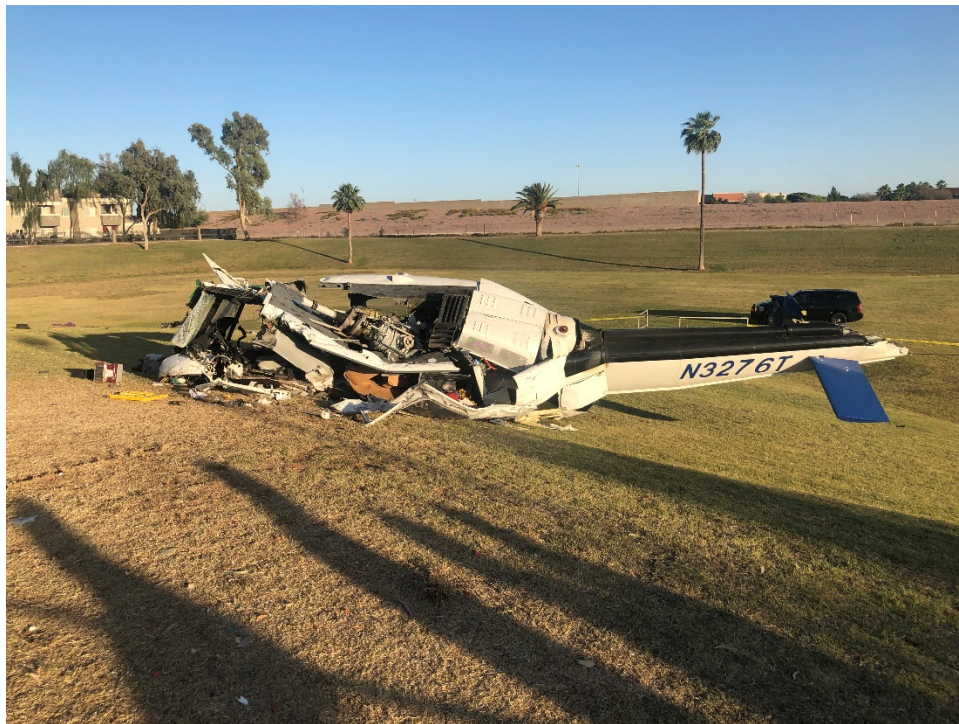
- Continuing along the debris path were two long and narrow ground strikes consistent with main rotor blade strikes.
- Next was the main wreckage, which came to rest on a small hill. The helicopter was slightly nose and left side low facing a heading of about 49 degrees. The helicopter exhibited upward crushing throughout the cabin and fuselage, most extensively on the left side of the fuselage. The mast and the main transmission were displaced forward, and the main rotor assembly was fracture separated.

Figure 7: Left Side of Helicopter

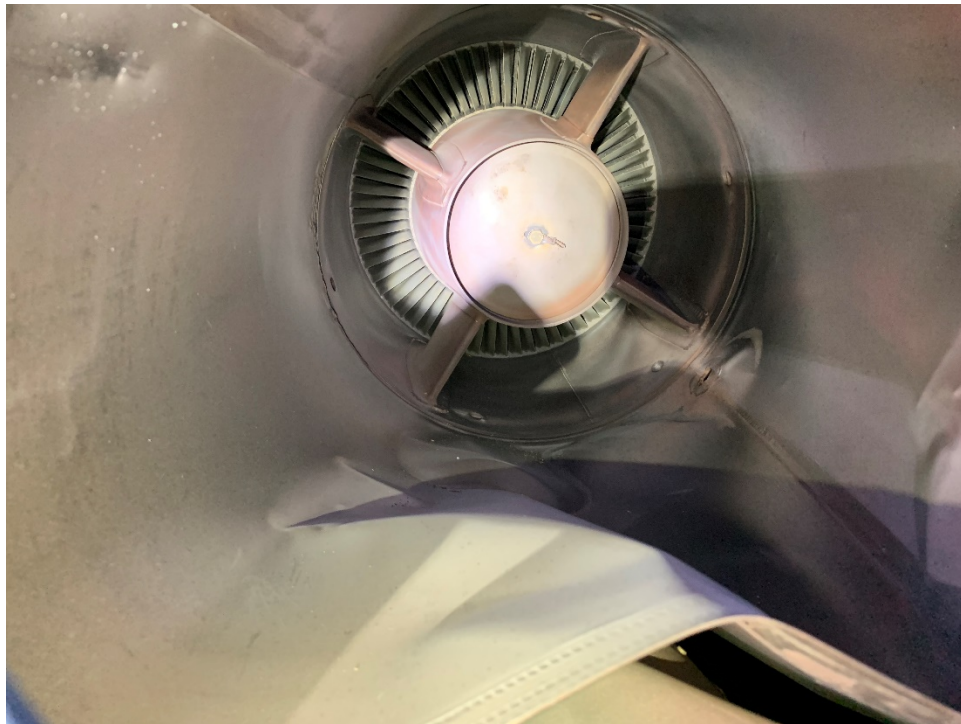
- Honeywell representatives were present on scene and they reported metal spray was noted on the turbine blades.
 - There was a strong, pungent, smell of Jet A fuel around the main wreckage.

Figure 11: Metal Spray on Turbine Blades

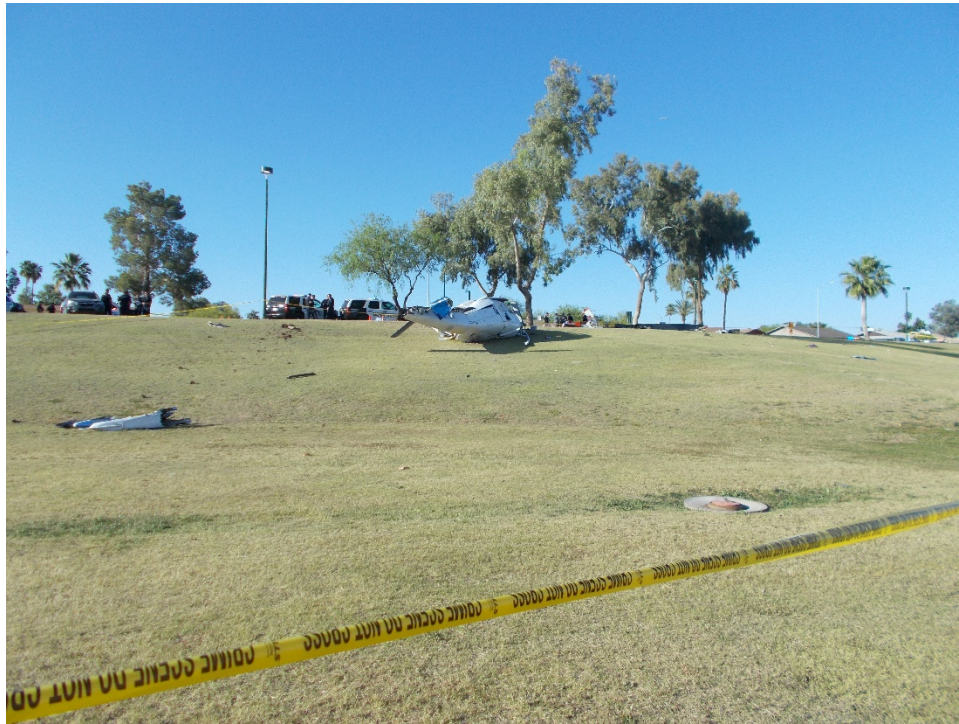
Figure 12: Overall View of the Main Wreckage Area

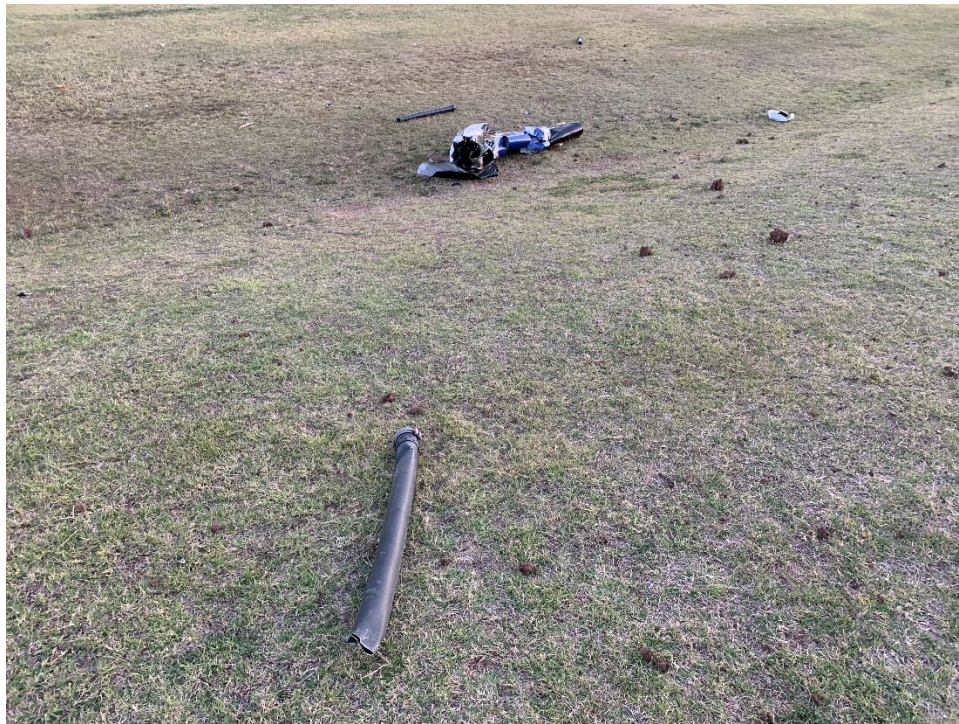
Figure 13: Aft Tail Rotor Driveshaft in Relation to Vertical Stabilizer

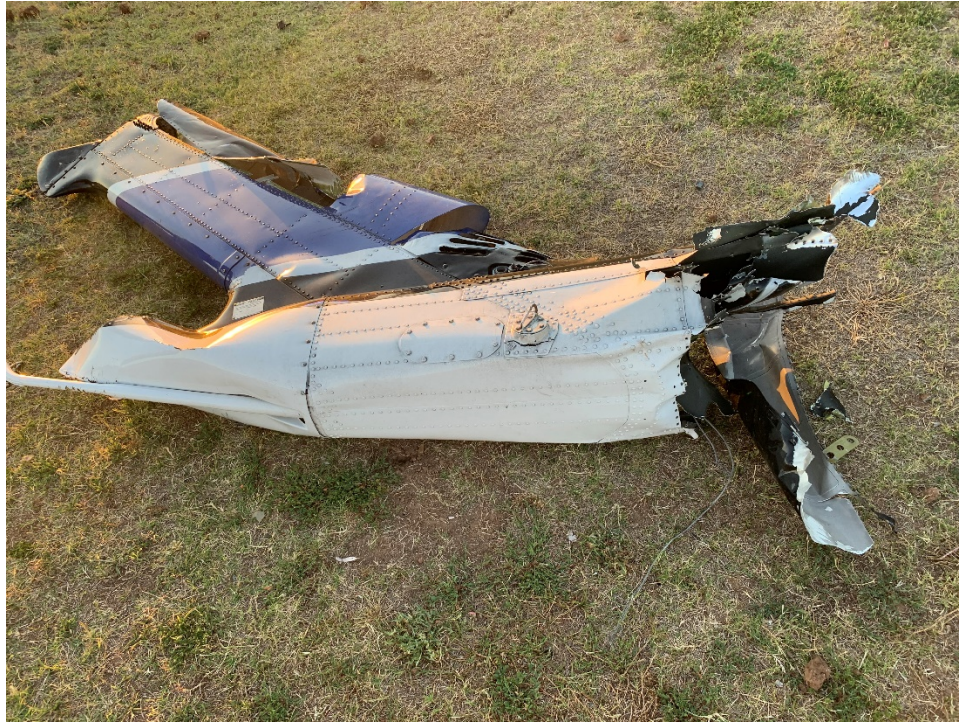
- The first pieces of debris in the field were the vertical stabilizer and a portion of the aft tail rotor driveshaft.
 - The vertical stabilizer was fracture separated from the helicopter and exhibited leading edge damage. The aft underside (near the stinger) exhibited upward crushing.

Figure 14: Vertical Stabilizer

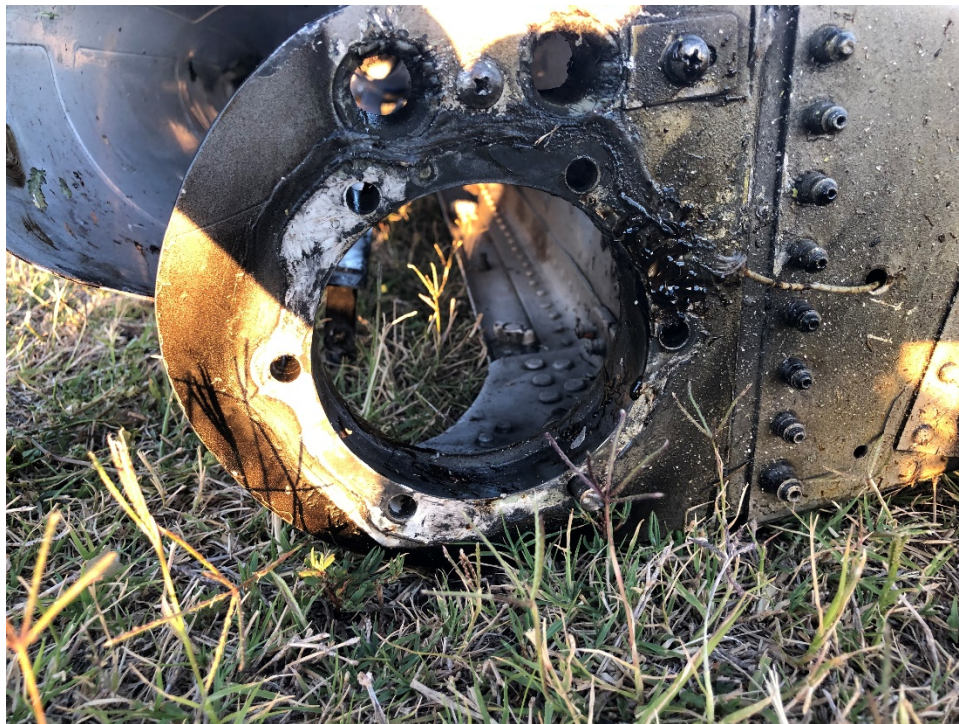
Figure 15: 90-Degree Gearbox Attachment Point on the Vertical Stabilizer

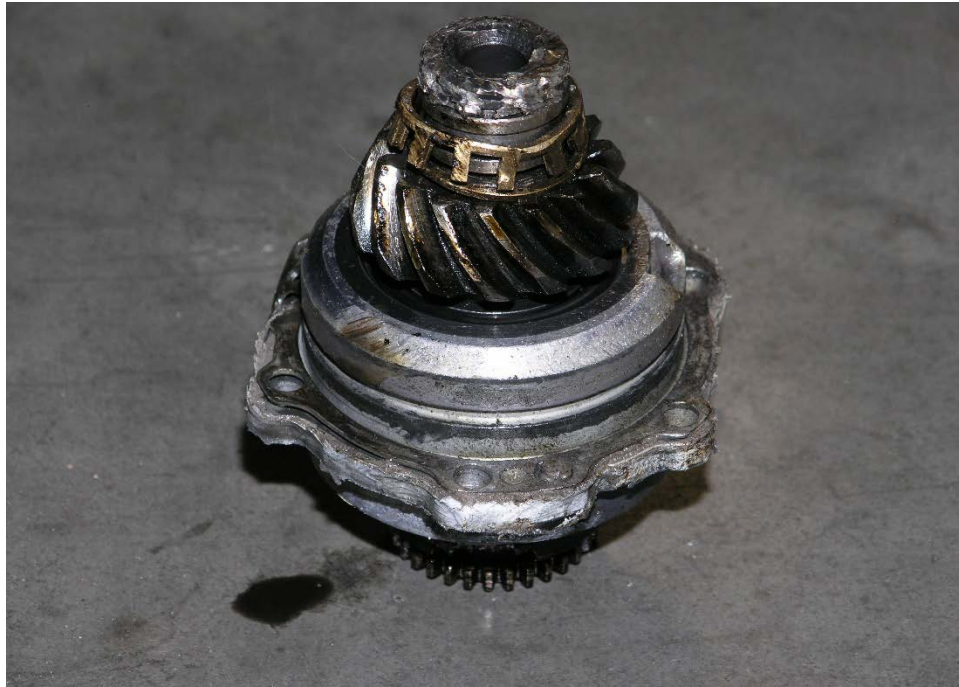
- The 90-degree gearbox housing exhibited rotational scoring where the input quill would be present.
 - The input quill came to rest inside of a nearby building and it impacted a concrete floor.

- The roller bearings were not present and unable to be located.
- The rest of the helicopter came to rest about ½ mile further northeast in an open, slightly sloped field.

Figure 16: The Input Quill

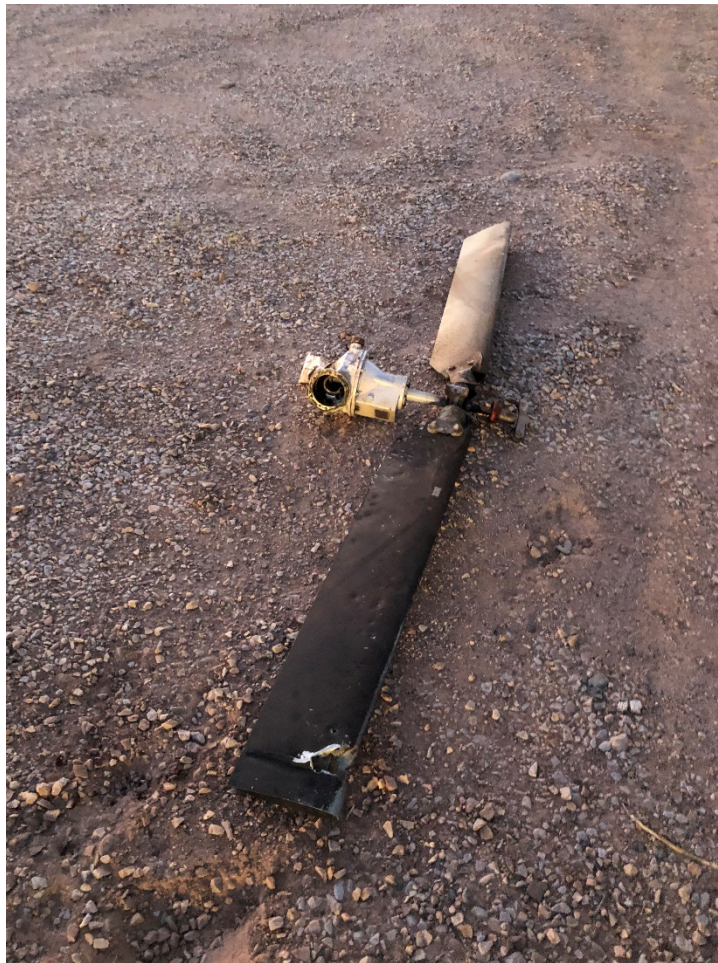
- About 200 yards further northeast was the tail rotor assembly, and the input quill assembly.
 - The tail rotor assembly (including the 90-degree gearbox) was mostly whole and came to rest in a dirt lot. All linkages remained intact and the blades exhibited minimal damage.

Figure 17: The 90-Degree gearbox and Tail Rotor Assembly

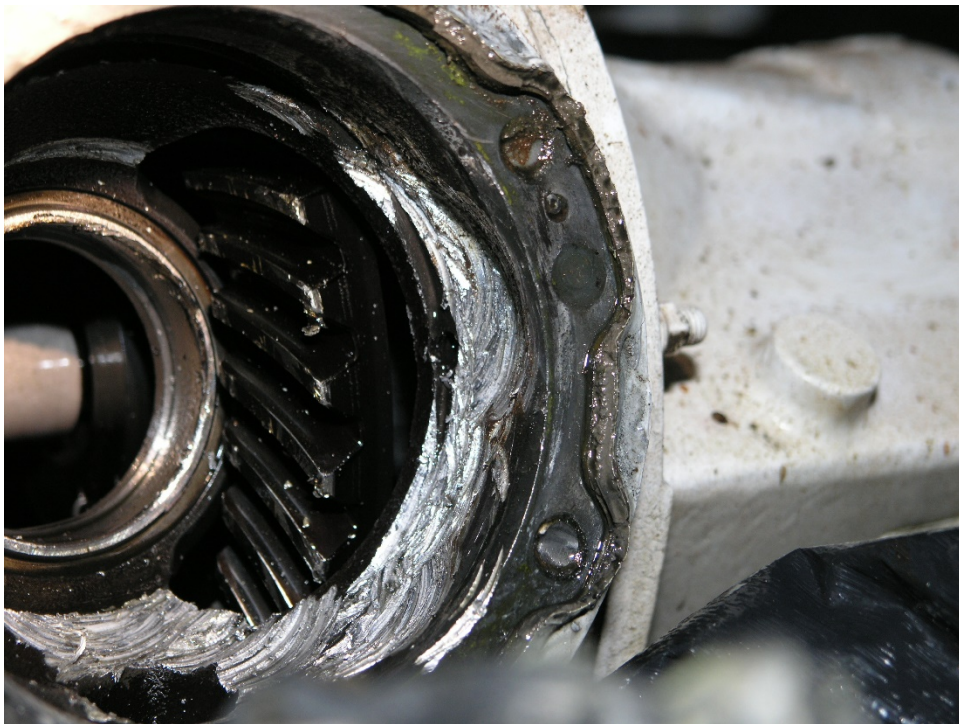
Figure 19: Rotational Scoring on the 90-degree Gearbox Housing

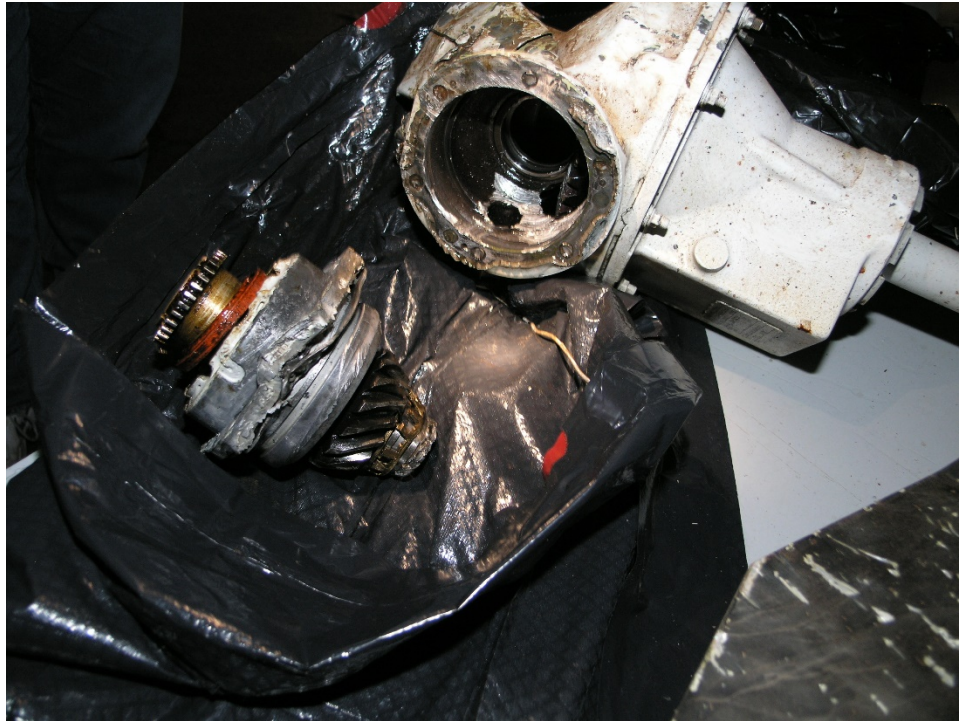
Figure 20: The Input Quill Gear next to the 90-degree gearbox
