Mitchell Gallo
Senior Aerospace Engineer
Aviation Safety - Central Region

Date: October 11, 2024
Subject: CEN24LA189, Fuel Selector Position
Contact: Mitchell Gallo, NTSB Investigator-in-Charge

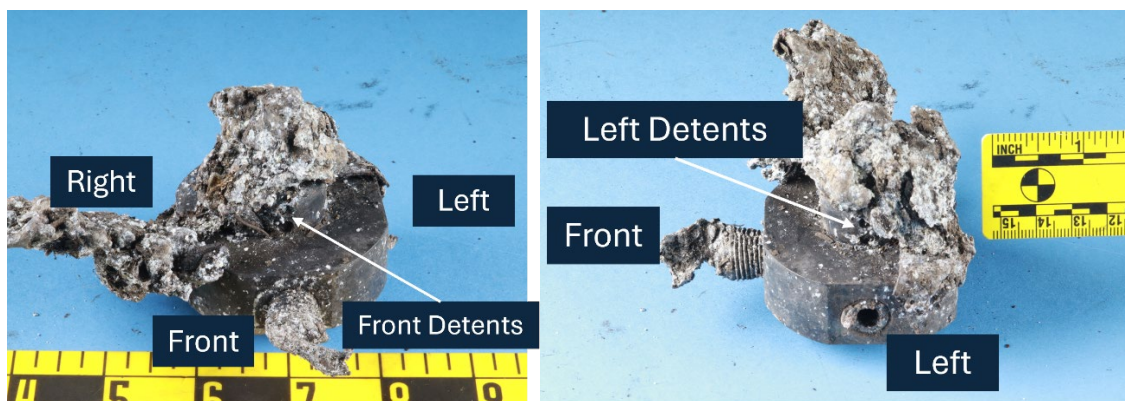
Attached images show that melted and re-solidified pieces of aluminum were attached to sections of the valve, including the right inlet port, the front of the valve, and the top of the valve where the switch control was located.

Figure 1 - Melted and Re-solidified Pieces of Aluminum Attached to Valve Sections

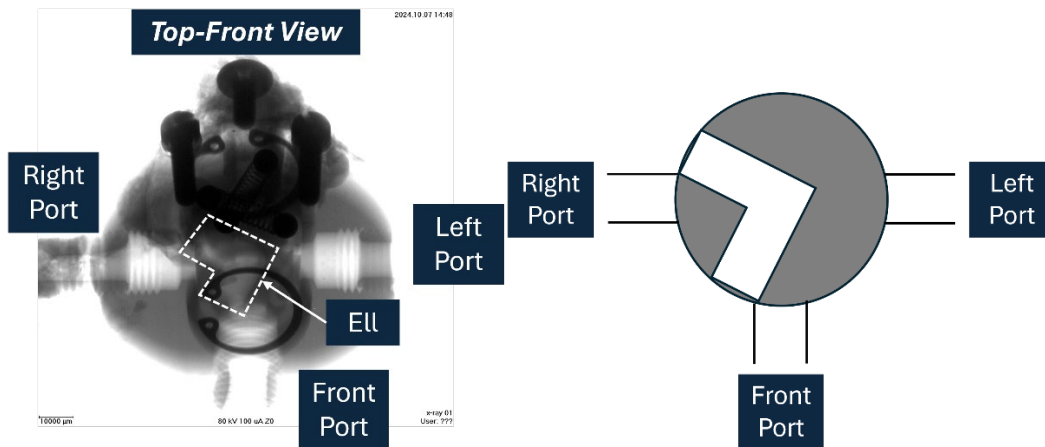
Radiographs of the internal features showed that the ell was not aligned with any ports. The ell was off by approximately 30° clockwise (when viewed from the top) from a position what would have connected the right and front ports. A schematic drawing is included.

Figure 2 - Top-Front View of Fuel Selector (left) with Schematic Drawing (right)

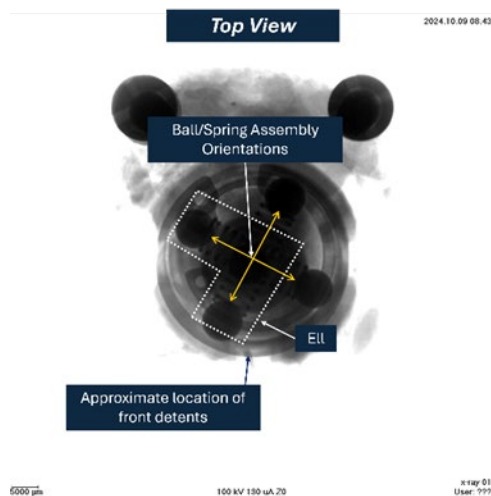
Two of the four pairs of detents (front and left) were visible on the case from the outside. The detents were circular in shape and filled with ash. The other two pairs of detents (right and rear) were covered by the re-solidified metal mass and could not be imaged with the X-ray to determine if they were damaged. A pair of spring and ball assemblies near the top of the switch would engage with the detents as the switch was turned.

Figure 3 - Top View of Fuel Selector with Ball/Spring Assembly Orientations and Front Detents

Each assembly consisted of two balls with a spring between them. The two assemblies were offset by 90°, such that the spring of one assembly was parallel to one leg of the ell, and the spring of the other assembly was parallel to the other leg of the ell. Radiographs showed that the relative orientation of both spring and ball assemblies to the ell was consistent with the part drawing. The re-solidified metal attached to the selector prevented turning the switch to test if the assemblies and detents were still functional.
