RECORD OF CONVERSATION

Date: April 29, 2020
Person Contacted: Gary Hendrickson (Aviation Safety Inspector – Airworthiness)
NTSB Accident Number: WPR20LA130

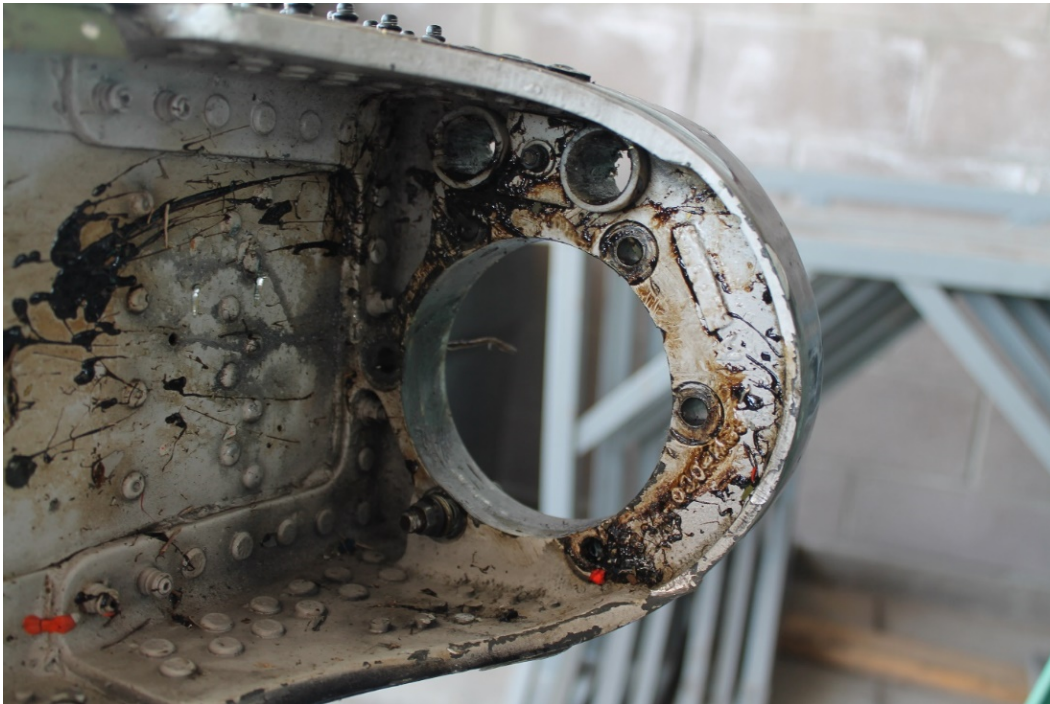
Figure 1: Underside of the top of the Vertical Stabilizer

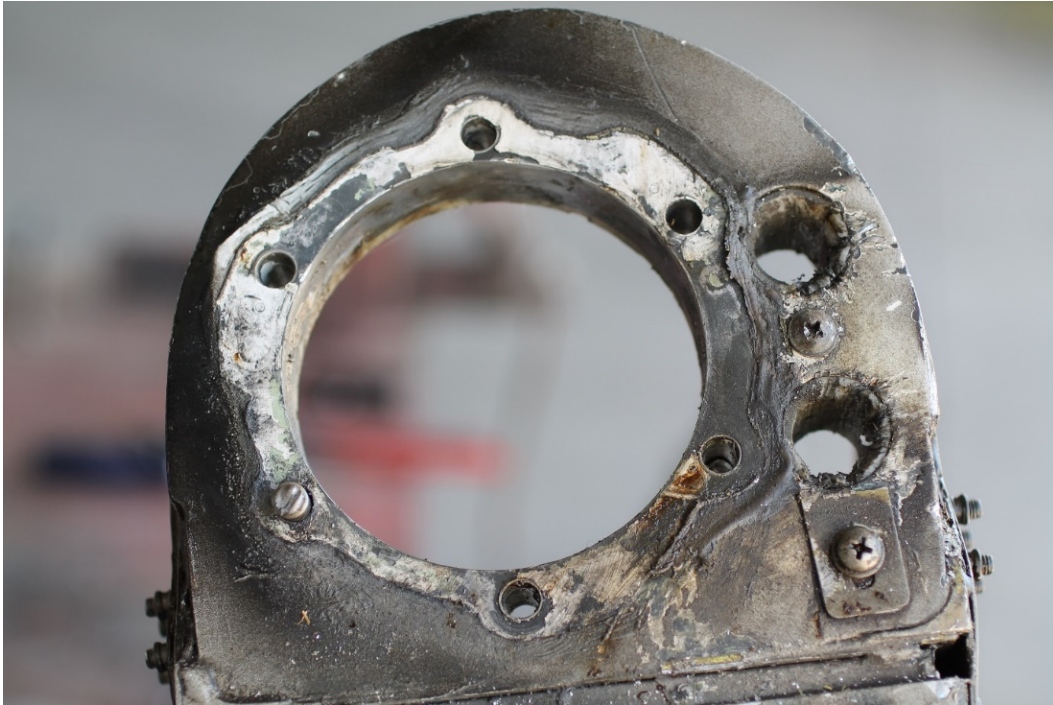
- The stinger was overall bent upward toward the vertical, however, it did not exhibit any abnormalities.
- A portion of the lower aft vertical stabilizer was fracture separated and the lower navigation light was not present.

Figure 2: top of the Vertical Stabilizer

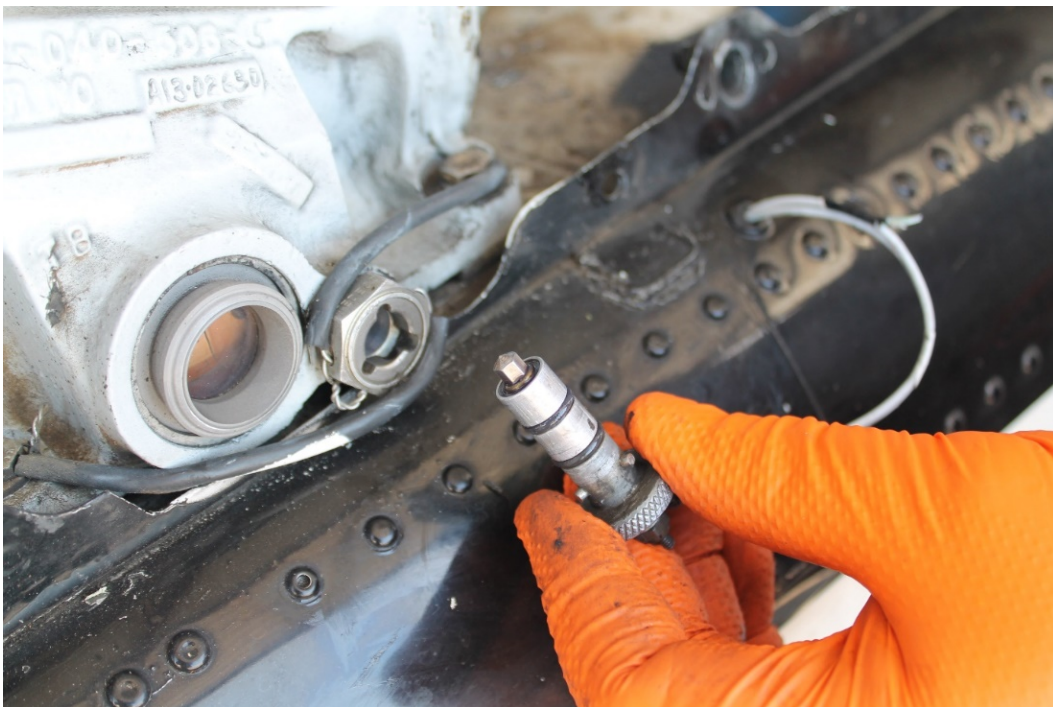
- The chip detector of the 42-degree gear box was removed and no metallic debris was noted.
- The chip detector of the 90-degree gear box was removed and metallic debris was present.

Figure 3: 42-degree gearbox chip detector

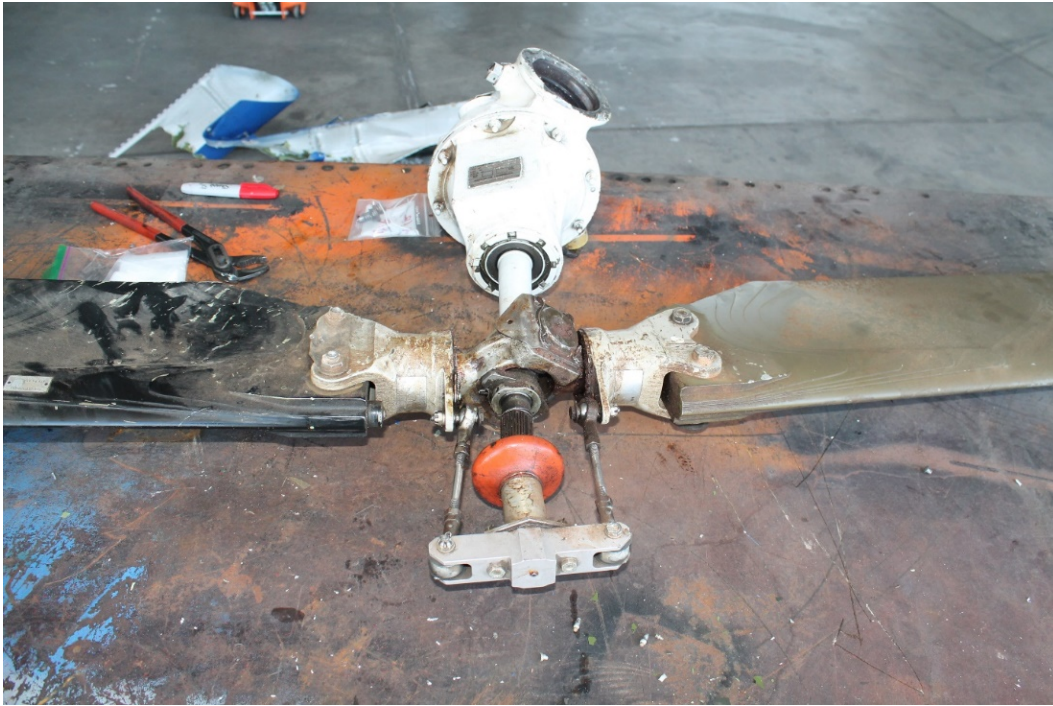
- The tail rotor assembly was mostly whole. All linkages were attached and secured in place. One tail rotor blade was mostly undamaged; the second blade had a big gouge in the outboard leading edge.

Figure 4: Tail Rotor Assembly

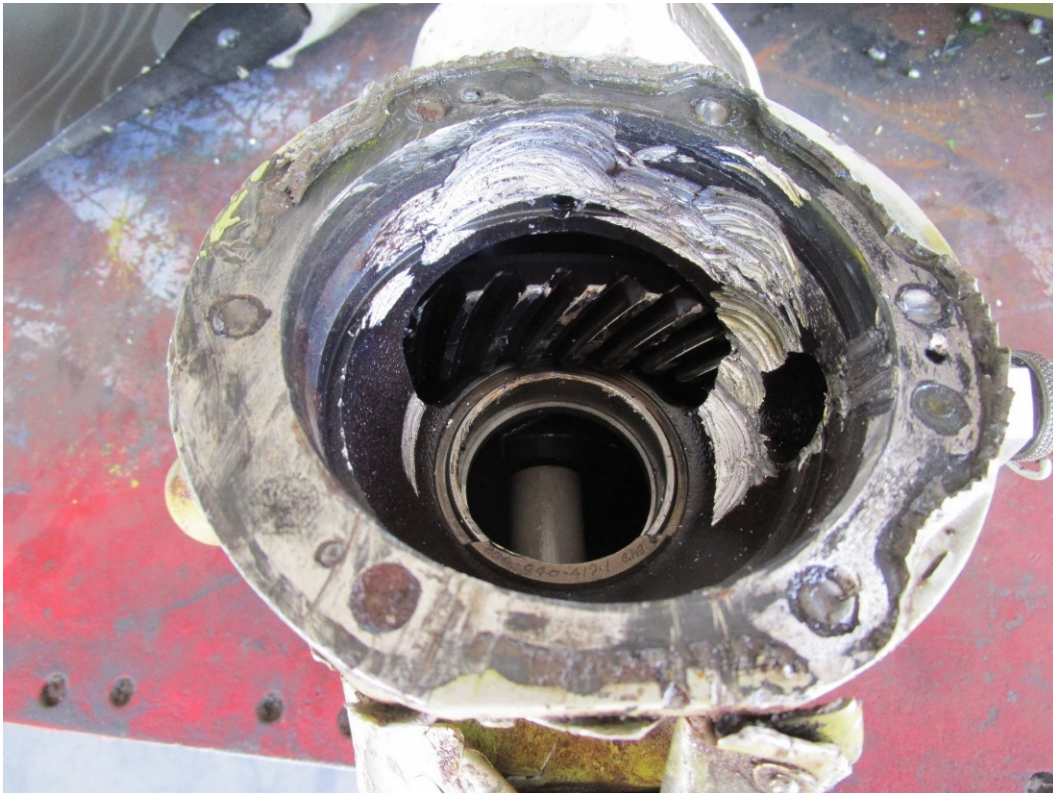
Figure 5: 90-degree gearbox Housing

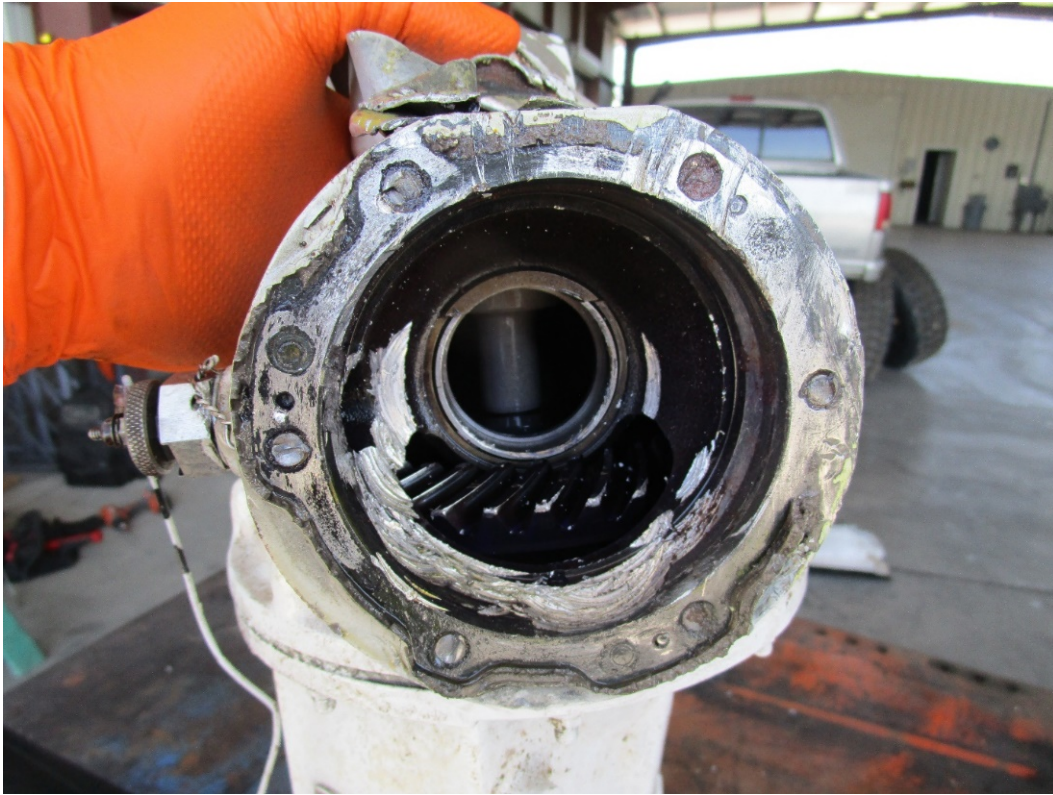
- FAA Inspector Ken Fanning was also present for the examination.
- The fuselage exhibited extensive damage and was difficult to stabilize.
- The bolts that secured the 90-degree gearbox to the airframe were fracture separated.

- Most of the bolts had fragments that remained in the attachment flange.
 - Portions of four of the bolts were found loose within the vertical stabilizer. The fifth bolt was stuck in the attachment hole and could not be removed; and the sixth bolt half was unable to be located.

Figure 6: Attachment Bolt Fragments

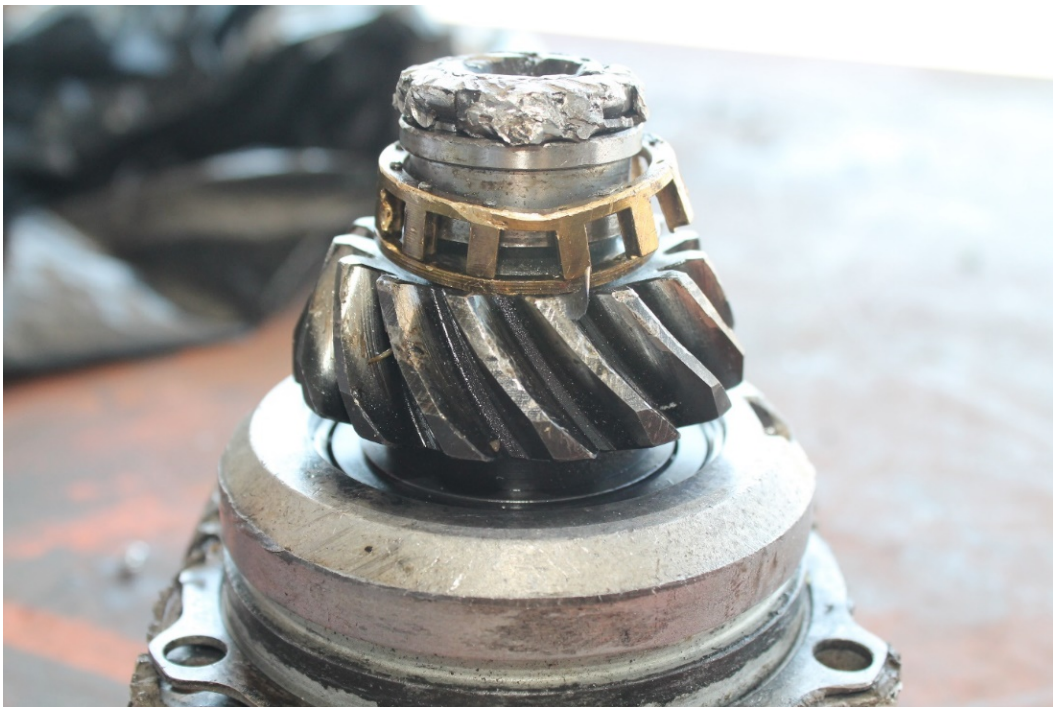
Figure 7: Input Pinion Gear

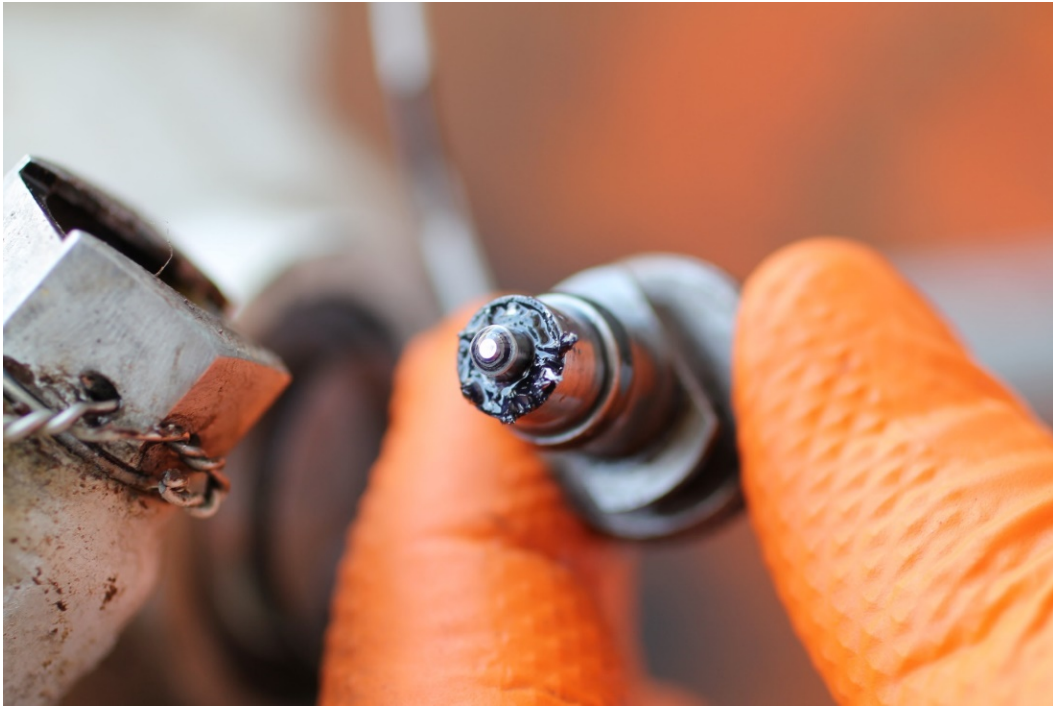
Figure 8: 90-degree Gearbox Chip Detector
