## **RECORD OF EMAIL**

Person Contacted: Mr. Paul Suffern (NTSB Meteorologist)

NTSB Accident Number: CEN21LA178

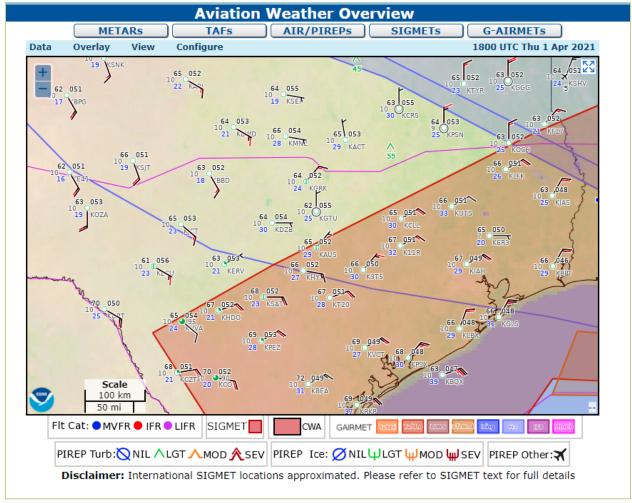
Figure 1: Aviation Weather Center (AWC) G-AIRMETs and METARs valid at 1300 CST
