**NATIONAL TRANSPORTATION SAFETY BOARD**

**FACTUAL REPORT**

NTSB Accident Number:	RRD19FR002
Date of Accident:	November 30, 2018
Time of Accident:	10:20 am (EST)
Railroad Owner and Operator:	CSX Transportation
Maintenance of Way Crew:	CSX, Welding Team
Train Number:	F-794-30
Fatalities:	1
Injuries:	0
Location of Accident:	Estill, SC

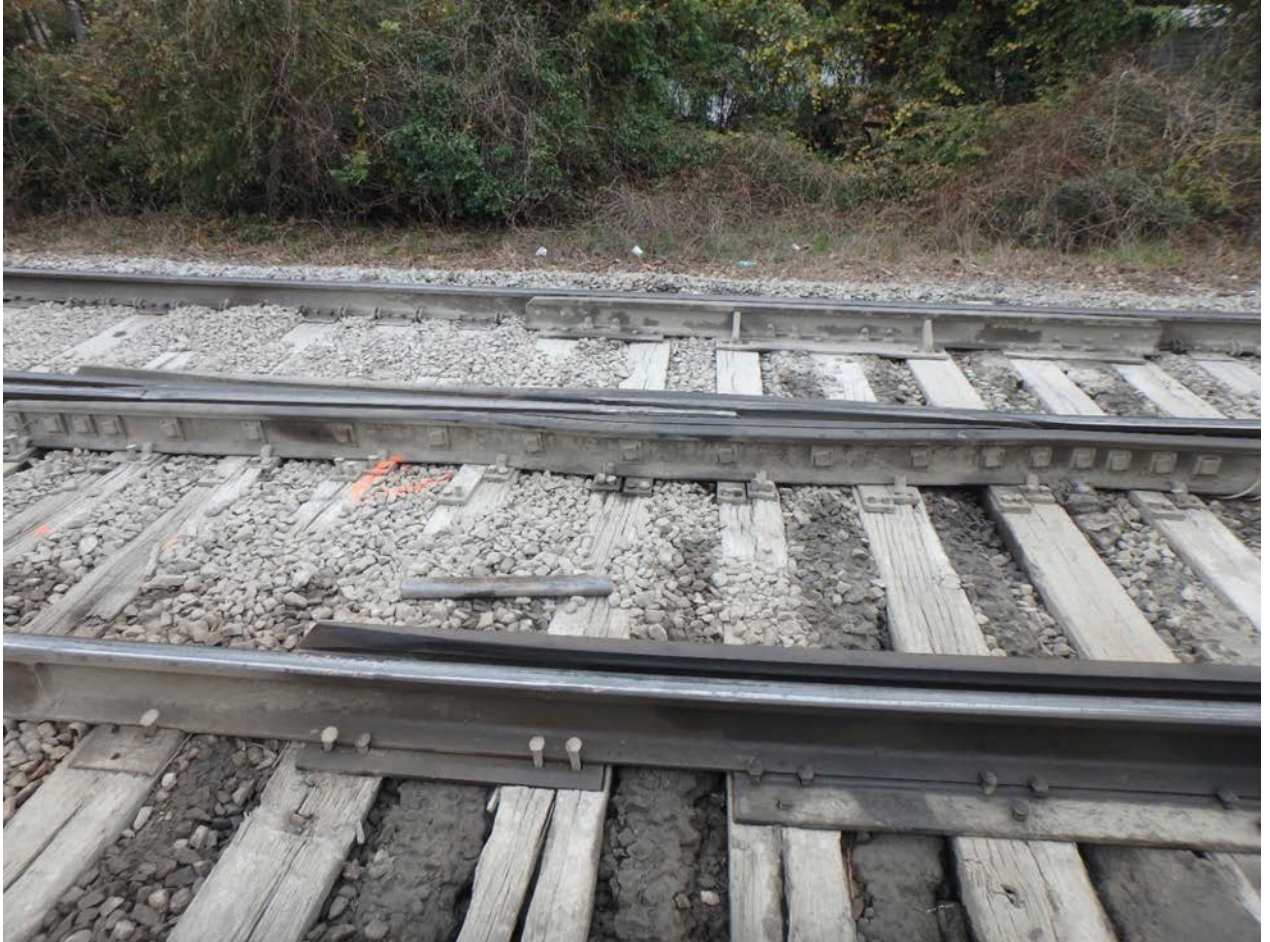
Figure 1. Photo of track frog at the accident location.

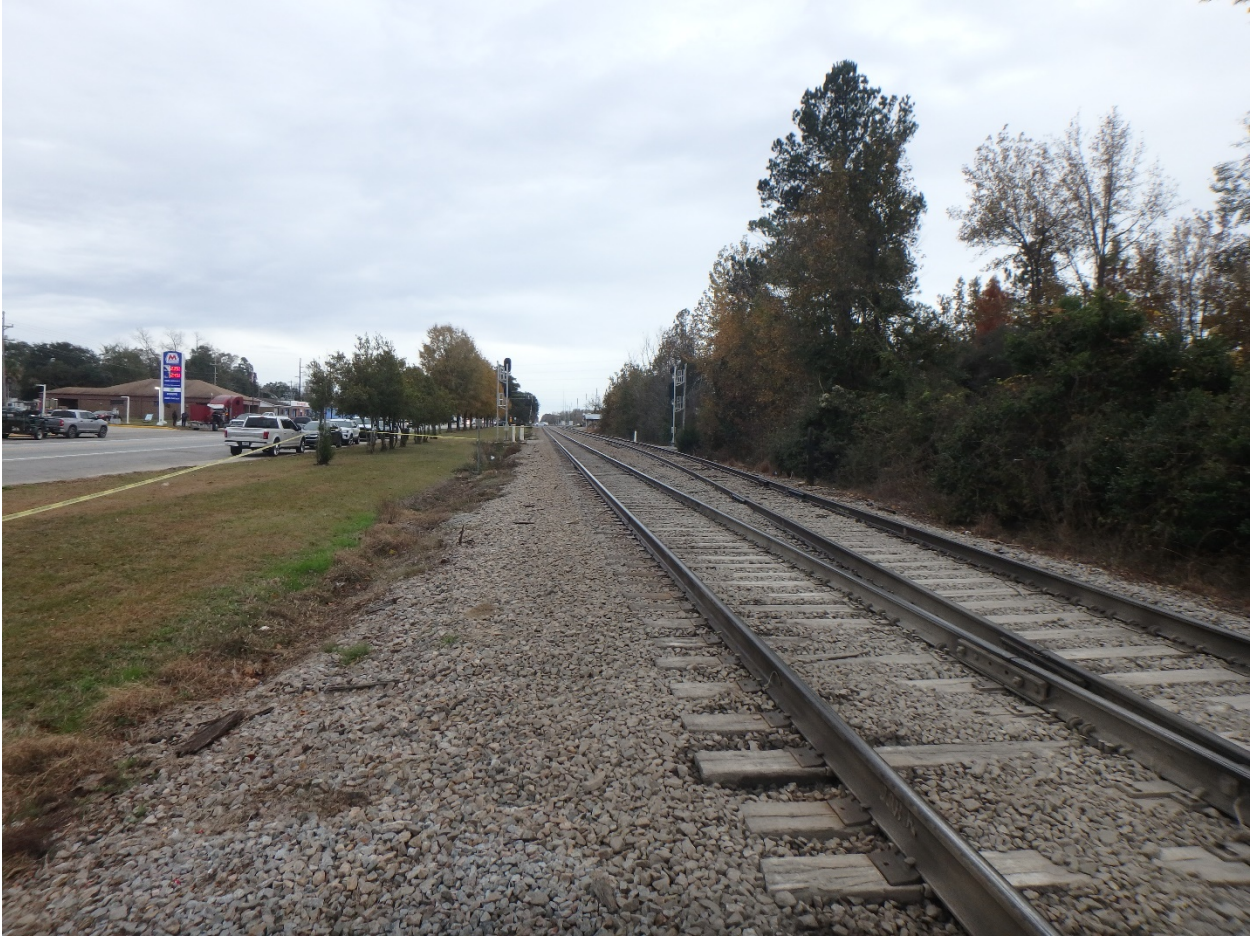
At the accident location, the North End Estill Siding switch, MP S-449.7, the maximum authorized train speed is 79 mph for Amtrak passenger trains and 60 mph for freight trains. Based on this highest speed of 79 mph for passenger trains, the employees would have needed between 3000 feet and 5280 feet depending on the required clearing time. During the sight distance observation, the team determined that the watchman would have had about 1.6 miles of sight distance for the accident train. It was also determined that the watchman would have had about 2.7 miles of sight distance for southbound trains.

Figure 2. Photo showing sight distance standing near the accident location, facing south.

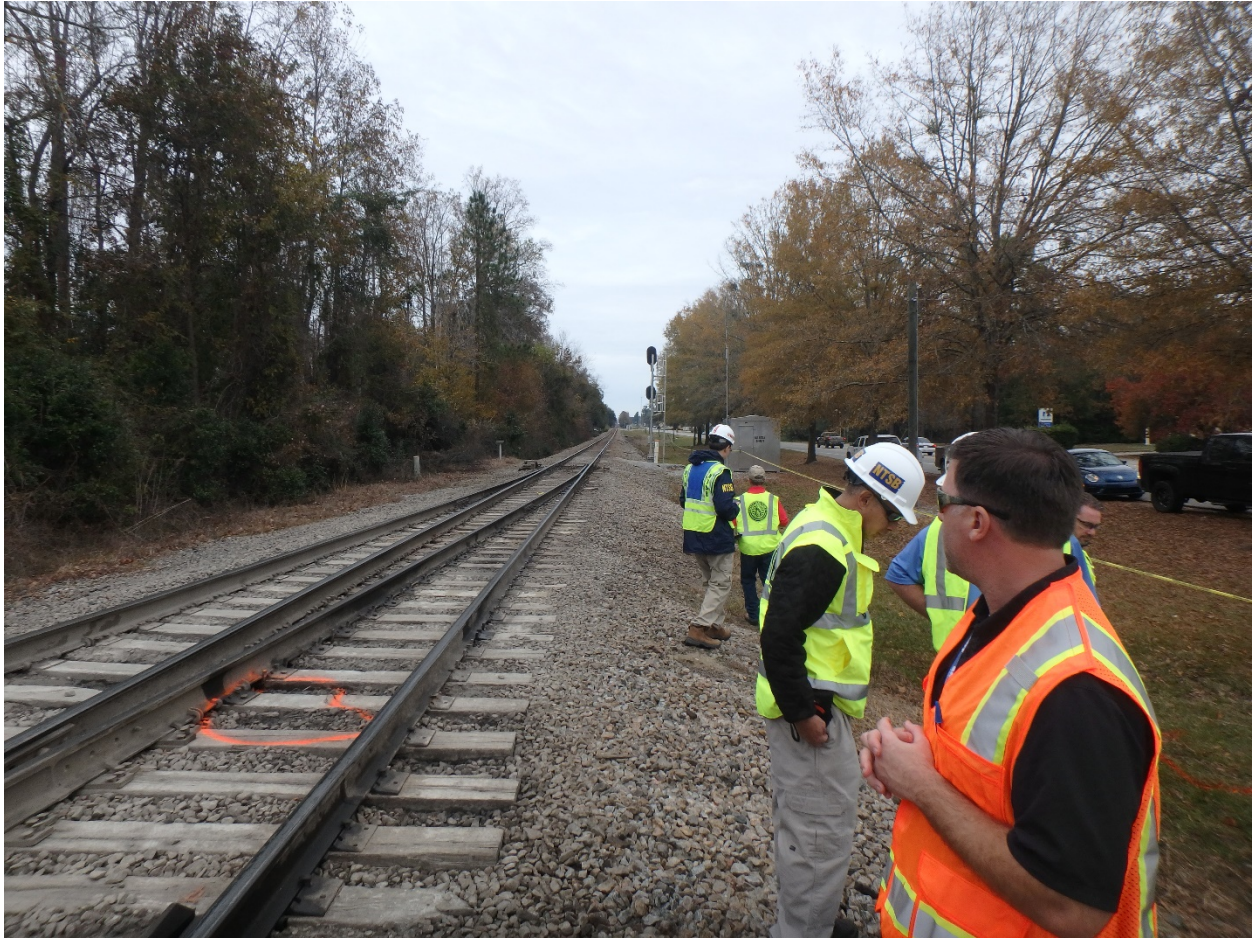
Figure 3. Photo showing sight distance standing near the accident location, facing north.

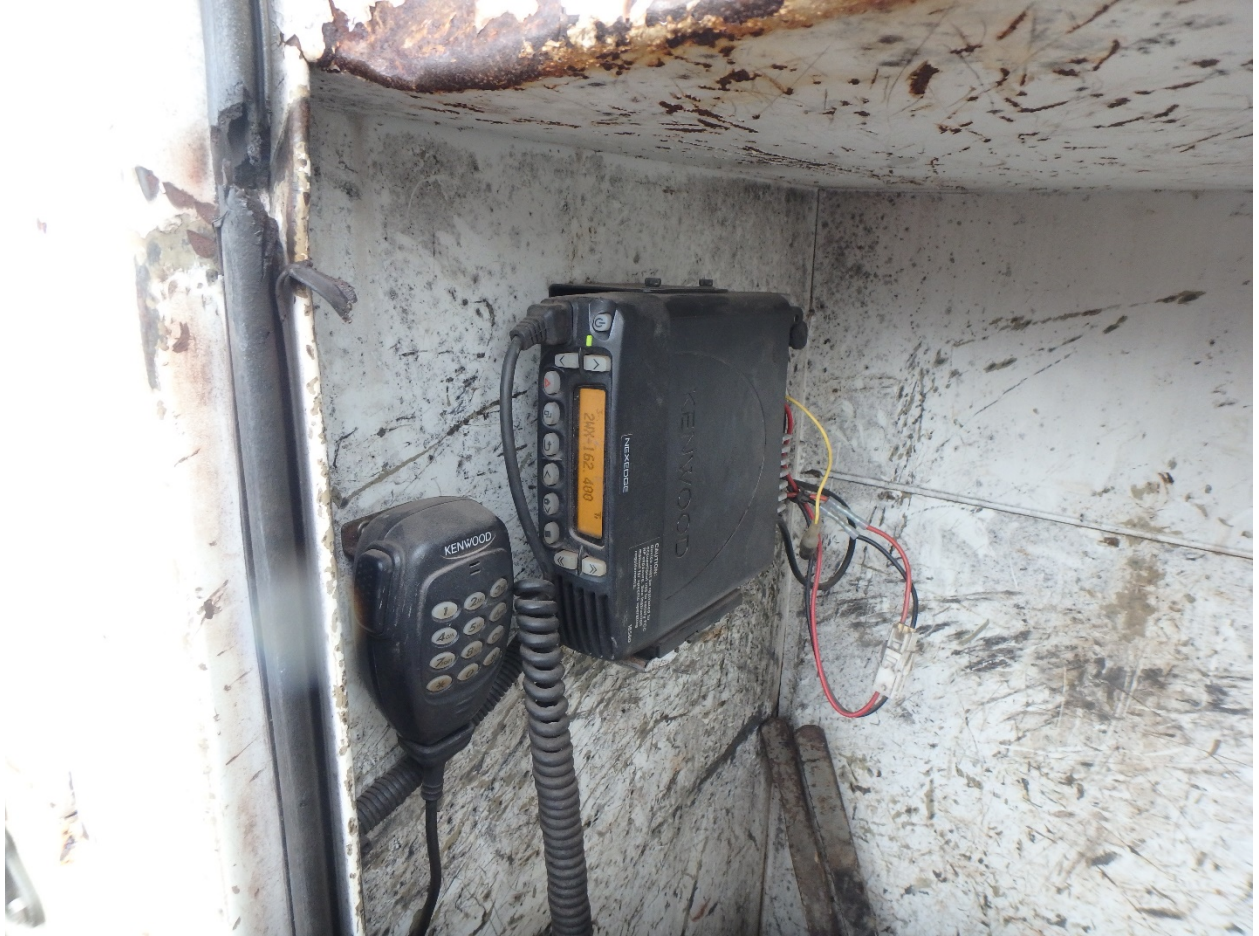
Investigators determined that the radio located in the cab of the welding truck was functional, however, the external radio (mounted inside a cabinet on the body of the truck) was not able to be heard. The external radio was disconnected from a speaker mounted on the body of the truck, near the middle, on the passenger's side. Two other speakers were in the same cabinet as the radio, however, neither of those were properly connected to the radio.

Figure 4. Photo showing the external radio mounted inside of a cabinet on the body of CSX welding truck No. 240150.

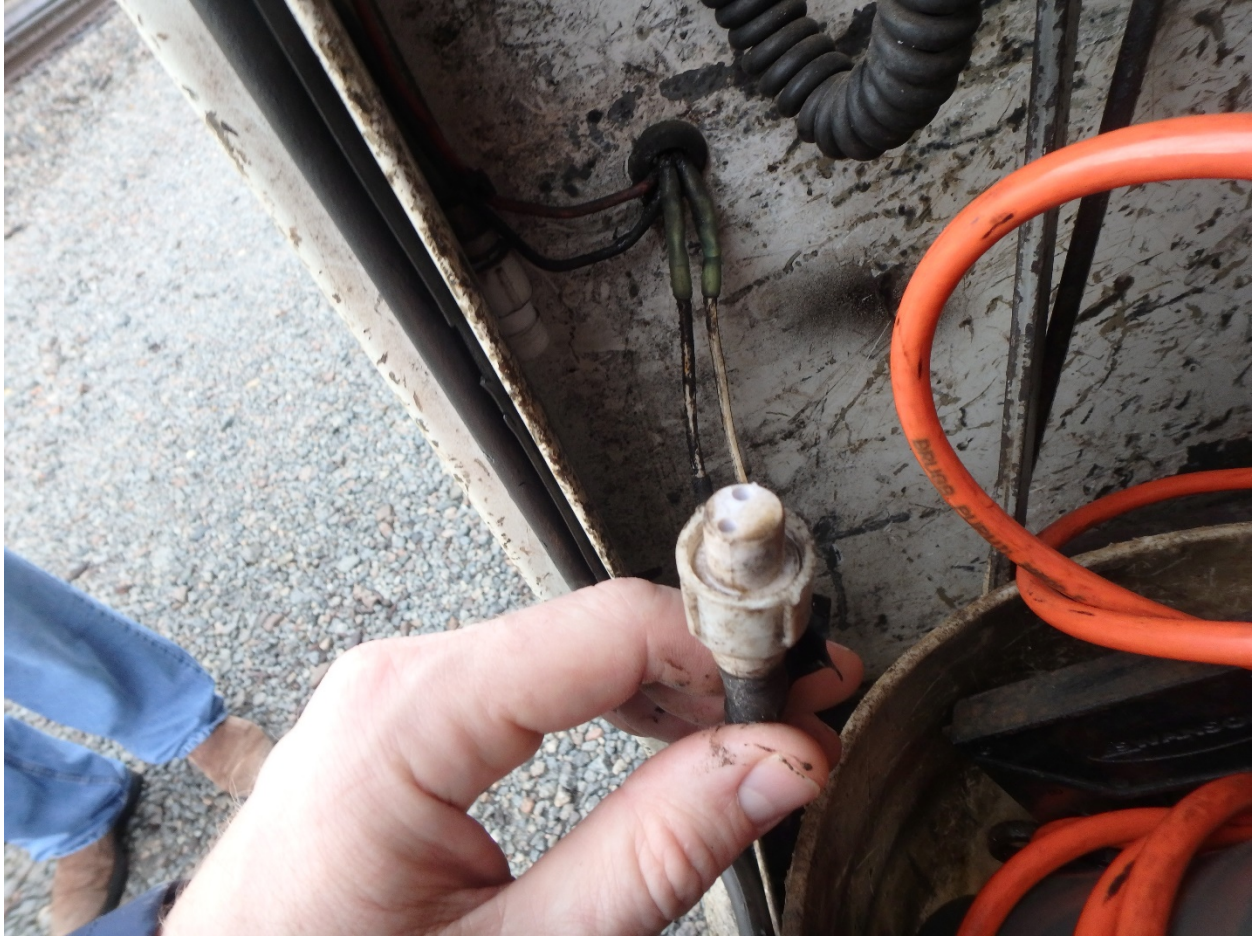
Figure 5. Photo showing disconnected wire connector that was intended to connect the external mounted speaker to the external radio. The wire was disconnected from the radio and hanging inside the cabinet.

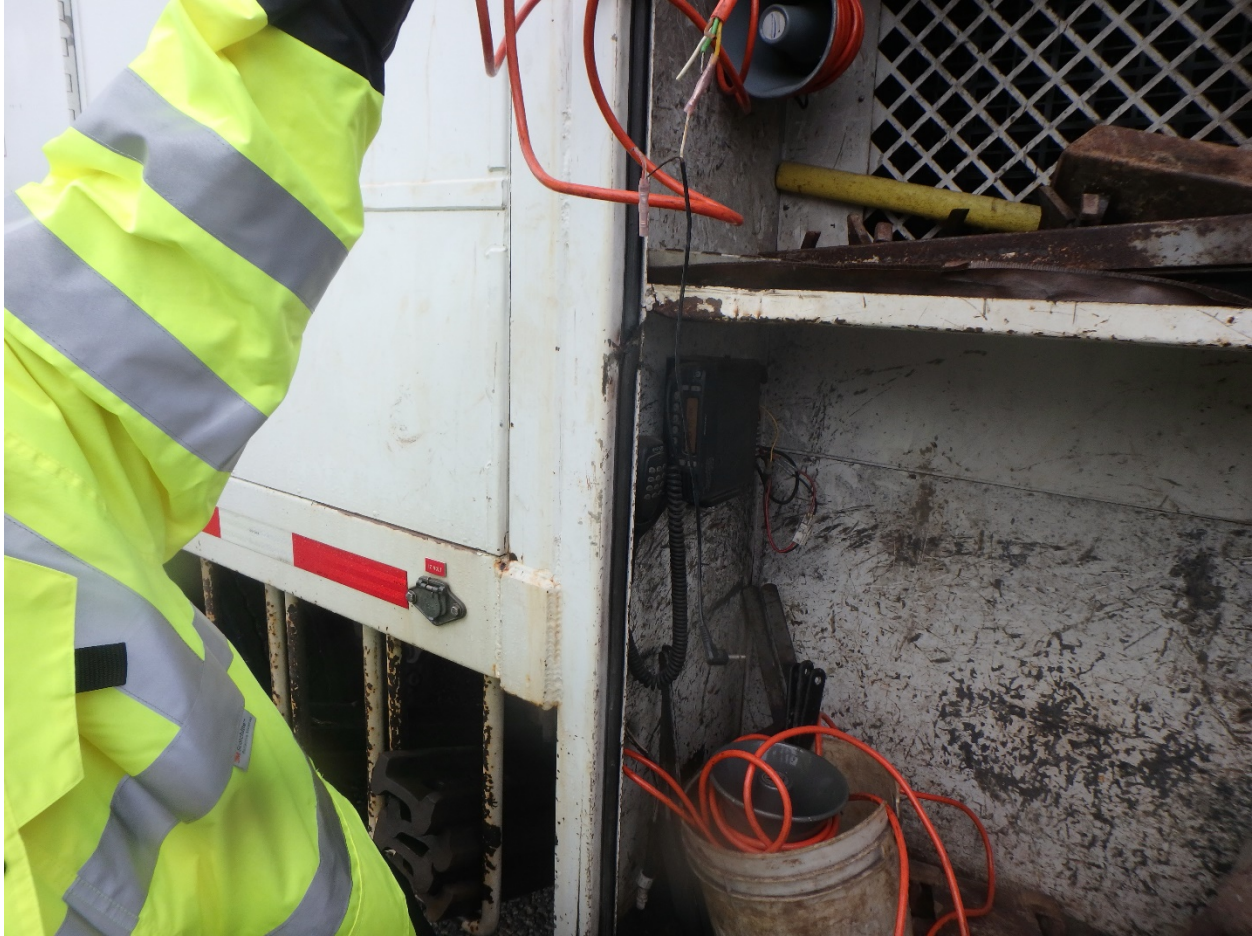
Figure 6. Photo showing two speakers that were located inside the truck cabinet that contained the external radio.
