NATIONAL TRANSPORTATION SAFETY BOARD
Vehicle Recorder Division
Washington, DC 20594

Onboard Image Recorder

Specialist's Factual Report
By Sean Payne

Location: Baltimore, MD
Date: February 7, 2019
Aircraft: Locomotive, NS9207
Operator: Norfolk Southern
NTSB Number: RRD19FR004

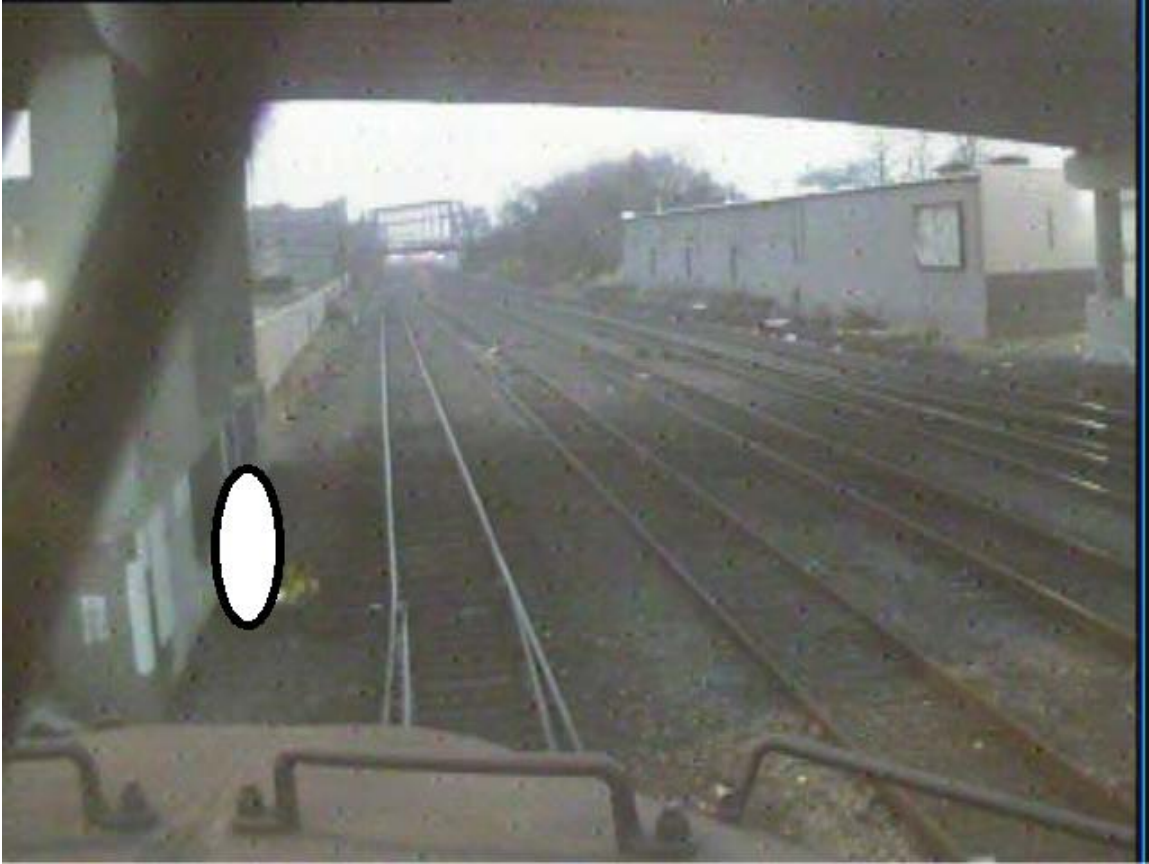
At 06:58:07, the next video file began. The locomotive was moving forward slowly. The conductor was no longer visible ahead of the locomotive. The locomotive passed over a series of switches as it headed toward the President's Street Bridge. At 06:59:07 the locomotive passed over the switch onto the Bank track. The conductor was visible on the left side of the track next to the switch, the conductor was wearing high-visibility apparel and was holding a lantern. Figure 1 is a screenshot of the forward-facing image recorder's data at this moment. The screenshot has been redacted to obscure the conductor's who was standing on the left side of the track.

Figure 1. A redacted screenshot showing the conductor at a switch in the vicinity of the President's Street Bridge. The oval object redacts the conductor's who was standing on the left side of the track.

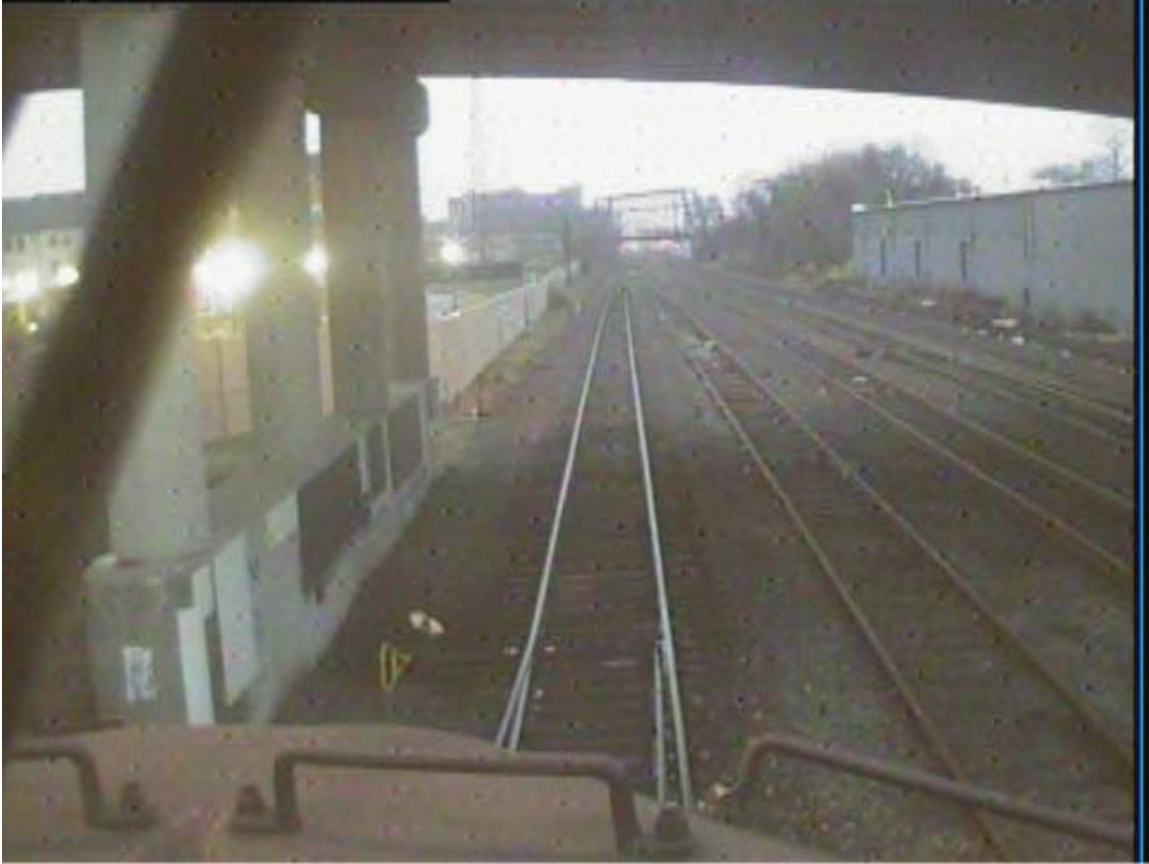
At 07:00:38, the locomotive began reversing. At 07:01:29, the locomotive reversed passed the switch it previously crossed. The switch was now lined straight onto the Bank track in which the locomotive was now reversing. A screenshot is included as figure 2 at this time.

Figure 2. The locomotive reversing past a switch in the vicinity of the President's Street Bridge. The switch is lined for the Bank track, the Perryville track is seen to the right of the locomotive.

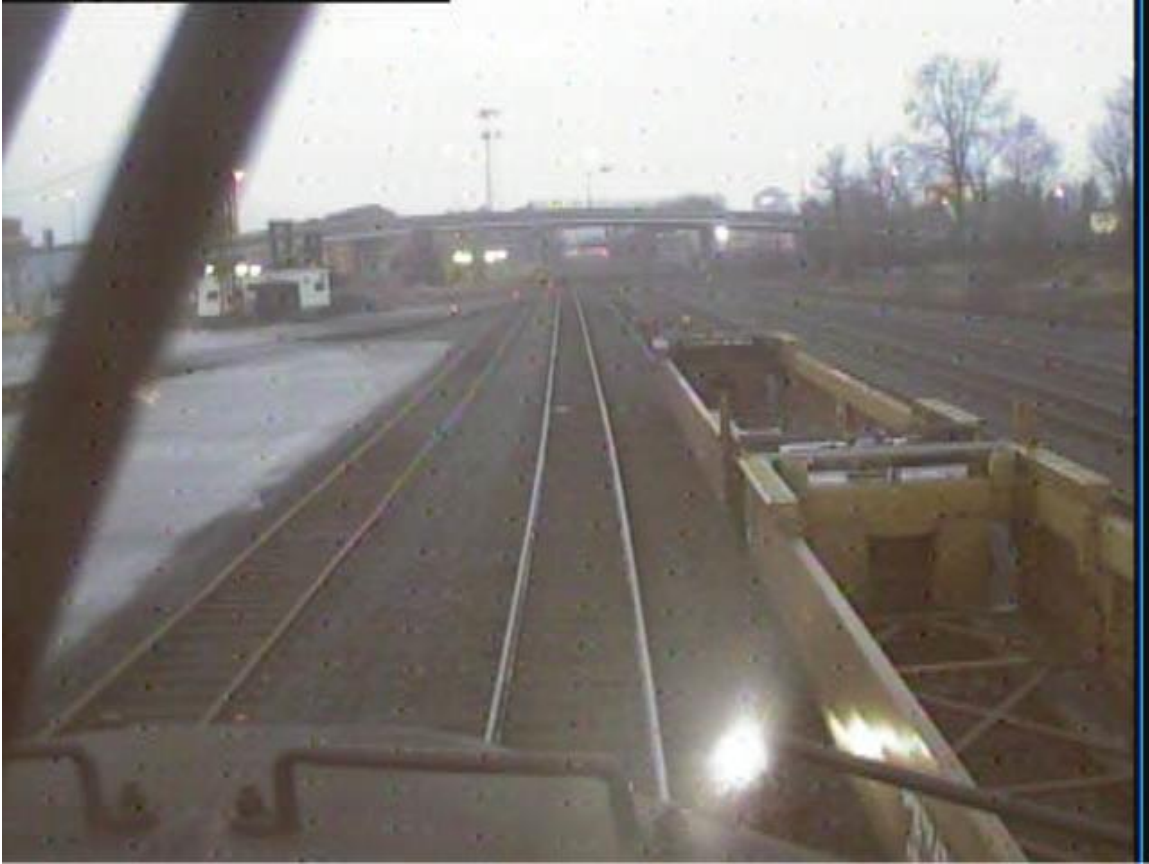
The locomotive continued to reverse past the first intermodal well car on the Perryville Track. At 07:02:38, the locomotive was still reversing and a lighted object consistent with a conductor's lantern was visible between the Bank Track (258) and the Perryville track (259), next to a set of intermodal cars. Data indicated the speed of the reversing locomotive was 5 miles per hour. A screenshot of the forward-facing camera is included at this time as figure 3.

Figure 3. A lantern consistent with that of the conductor's visible between the Bank track and the Perryville track.
