1 **NATIONAL TRANSPORTATION SAFETY BOARD**

Operations Factual Report
Train Derailment Hazmat Release

Description: Derailment/ Mudslide
Location: Draffin, KY
Accident Date: February 13, 2020
NTSB accident number: RRD20FR002

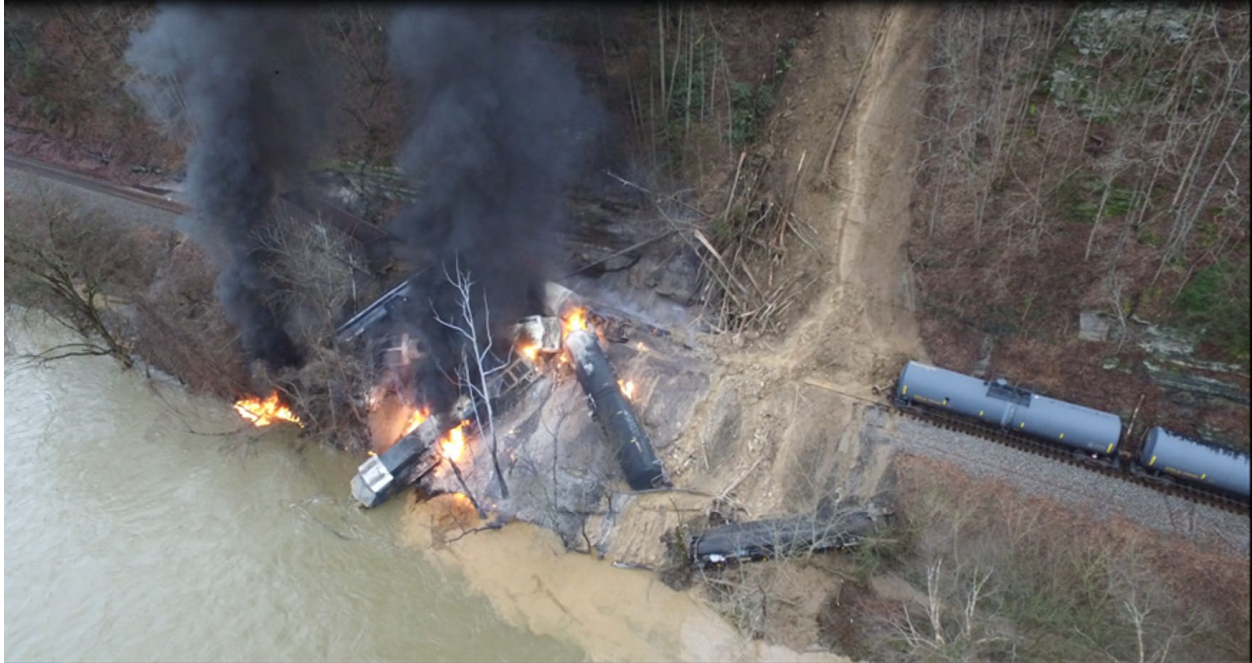
2 *Figure 1 Photo Courtesy of Darffin, KY Police Department*

3 508 Text: Photo is an aerial view of the train derailment. To the right of the train is a hill and shows where
4 a mudslide occurred. To the left of the train is the river. The lead locomotive and 2 trailing locomotives
5 are derailed to the left of the railroad tracks. The nose of the lead locomotive is in the water with fire on
6 both sides of the locomotive. Also seen on the photo are two derailed tank cars, one is near the rear of
7 the lead locomotive and on fire.
