**NATIONAL TRANSPORTATION SAFETY BOARD**

**RRD21FR009**

**Fatality to Railroad Employee During Switching Operations**

**BNSF Railway  
Louisiana, Missouri  
April 7, 2021**

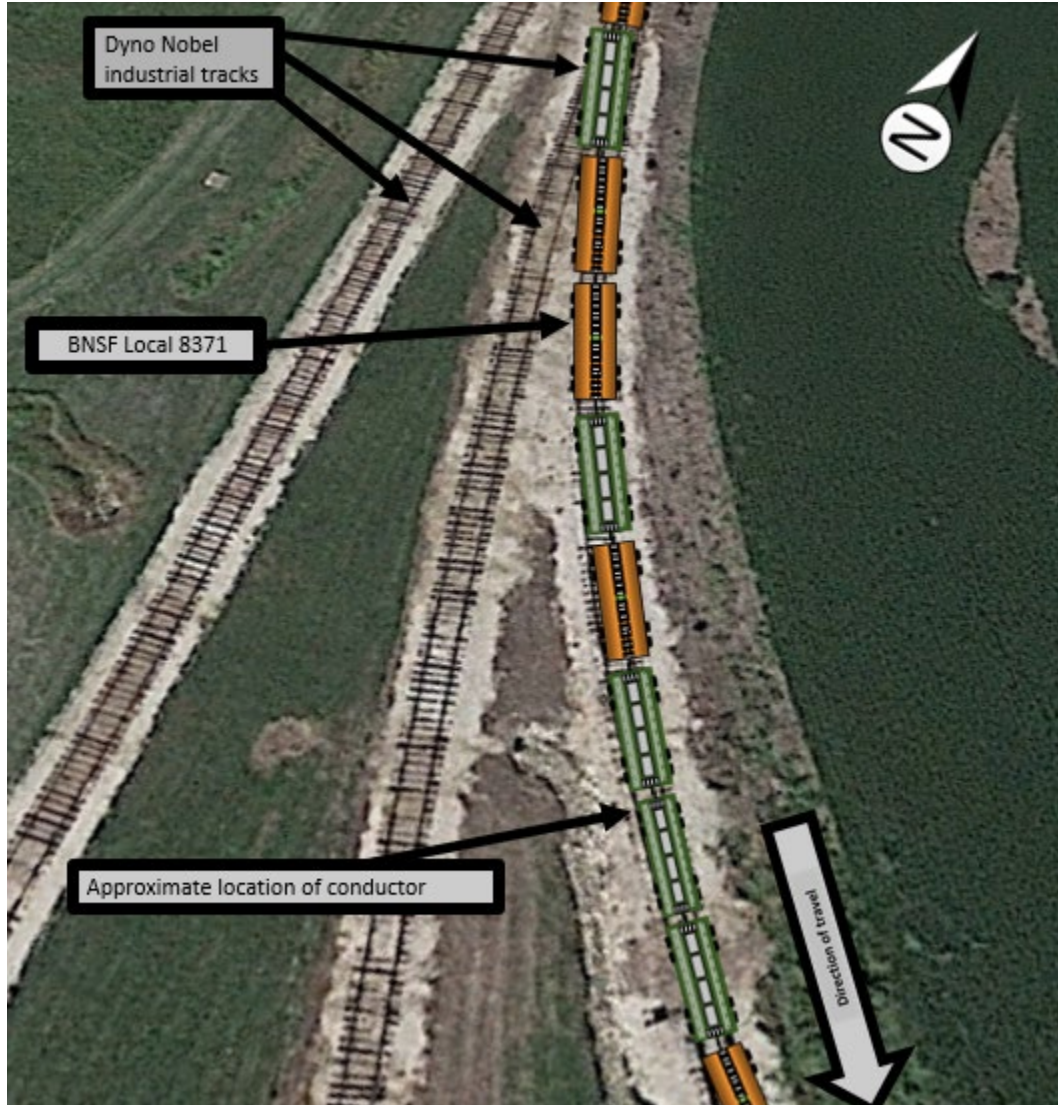
Figure 1: Illustration of the accident. (Photograph courtesy of Google Earth.)  
[508 text: Illustration of accident shows BNSF local 8371 shoving southeast through the facility as well as the approximate location of the fatality injured employee.]

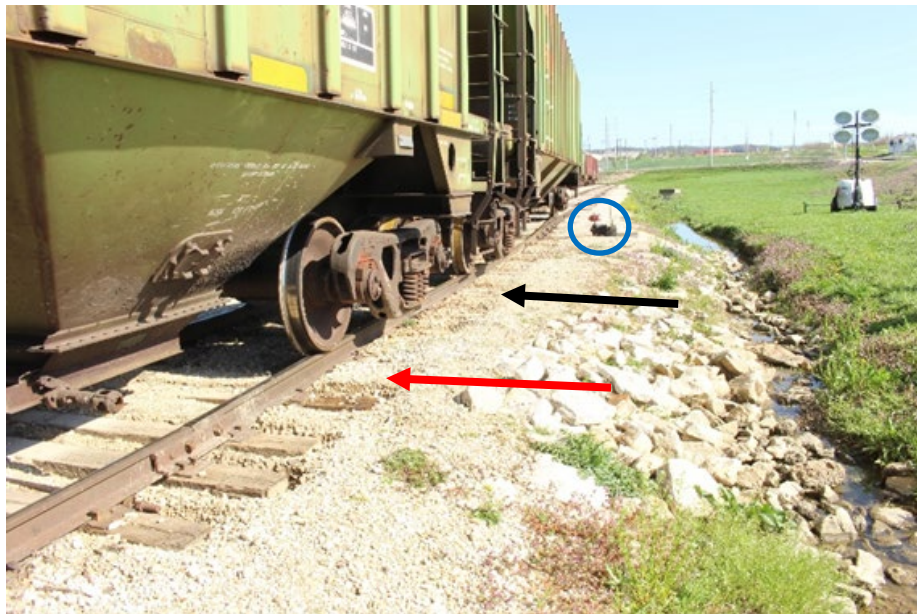
NTSB investigators took measurements and performed a post-accident walking inspection of the track in the area of the accident. **Table 1** contains the distance from the switch to the final rest position of the conductor as well as the distance from final rest to the area identified as the first harmful event by the coroner on the scene.

Distance
6212/6213 switch to final rest of conductor	31 feet
Final rest position of conductor to slide marks found by coroner	10 feet
Rail tie to aggregate (Rocks)	21 inches

**Figure 3** Looking southeast, in the direction of the shoving movement of the train, on the south side of the track. The red arrow indicates the location of the perpendicular slide marks found by the coroners. The black arrow indicates the location of the final rest position of the conductor. The switch is indicated by the blue circle.

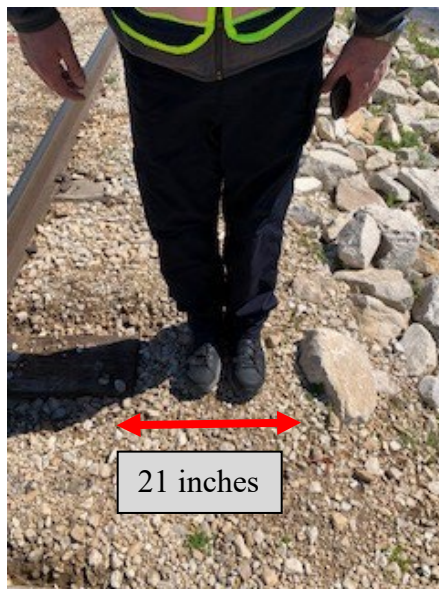
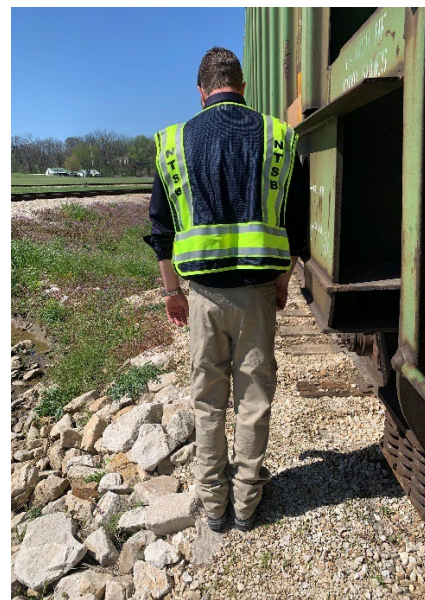
During the inspection of the area, it was noted that large rocks were located on the south side of the track near a decline leading to a drainage ditch. The measurements taken revealed the distance from the end of the rail tie to the large rocks only allowed 21 inches of walking space.

**Figure 4** the photo on the left shows the width of the walking space available between the edge of the railroad tie and the adjacent rocks at the location where the slide marks in the ballast were found. The photo on the right displays the available space.

*(2) Except in cases in which the division finds that construction or reconstruction is impracticable, unnecessary or where existing in structures or tracks prevent construction, walkways shall be constructed along each side of industrial railroad trackage a minimum of eight feet six inches (8'6") from the center of track measured at right angles to the center. Walkways shall be reasonably level with the top of the railroad ties and beginning*
