NATIONAL TRANSPORTATION SAFETY BOARD

Vehicle Performance and Engineering Group Factual Report

**Collision Between two Trolley Cars
Massachusetts Bay Transportation Authority (MBTA)
Green Line B-Branch
Boston, Massachusetts
July 30, 2021**

RRD21FR013

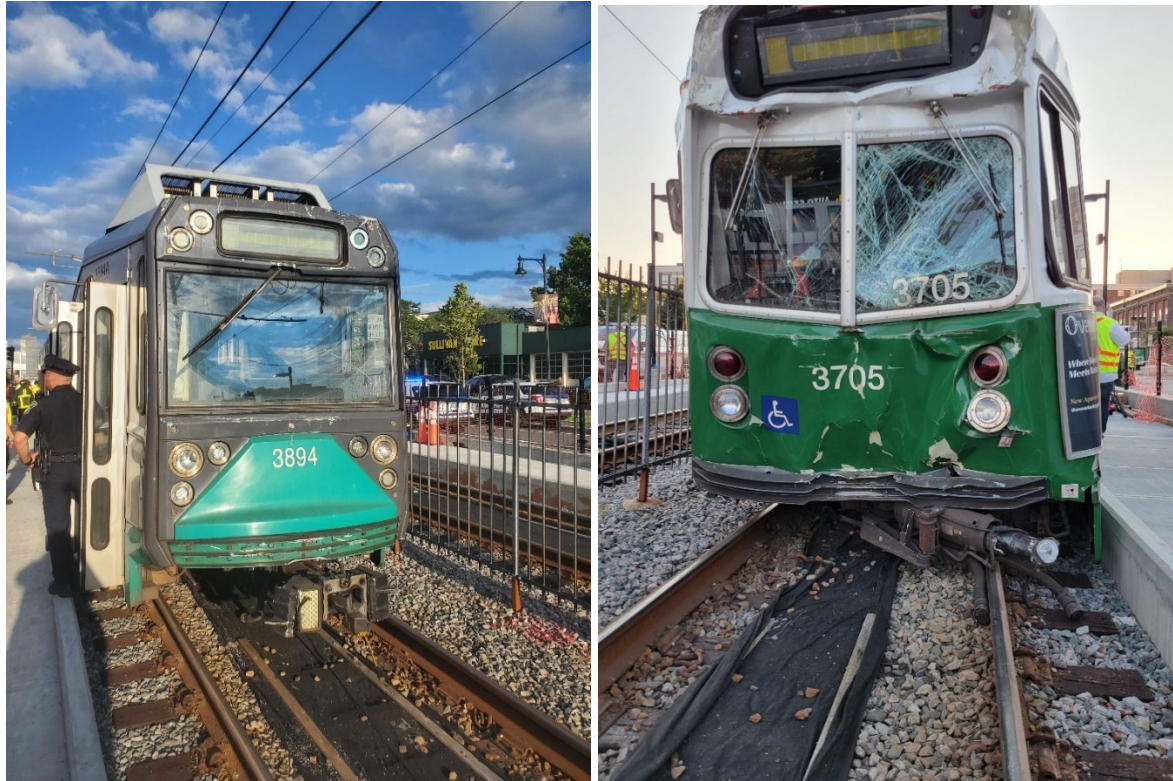
Figure 1. Trolley 3894 and 3705 at the accident scene

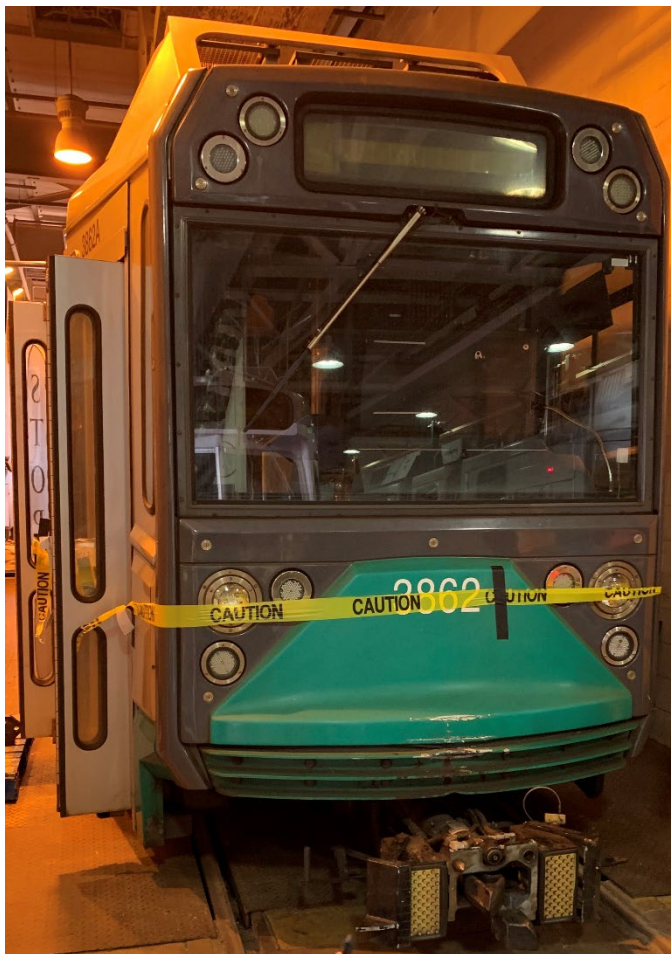
Trolley 3862 is a Type 8 vehicle and was the leading trolley in the struck consist. The No. 3 axle was derailed. The B-end was leading in the direction of travel. The B-end cab was occupied by a motorperson.

The exterior of the vehicle showed evidence consistent with the trailing trolley impacting the A-end after that vehicle was struck from behind. The A-end anticlimber showed witness marks, paint transfer, and nearby Fiber Reinforced Plastic (FRP) was torn, approximately 14-inches

long. There were witness marks from the anticlimber on the A-end coupler. The A1 door was deformed approximately 1/8-inch, but did operate. The AL corner was observed to have cracked FRP. There was exterior skin and roof deformation noted approximately 8-feet from the nose on the AR side. The A-end anticlimber was noted to be 27-inches ATOR at the top and 22-inches ATOR at the bottom. The A coupler was fully compressed during the accident. The L3 dog bone showed witness marks from riding on the rail, consistent with the axle derailing post-impact. The A-end coupler guide plate was broken, with all bolts sheared off.

The BL roof was deformed behind the cab windows and there were witness marks and paint transfer consistent with wayside structure contact on the BL skirt.

Figure 2. Trolley 3862 in the maintenance facility.

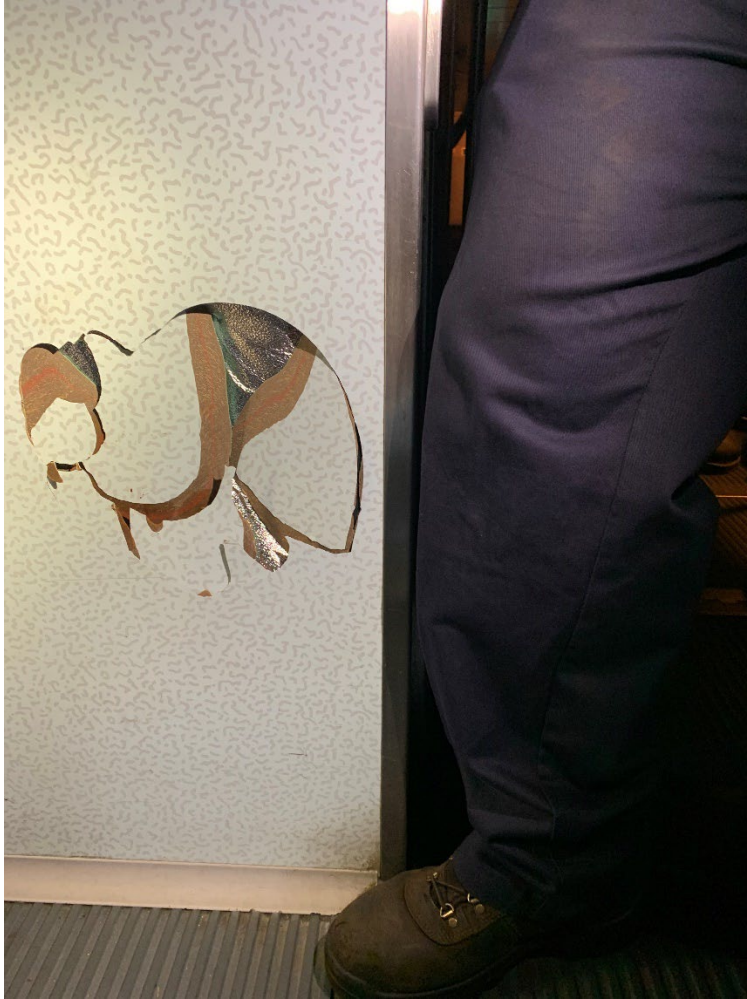
Inside the B-car, on the right-side forward facing wall just prior to the C-Car connection, there was an impact mark, including broken fascia about 10-inches in diameter, centered approximately 18-inches above the floor. This is consistent with a person or luggage impacting the wall at this location during the accident. Additionally, some limited signs of injury were noted on the floor in the single seat facing door B3.

Figure 3. Trolley 3862 inside facia with hole.

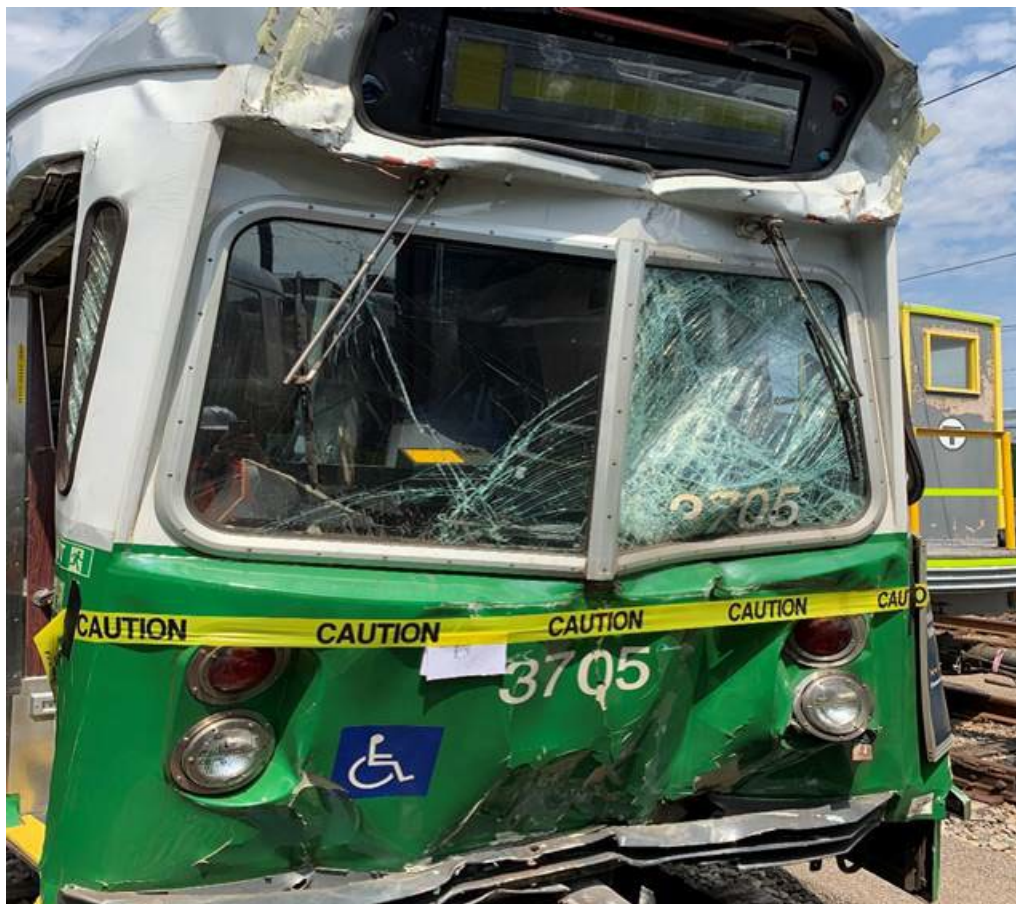
The exterior of the vehicle contained evidence consistent with being both struck from behind (B-end) by the striking train and colliding with the trolley it was coupled to in the consist. The B-end anticlimber was crushed inboard longitudinally. The top of the anticlimber was 22.5-inches ATOR and the bottom of the anticlimber was 17-inches ATOR. An exemplar anticlimber was noted to be 30-inches ATOR at the top and 24-inches ATOR at the bottom. The anticlimber outer edge to the first axle was noted to be 89.5-inches. An exemplar trolley distance was 117-inches for this measurement. Therefore, the anticlimber was crushed approximately 27-inches.

The B1 door was removed during the recovery operations. The stairway at this location was buckled and crushed approximately 4-inches. The right side roof rail buckled at the first window. The B-end destination sign was crushed. The glazing was shattered, but not penetrated. There was sheet metal buckling on the right side from the nose to a location 9-feet inboard.

The B-end cab had its occupied volume reduced by approximately 15%. The operator's space was observed to be 36"x28"x55" in post accident measurements, this is 55,440 cubic inches. An exemplar space 40"x28"x58" or 64,960 cubic inches. This cab was unoccupied at the time of the accident. Additionally, the floor was buckled between doors B2 and B3.

Under the car, the B-end coupler showed evidence consistent with impact damage failure. The anticlimber was separated from the front end frame, with the bolts torn through the mounting plate. The coupler mounting/ center sill area was twisted approximately 1.5-inches. From the nose to the plow area, about 5-feet of sheet metal underside was torn, deformed, and separated from the center sill. The underframe/ center sill shows signs of elastic strain in the curved gooseneck areas.

Figure 4. Trolley 3705 in the maintenance facility.

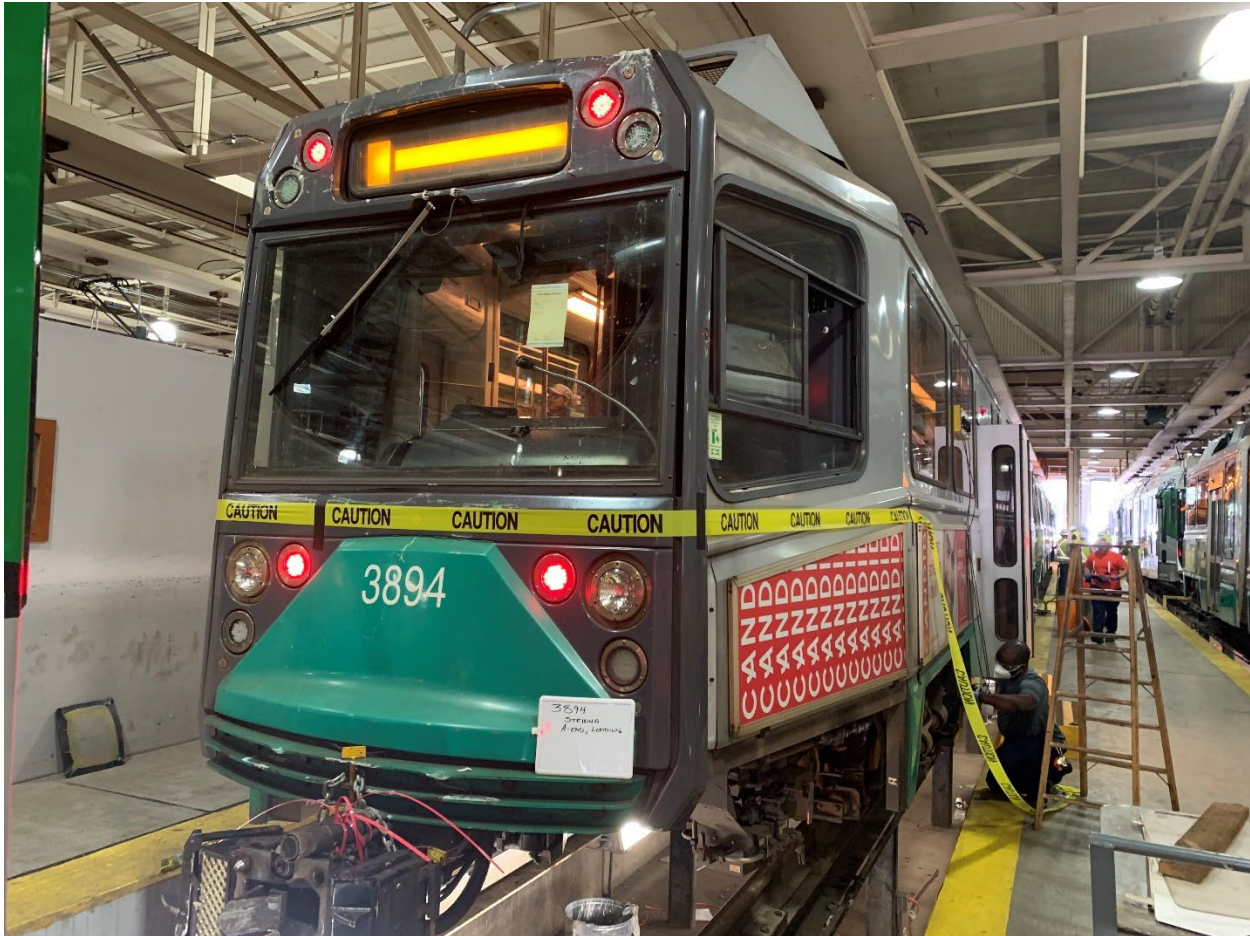
The exterior of the A-end showed signs of paint transfer and witness marks on the FRP along its entire height. Relatively, there is less structural damage than the end of the trolley which was struck. The A1 door will not cycle normally, nor manually open. It is bent out of alignment approximately 1-inch. There is approximately 1-inch of deformation visible approximately 22-inches from the nose above the top corner of the A1 door.

The underside of the B-end has witness marks on the coupler consistent with a lifting motion. The B-end anticlimber bolts are secure. The A-end High Voltage junction box, plow, and support tray show signs of impact damage from debris on the right-of-way. The A-end couple height adjustment bolts are bent.

Figure 5. Trolley 3894 in the maintenance facility.

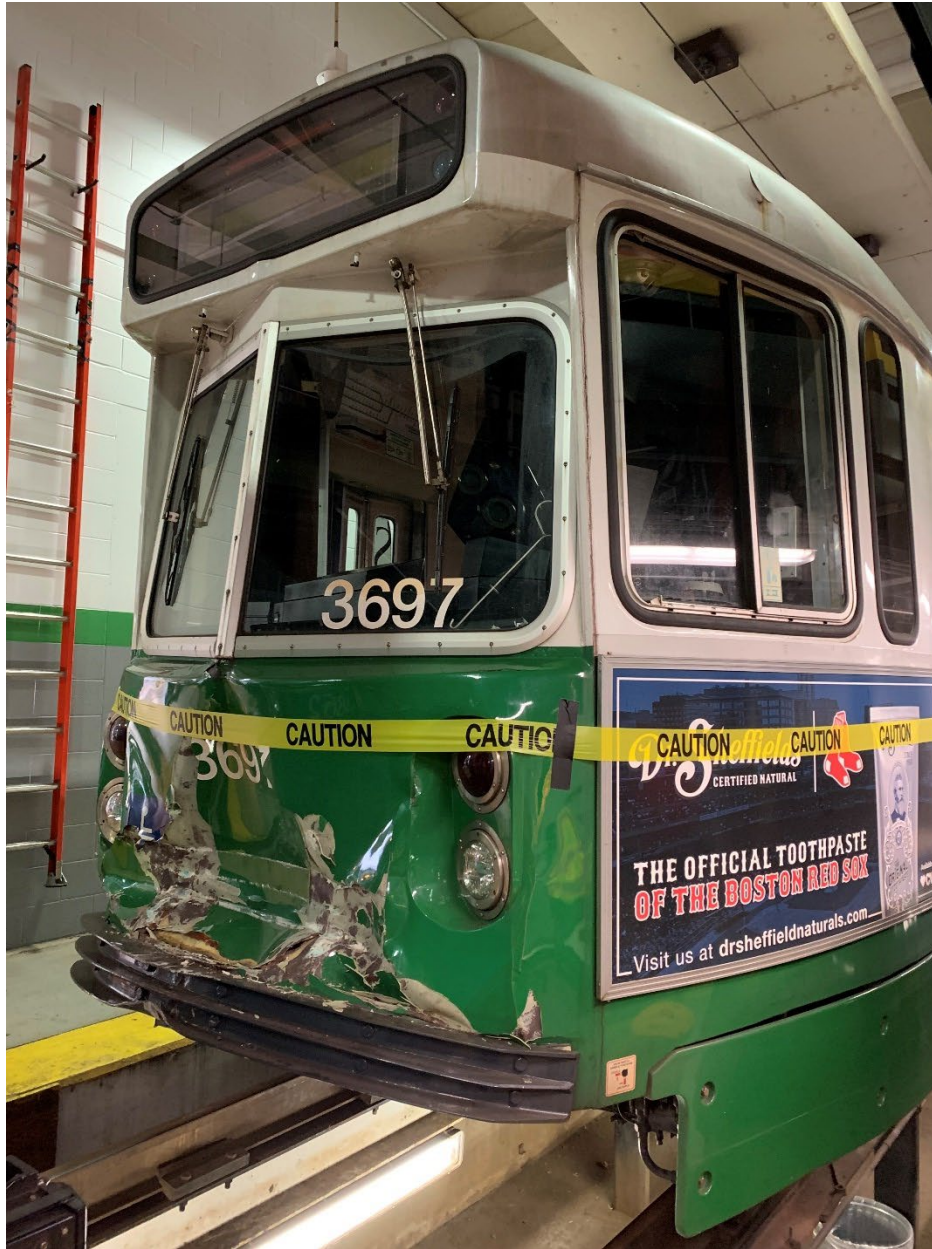
Damage to the front skin of the trolley is consistent with the anticlimber from the 3894 overriding the 3697. There are clear witness marks from an anticlimber in the front skin/nose area of 3697. The front skin is deformed over most of its surface area, the penetration is about 8-inches. The structural members behind the skin are vertical posts which crumpled to ‘pinch’ the 3894 anticlimbers as evidenced by matching witness marks. There are additional witness marks inside the anticlimber on 3697. There is paint transfer and paint removal on several anticlimber connection bolts.

The area behind the A1 door shows skin deformation, buckling and extends the entire vertical height of the trolley.

The underside of the trolley shows plastic deformation. The center sill began to fold in a type of U-shape with the peaks at the front/nose and first horizontal structural member above the plow area. The evidence is consistent with all four coupler shear pins failing by design at 70,000 pounds of force. The coupler itself failed and left pieces on the right of way. The anticlimber was bent 2-inches upward directly in the center of the device, corresponding to a broken tippet valve on the coupler head. The welds connecting the center sill to the sheet metal on the exterior bottom of the car were failed along the longitudinal axis. The center sill showed signs of elastic strain at the gooseneck above the plow.

Inside the car, the right side of the operator's cab floor was bent down 1.5-inches as measured at the corner post of the operator's door.

Figure 6. Trolley 3697 in the maintenance facility.

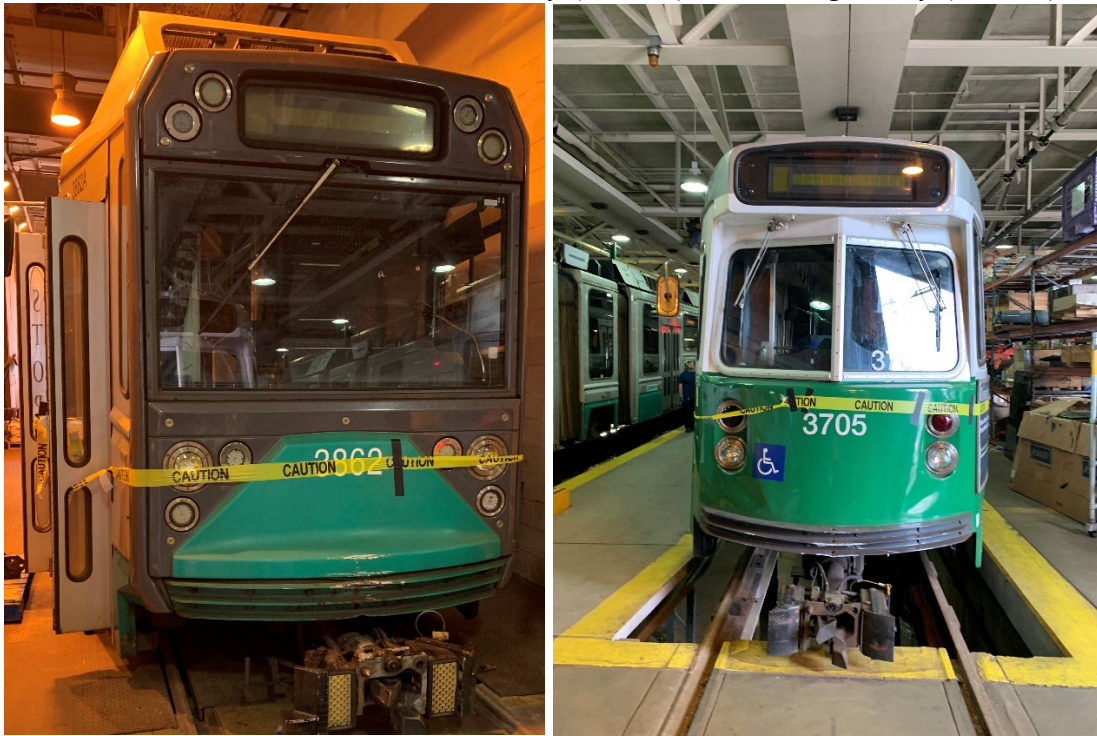
Figure 7. Collision interface 1

1. Struck Train, Interface between lead trolley (3862/A) and trailing trolley (3705/A)

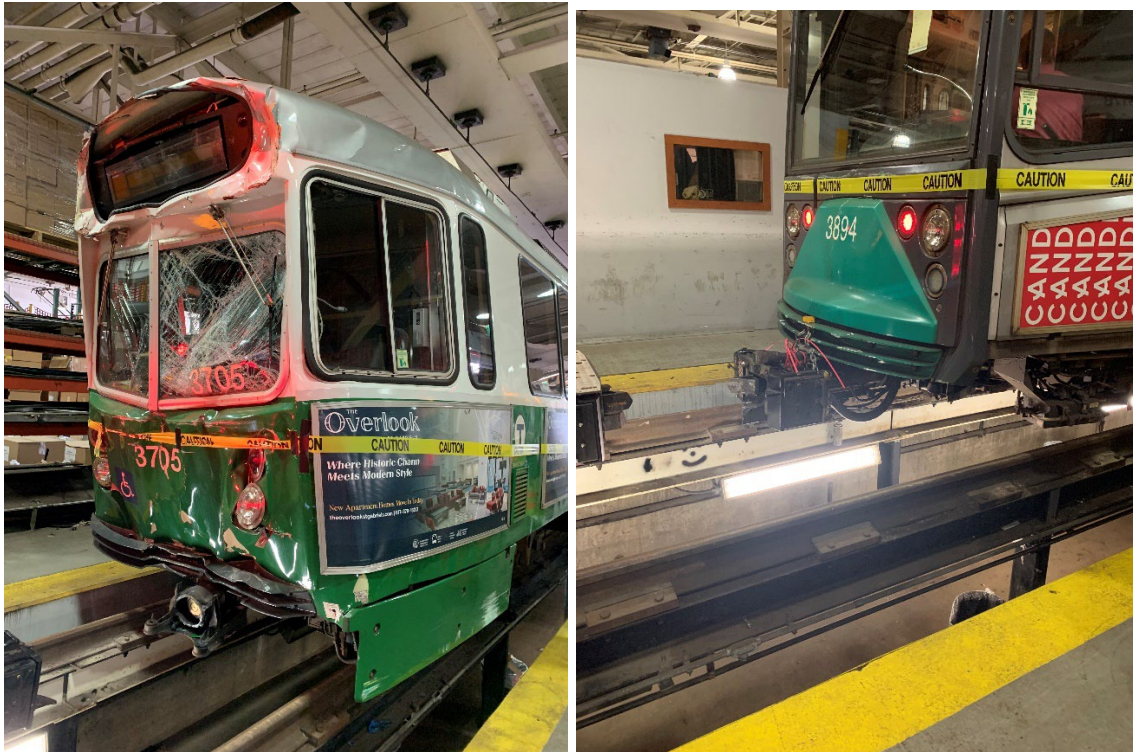
Figure 8. Collision interface 2

2. Between Struck Train (3705/B) and Striking Train (3894/A)

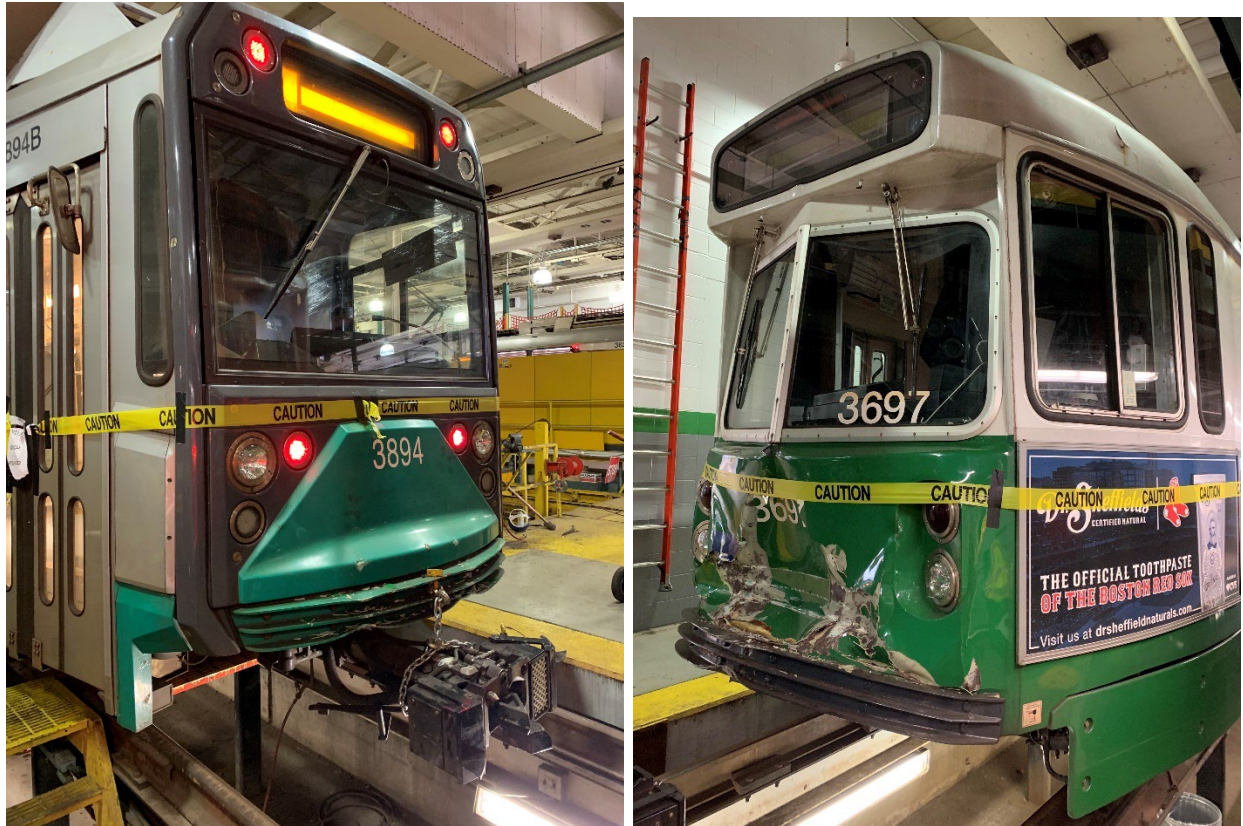
Figure 9. Collision interface 3

3. Striking Train, Interface between lead trolley (3894/B) and trailing trolley (3697/A)
