**NATIONAL TRANSPORTATION SAFETY BOARD**

**RRD21LR005**

**IIC FACTUAL REPORT**

NTSB Accident Number:	RRD21LR005
Date of Accident:	November 17, 2020
Time of Accident:	2:26 pm (local)
Railroad Owner and Operator:	Alabama Export Railroad

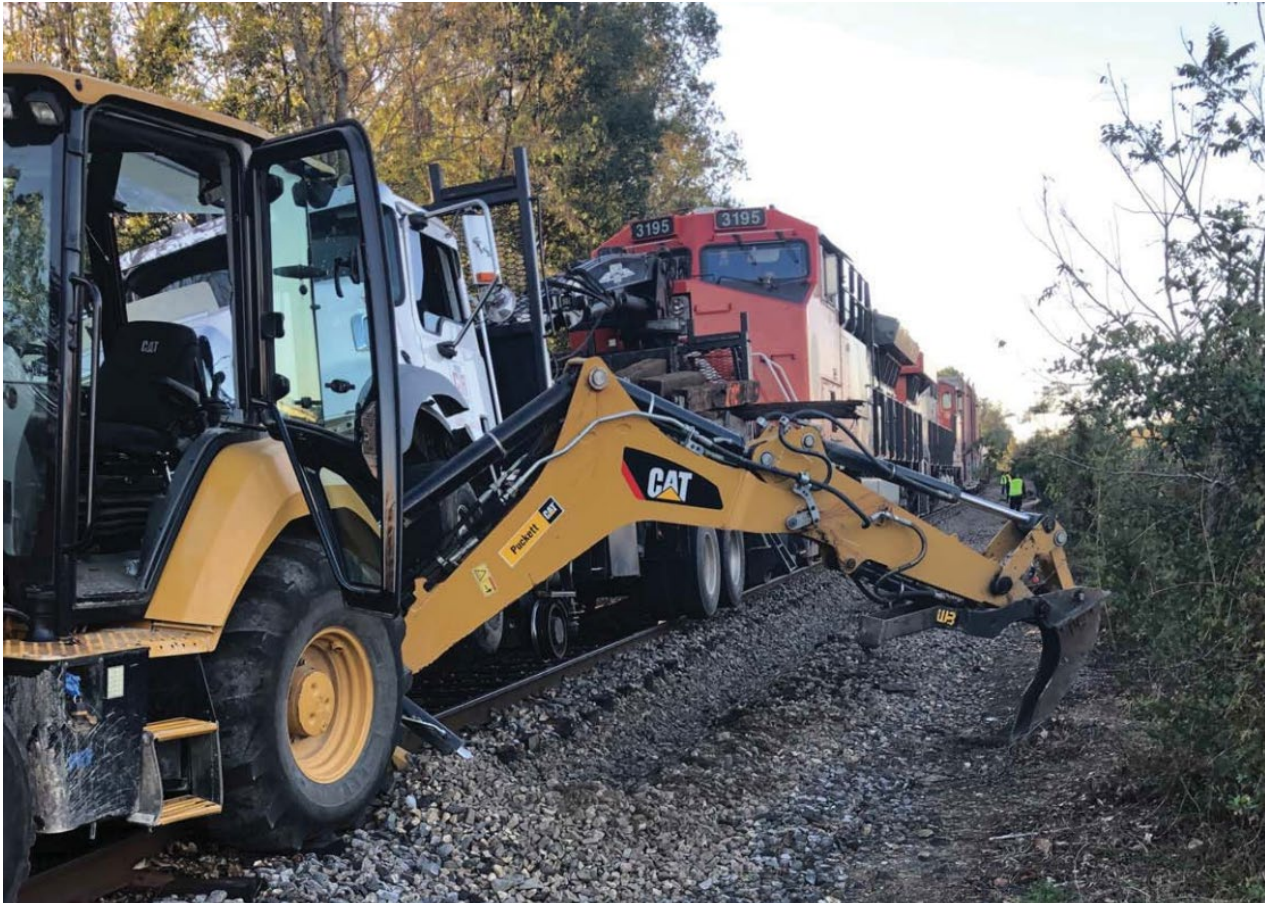
All members of the work group recalled having no knowledge of the approaching train until it struck the material handling truck.

Figure 2. Photo of equipment after impact at the accident location.
