NATIONAL TRANSPORTATION SAFETY BOARD

RAIL FACTUAL REPORT

NTSB Accident Number:	RRD21LR007
Date of Accident:	January 31, 2021
Time of Accident:	12:40 p.m. (Local)
Railroad Owner and Operator:	Union Pacific Railroad
Maintenance Equipment:	Track Maintenance Tamper-1602
Maintenance of Way Crew:	UP Tie Team- 9062
Fatalities:	1
Injuries:	1
Location of Accident:	Vail, AZ

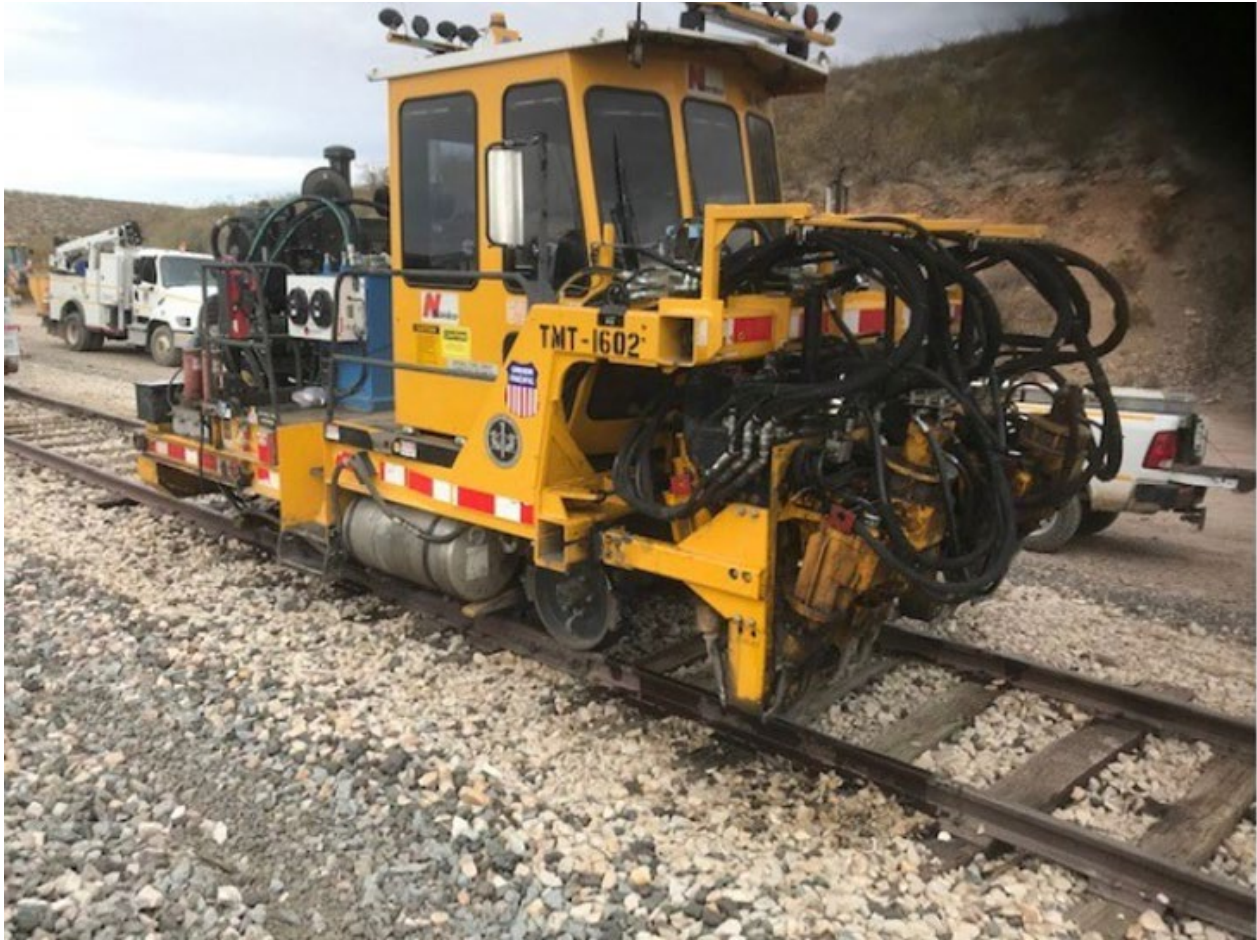
Figure 2 The TMT at the accident scene. (Photograph provided by UP.)
