NATIONAL TRANSPORTATION SAFETY BOARD

WT Byler Contractor Fatality

Castroville, Texas

IIC FACTUAL REPORT

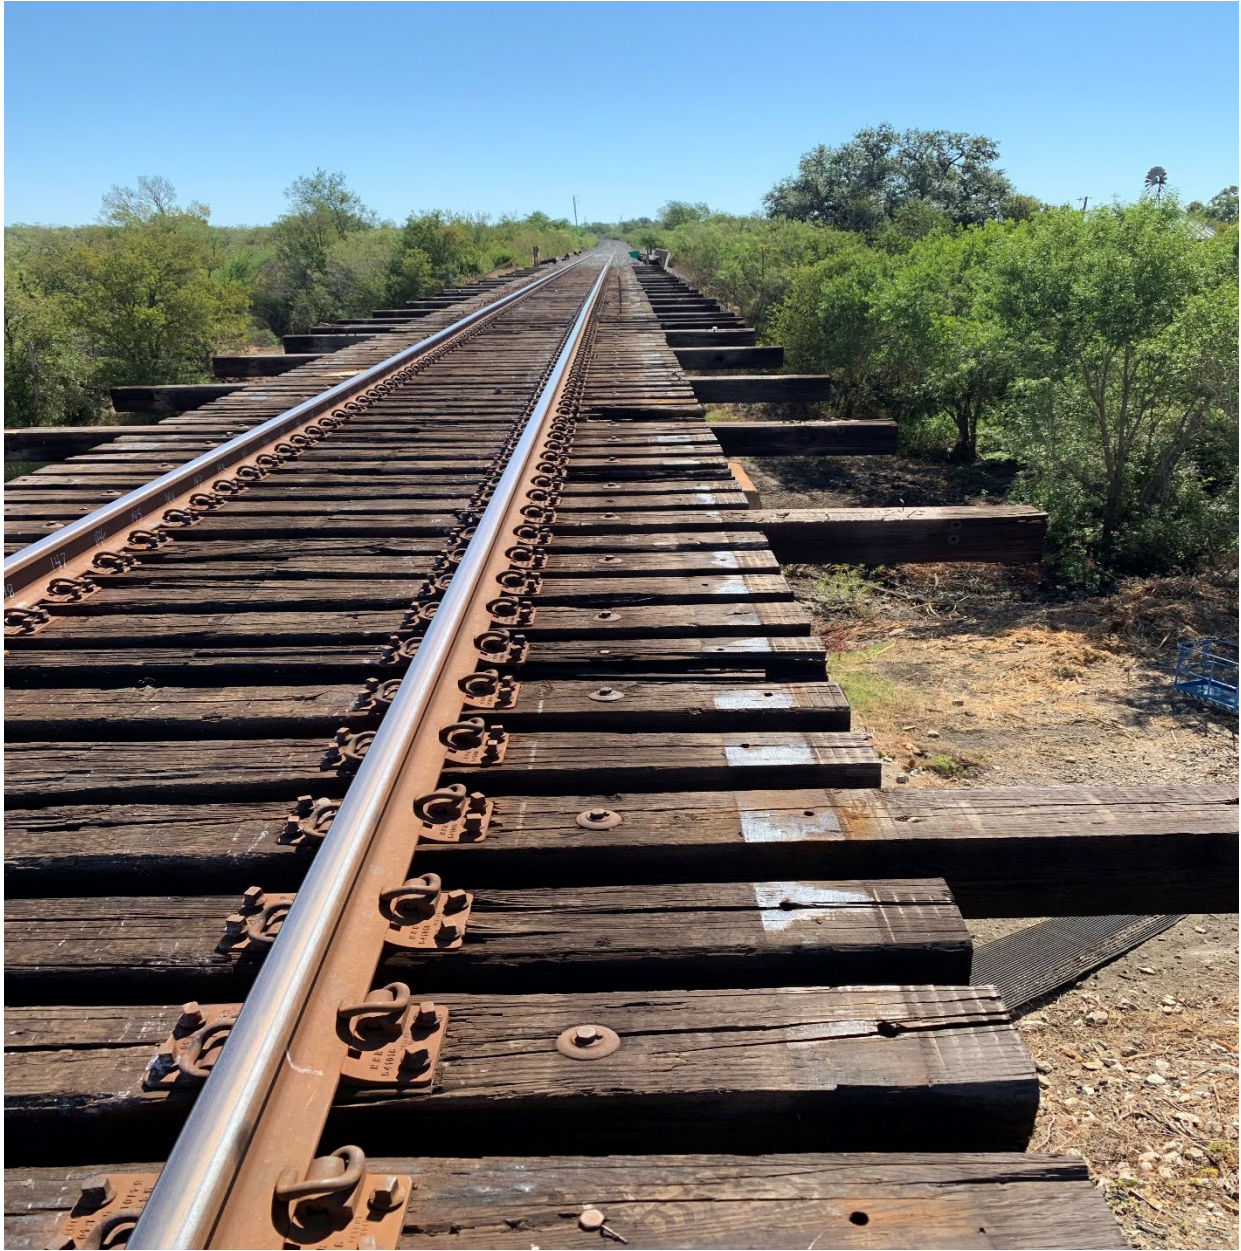
Figure 1- photo of Chacon Creek Bridge

The Chacon Creek Bridge was constructed in 1907. The bridge is an open-deck wood timber structure and measures 198 feet long. The running rails are fastened to the bridge timbers with MSR (plate manufacturer) bridge plates, screw lags and rail clips fasteners. The bridge is mainly constructed with 15 feet long bridge timbers, and at every 10 feet interval, a 20 feet long bridge timber exists for fastening down the steel walkway gratings. There are ten 20 foot long by 3 feet wide steel walkway gratings located to the field side of each running rail that permits a location for personnel to clear for trains while traversing the bridge.

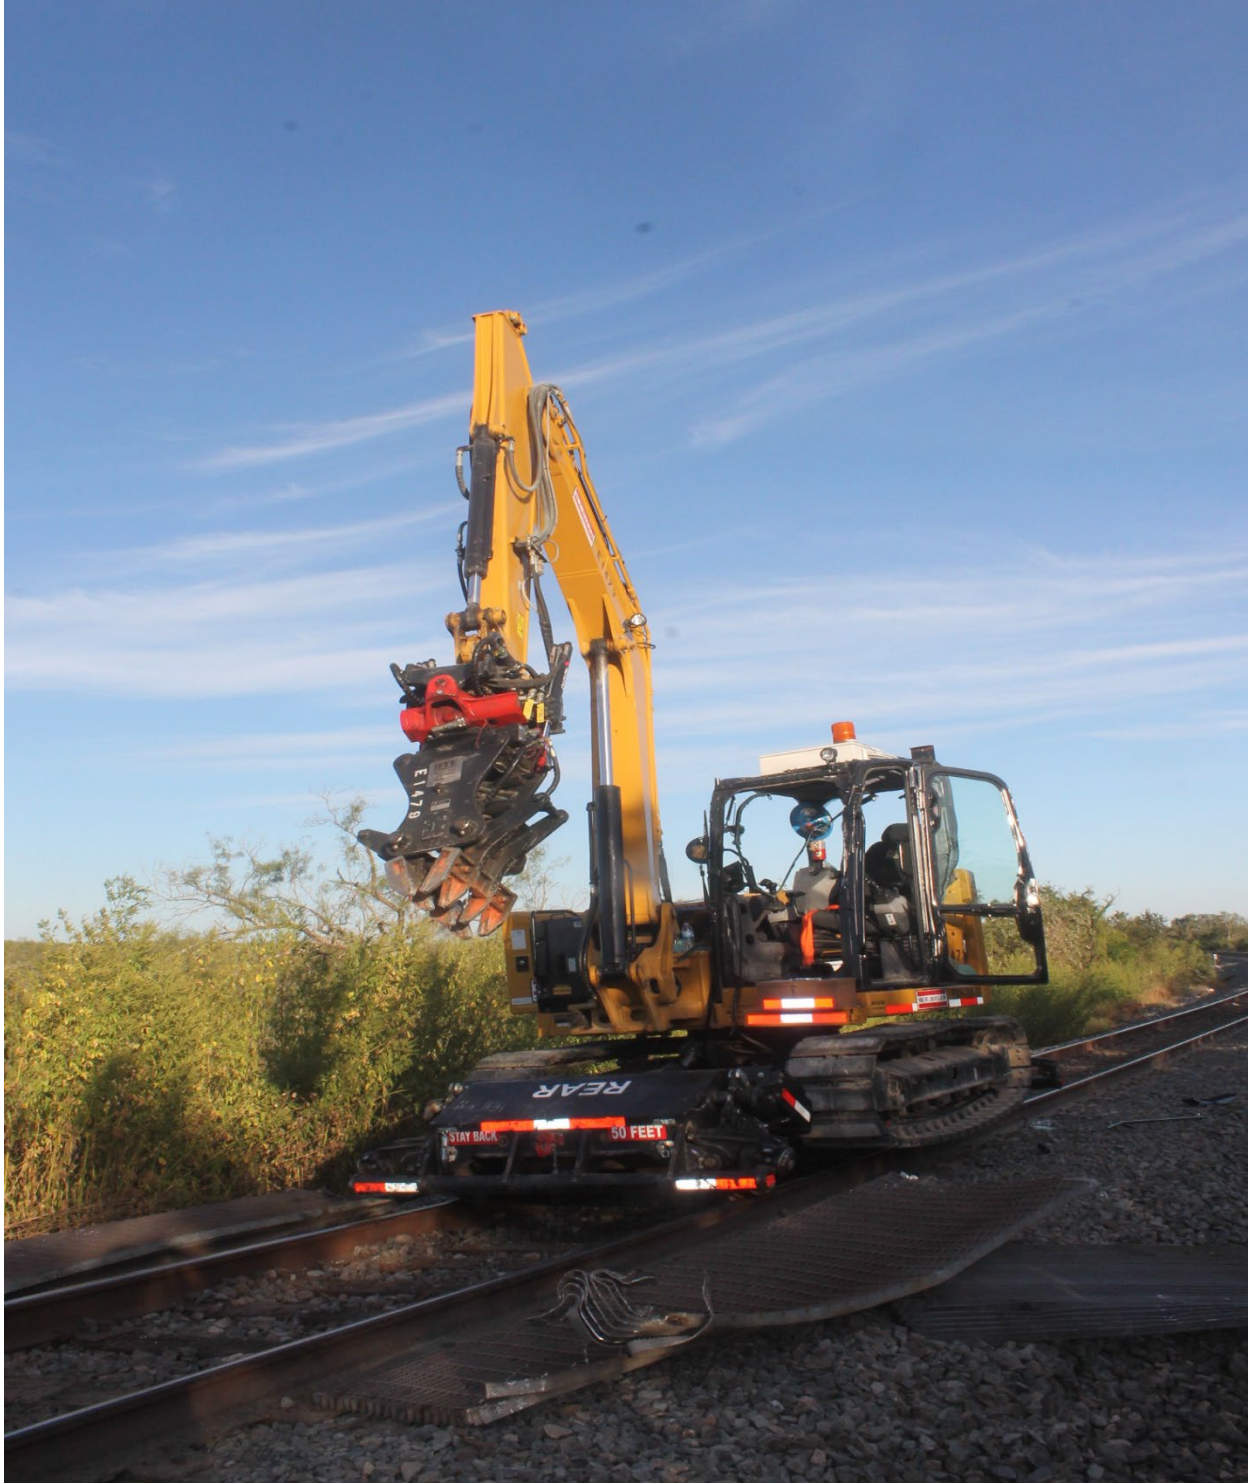
Figure 2- photo of the accident equipment at the accident site

The accident equipment was a model BTE-308-CR-Caterpillar Mini Hydraulic Excavator (BTE 308-WT) equipped with retractable railroad wheels that allows it to travel on railroad tracks. The machine was designed and outfitted to operate as a railroad roadway maintenance machine by Ballast, Tools, and Equipment (BTE). BTE designs, builds, sells, and leases specialty equipment for railroad track maintenance and construction. At the time of the accident, the machine was being utilized for the maintenance and repair of an open deck railroad bridge; thus, classifying the machine as an FRA defined roadway maintenance machine. The machine falls under FRA's roadway maintenance machine (RMM) standards as specified in 49 CFR Part 214- Subpart D, and is defined as an RMM equipped with a crane meaning "*any RMM equipped with a crane or boom that can hoist, lower, and horizontally move a suspended load*".

BTE conducted a postaccident mechanical inspection of the accident involved equipment. They found no mechanical issues with the machine including missing pins, safety stops, and boom connection and work head connections. BTE was able to conduct a leak and loss of pressure testing on the machines hydraulic system with no significant findings. BTE was unsuccessful in getting the machine operable in order to conduct electrical and on-board computer diagnostic testing due to the extreme damage to the inner-cab electrical components and equipment controls.
