NATIONAL TRANSPORTATION SAFETY BOARD

Mechanical Group Factual Report

**Derailment of Train Number 7, Empire Builder
National Railroad Passenger Corporation (Amtrak)
BNSF Railway Hi Line Subdivision near
Joplin, Montana on
September 25, 2021**

RRD 21 MR 017

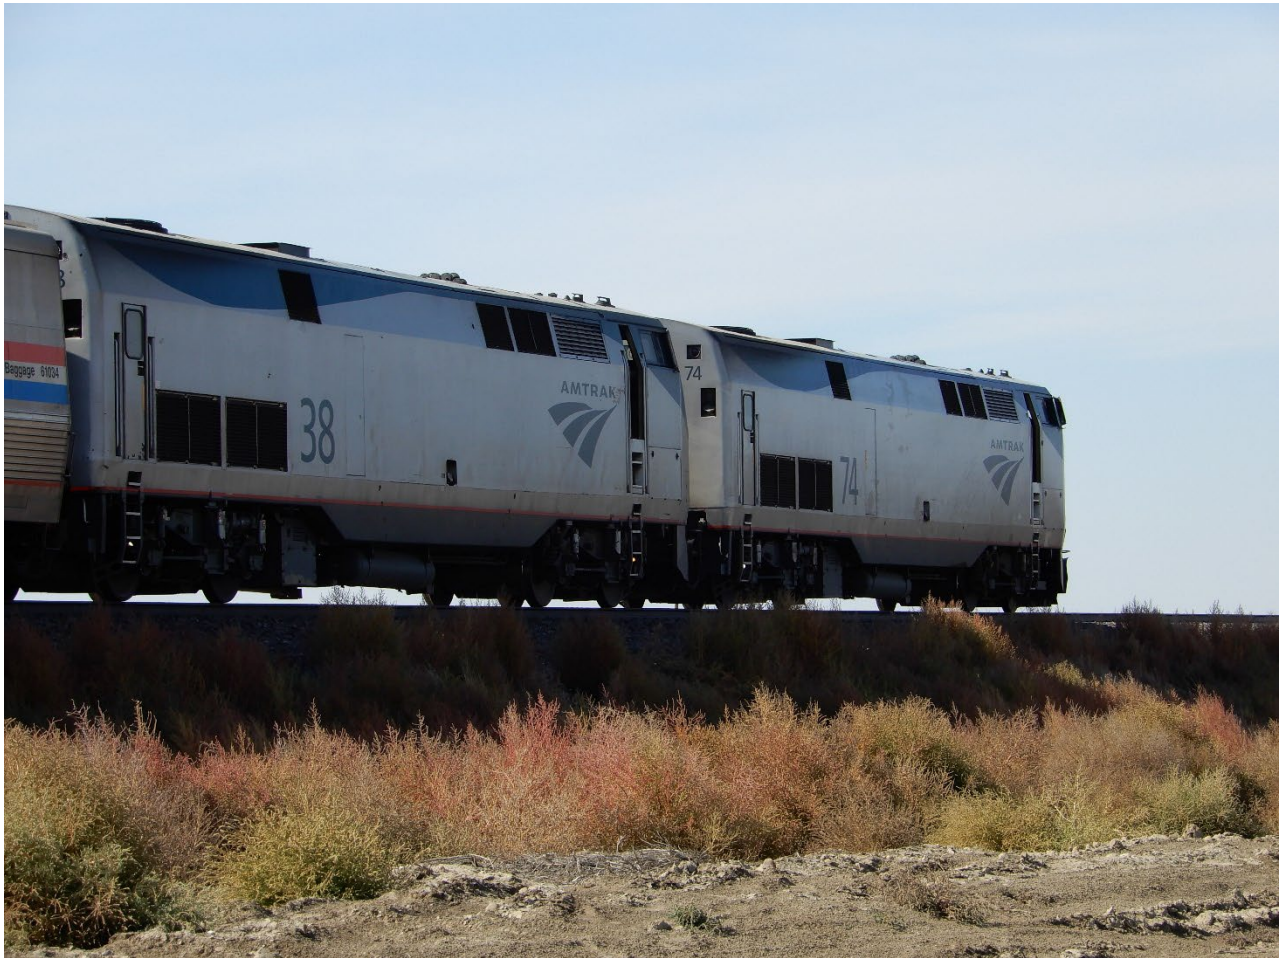
Figure 1. Post-accident image of Train No. 7 locomotives Near Joplin, MT

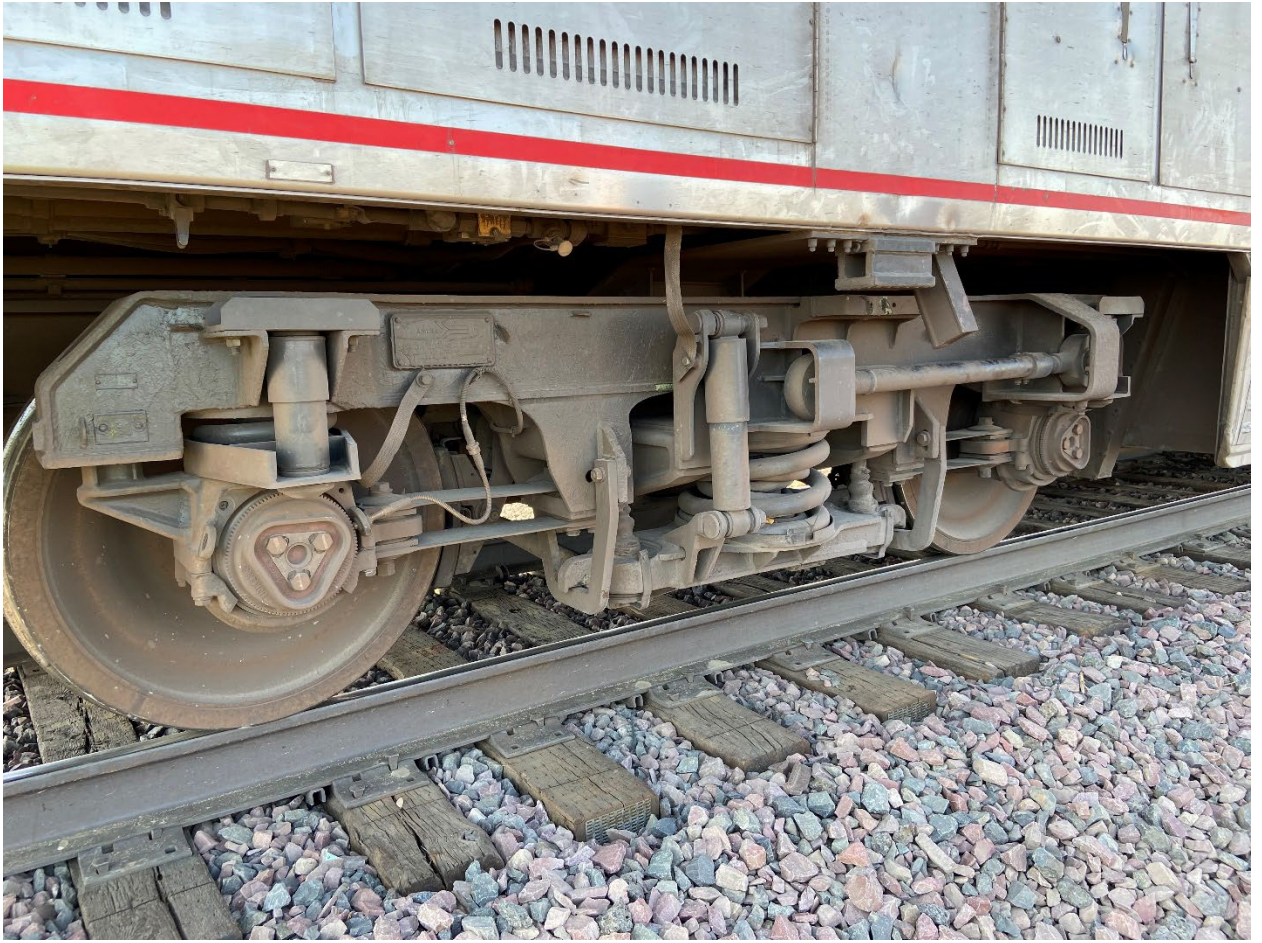
Figure 2. Post-accident image of a Superliner I truck assembly.

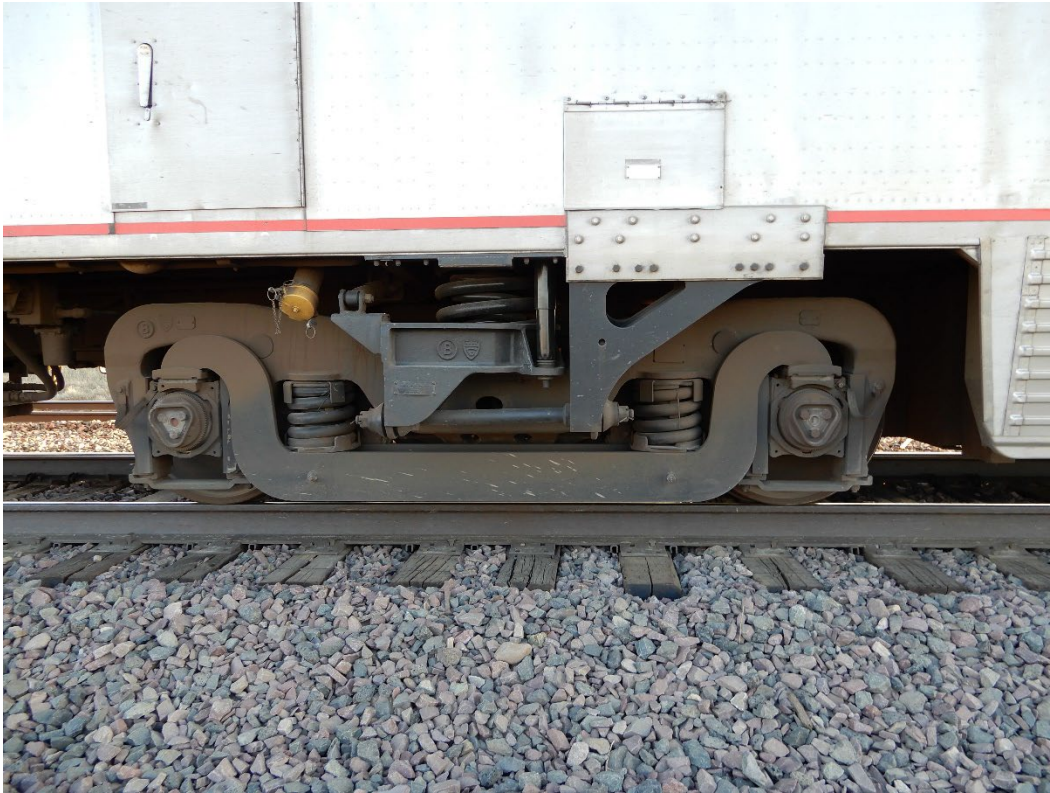
Figure 3. Post-accident image of a Superliner II truck assembly.

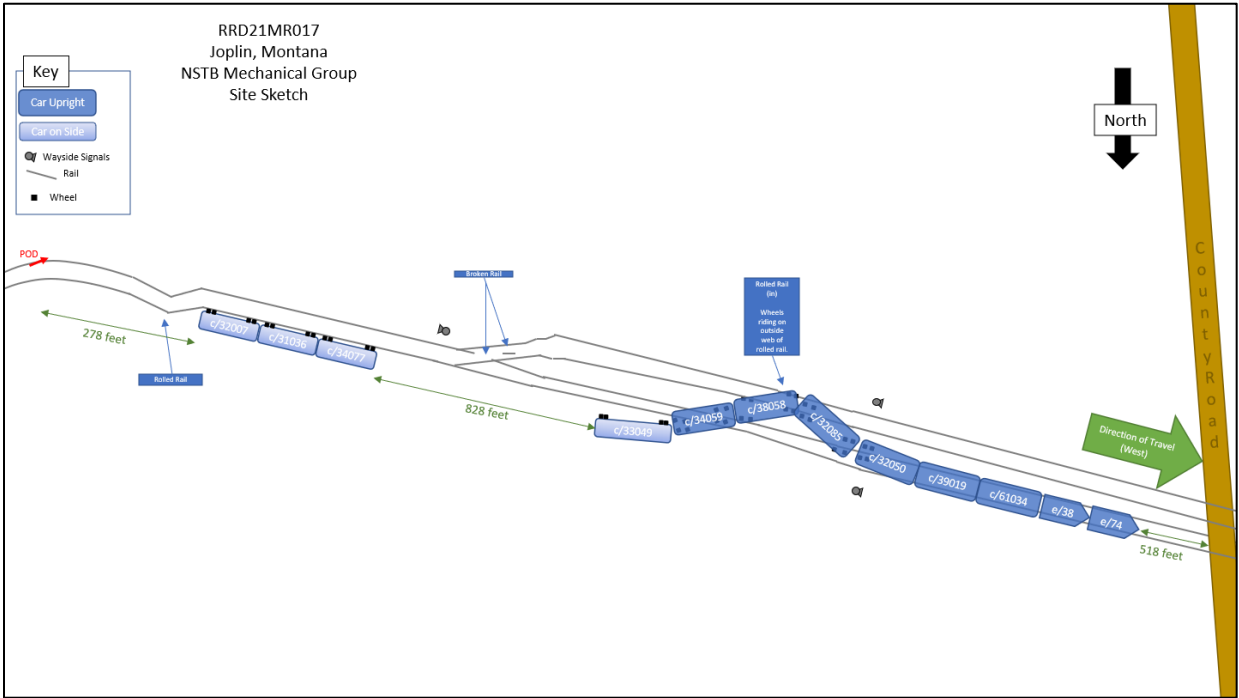
At mile post 1014.57 the train derailed along the high (south/left) rail in the curve. Evidence such as final resting position and total damage and witness marks are consistent with Car No. AMTK 32085 derailed the lead axle first, followed by Car No. AMTK 38058 also derailed to the high side. Subsequently, the rear three cars (AMTK 34077, 31036, 32007) tipped over onto their right sides and came to rest apart from the rest of the train. A broken knuckle was found on the trailing end of Car No. AMTK 33049. This car came to rest on its right side on the north side of the track past the siding switch for East Buelow. Evidence found inside the car, components from a wayside switch heater fan, is consistent with this car riding on its side prior to and through the area of the switch points. Car No. AMTK 34059 was derailed leaning, with its trailing truck on the north side of the right of way and the leading end trucks essentially straddling the siding and main track rails. Car No. AMTK 38058 was derailed upright. The rear truck was also straddling the siding and main track rails. The leading truck was position off the tracks to the south side, favoring the siding track. Car No. AMTK 32085 was also derailed upright. The trailing truck was also primarily on the heavily damaged siding track. The leading truck came to rest more in-line with the main track, right wheels were between the gauge of the main track. Car No. 32050 was on the main track with only the rear wheels derailed. The remainder of the train was not derailed.

Figure 4. Site sketch of the Amtrak Train No. 7's final resting positions.
