National Transportation Safety Board

RRD22FR013

OPERATIONS

Group Chair's Factual Report

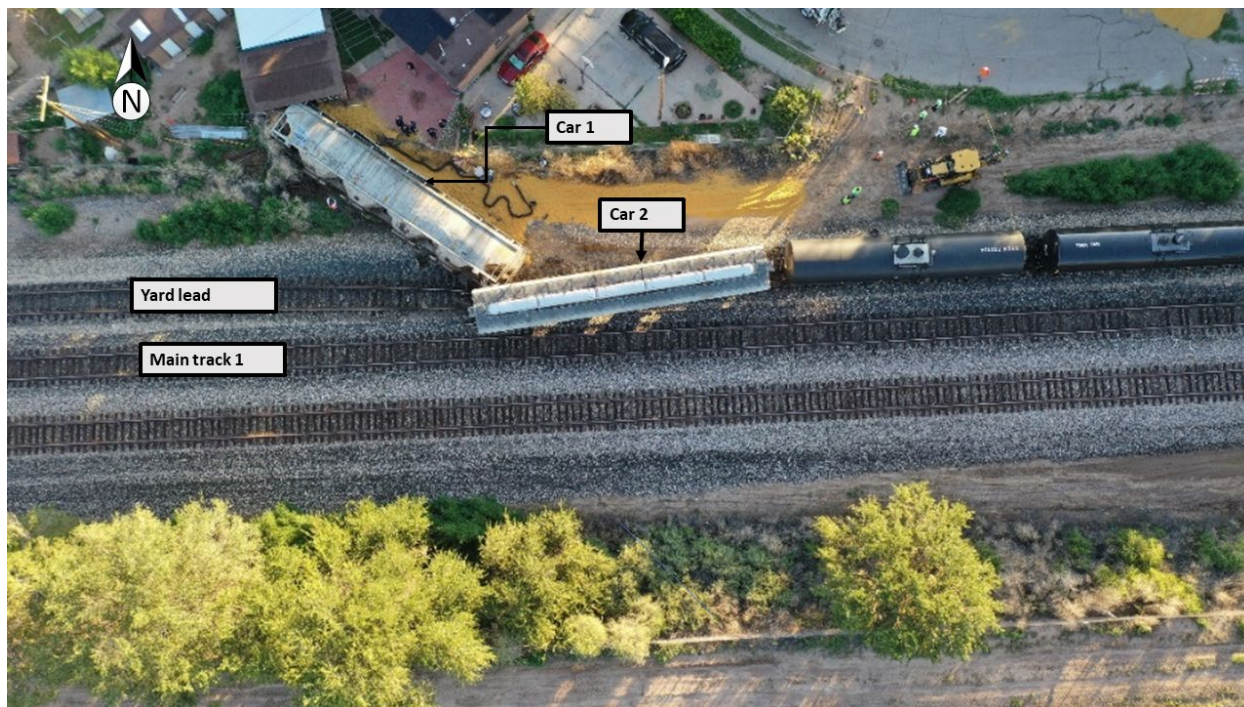
On August 29, 2022, about 9:14 p.m.¹ local time, the conductor of Union Pacific Railroad (UP) train, ISIEP-29, was killed when two cars of the train derailed while performing a westward reverse movement near UP's Alfalfa Yard in El Paso, Texas. The train consisted of two locomotives and 63 cars. The conductor was riding on the lead car of the train during a move from Main Track 1 through Control Point Rosedale onto the yard lead when it encountered a derauling device. The derauling device had been placed on the track to protect maintenance-of-way (MOW) employees installing a switch at the east end of Alfalfa Yard. The first two cars of the lead end of train derailed with the lead car landing on its side and then sliding into a

residential property and severing a natural gas line. Conditions were dark, the temperature was 80°F with light wind at the time of the accident.

Figure 1: Accident Scene. (Drone image courtesy of UP)

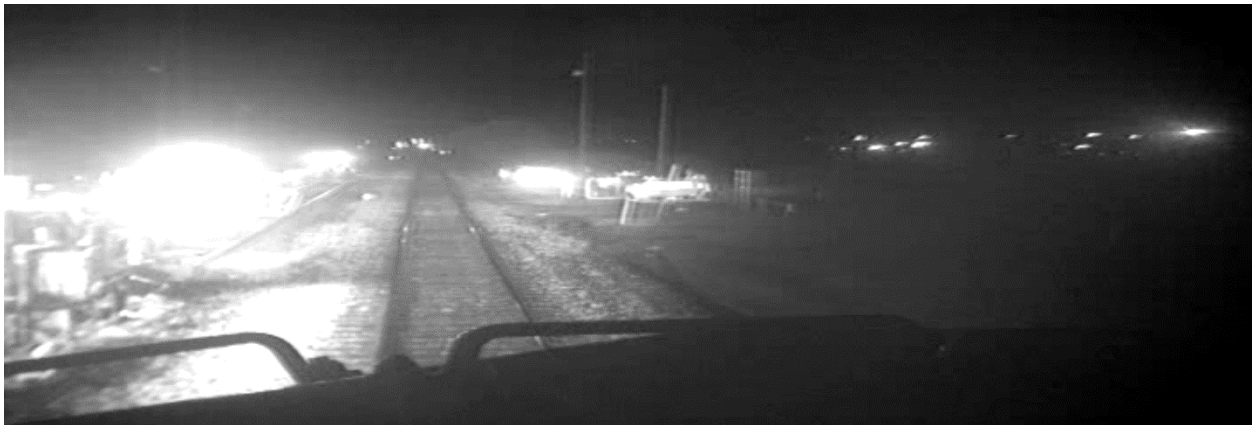
Figure 2: Photo from the forward-facing video showing the train passing the MOW working on main track one (left side of picture) [See Video Image Factual Report in NTSB's docket]

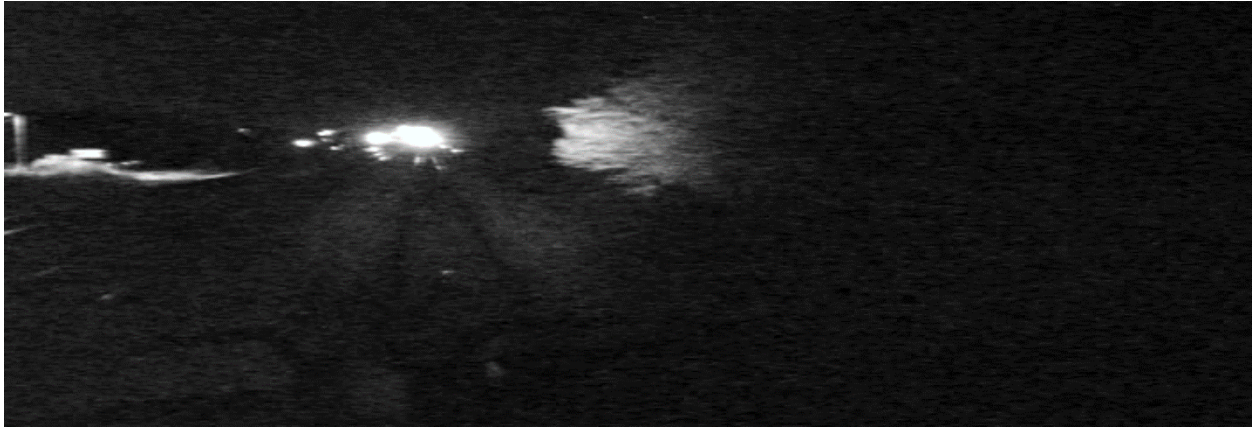
Figure 3: Photo from the forward-facing video showing the train passing the location of the derail which is located on the top left near the yard light with the locomotive headlight dimmed. [See Video Image Factual Report in NTSB's docket]

It was moments later that the train went into emergency and derailed when the rear car hit the derail, derailing two cars with the rear car derailing on its side. After the train stopped, the engineer called out to the conductor, but heard no response. The engineer also heard the brakeman calling for the conductor. The engineer then

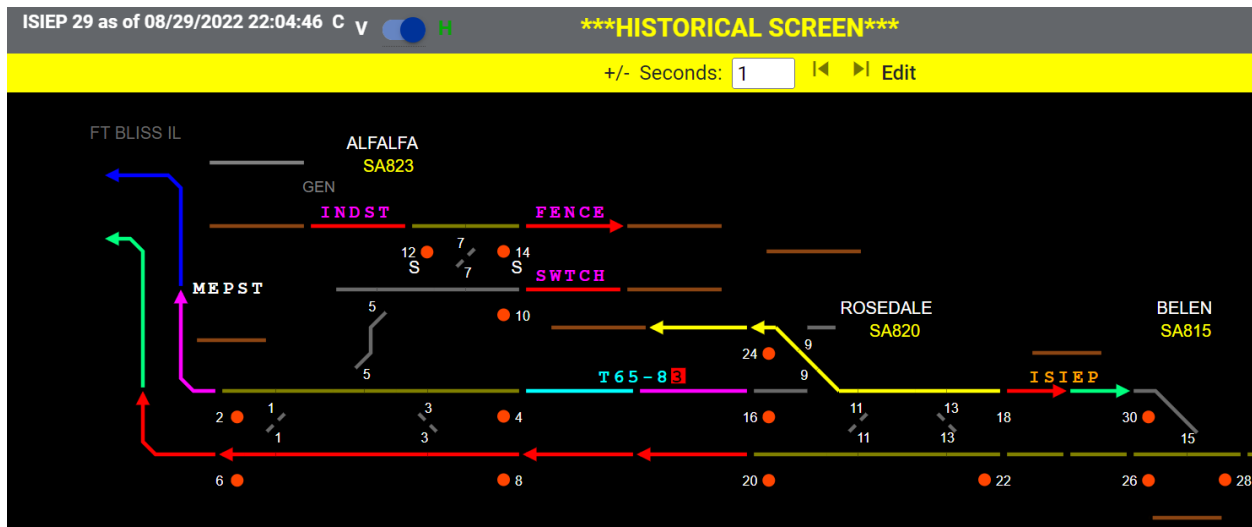
Figure 4: CAD log showing ISIEP lined up for a reverse move onto the yard lead track 191 at 9:04 p.m. local time.

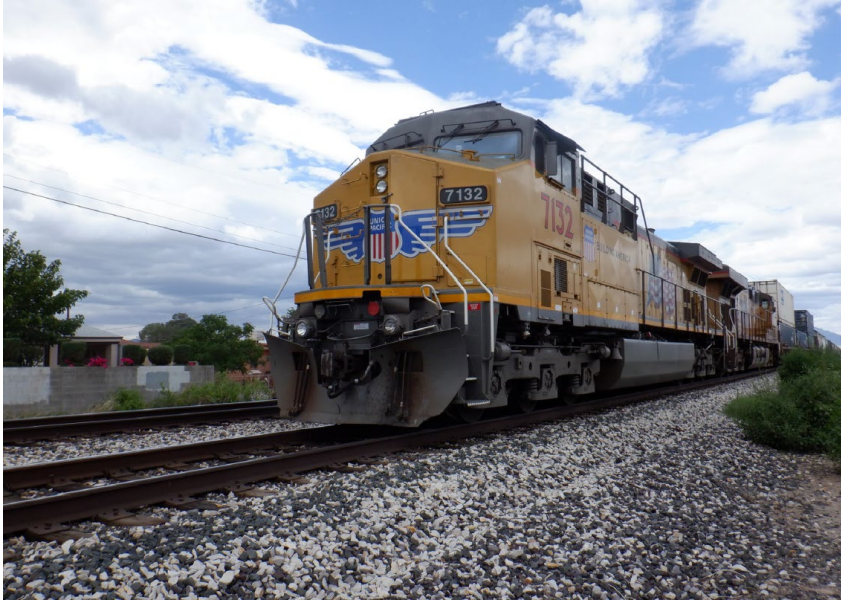
Figure 6: Lead Locomotive of the UP Train ISIEP-29

Additionally, the two-unit conventional locomotive consist of UP train ISIEP-29, were inspected for compliance with Federal regulations, 49 CFR Parts 229, 231 and 232. No defective conditions were noted.

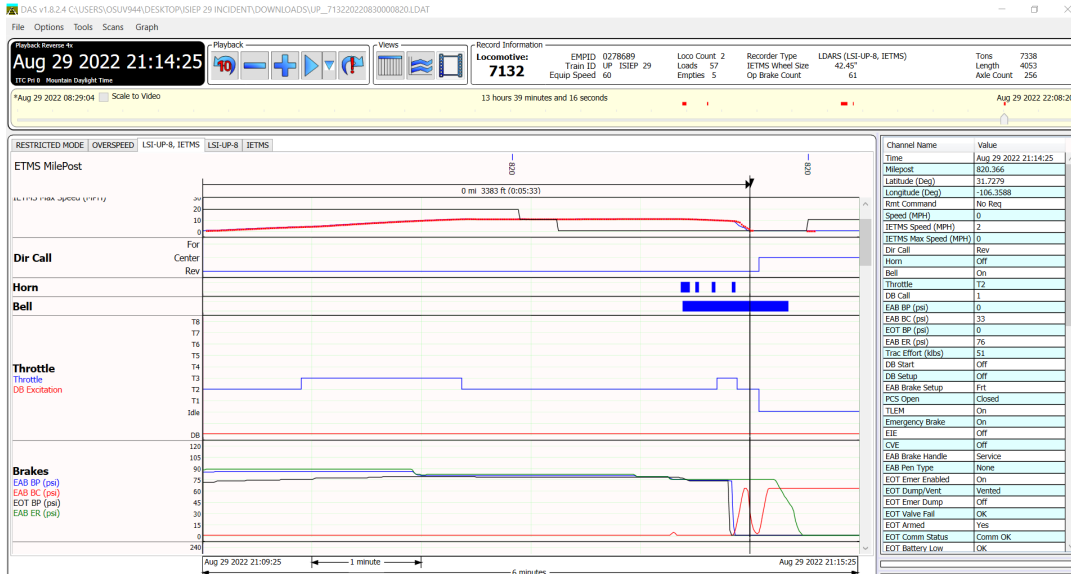
Figure 7: The UP 7132 remains stationary until: 9:08:42 (approximately 19 minutes, 12 seconds). The shoving move passes CP SA820 (Rosedale) towards the Alfalfa yard lead until the locomotive has an emergency brake application at 9:14 p.m. [See Locomotive Event Recorder factual report in NTSB Docket]
