National Transportation Safety Board

RRD22LR013

ONBOARD IMAGE RECORDER

Specialist's Factual Report

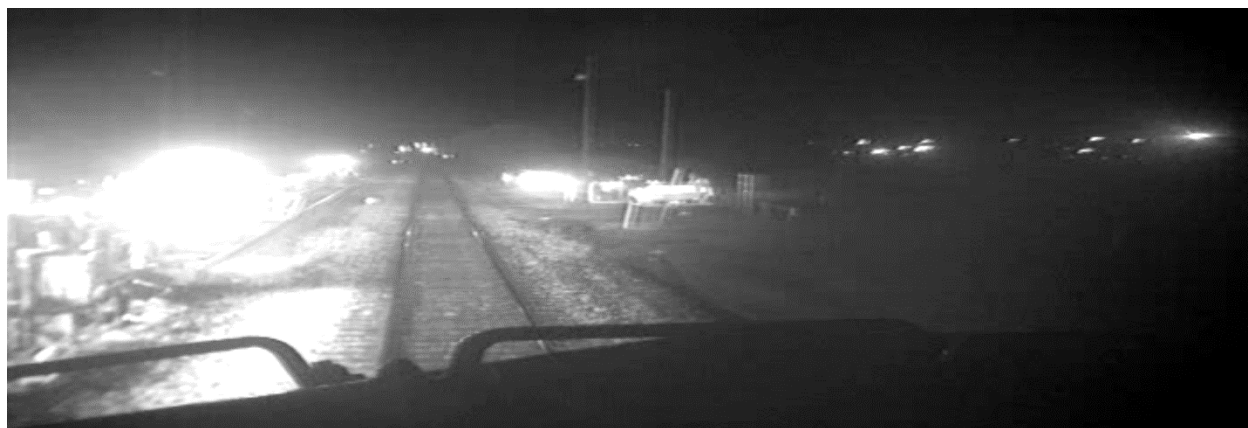
At 2041:50, while in an idle throttle setting and traveling forward at 28 miles per hour (mph), the locomotive passed a work crew on the parallel track to the left, as seen in Figure 1.

Figure 1. View as the locomotive passed the work crew to the left, at 2041:50.

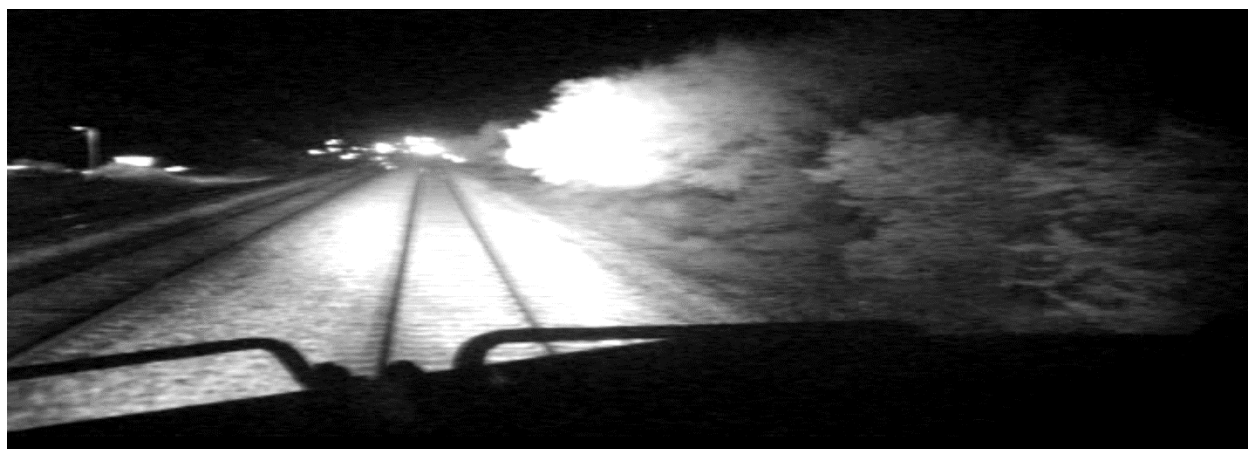
Between 2042:30 and 2042:32, while switching from an idle throttle setting to a T1 setting, and travelling forward at 26 mph, the locomotive switched its headlight setting from bright to dim, as seen in Figure 2 and Figure 3. The locomotive had travelled 1,565 ft from its location in Figure 1.

Figure 2. View shortly before the locomotive dimmed its headlight, at 2042:30.

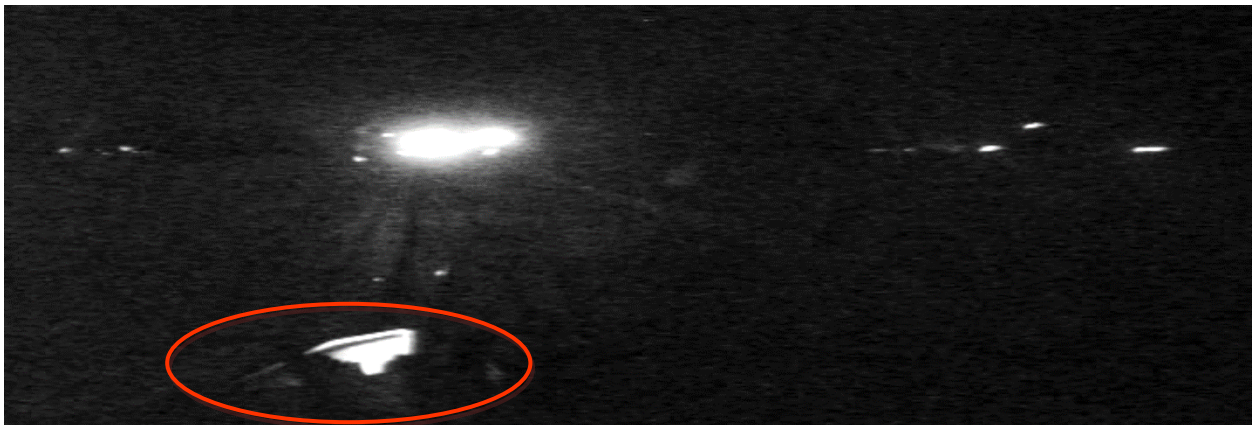
At 2044:16, while at an idle throttle setting and travelling forward at 12 mph, the locomotive's front door could be seen to open, and the conductor stepped out and left the frame shortly after. The opening door can be seen, circled in red, in Figure 4. The locomotive traversed approximately 4,784 ft between Figure 1 and Figure 4.

Figure 4. View of the door opening in the front of the locomotive.
