# **Proposed Findings and Recommendations**

**Kawasaki Rail Car, Inc.  
as a Party to the Mechanical Group of the  
National Transportation Safety Board  
investigation into the**

## **Derailment of Washington Metropolitan Area Transit Authority (WMATA) Metrorail Train**

**NTSB Accident No. RRD22LR001  
Accident Date: October 12, 2021  
Accident Location: Arlington, VA**

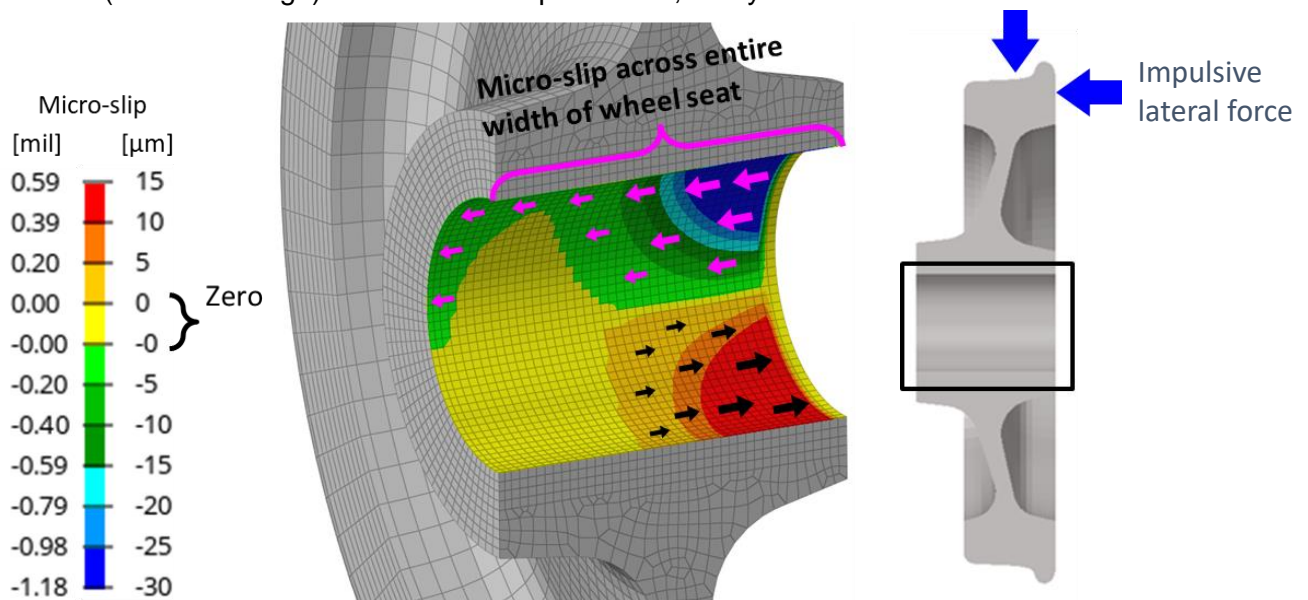
Figure 1: Relative Displacement Between Wheel and Axle

The color contour in Figure 1 shows the relative displacement between a wheel and its axle using the finite element analysis (FEA) model. Negative numbers (blue and green) show outward displacement, positive numbers (red and orange) show inward displacement, and yellow shows no movement.

Under zero loading conditions, one would expect the entire expanse of the wheel seat to be shown in yellow, above. Kawasaki found that under impulsive force conditions, outward displacement forces run across the entire width of the wheel seat (i.e., replacing yellow with unbroken blue/green from face to face, albeit not necessarily across the entirety of the seat at any one time). Thus, when significant impulsive outward lateral force is applied to the wheel flange back, micro-slippage occurs across the entire width of the wheel seat along some arc of the axle/seat interface. If the micro-slip across the entire width of the wheel seat transits often enough through the full circumference of the axle/seat interface as the wheel turns, the accumulation may eventually result in a gradual, progressive migration of the wheel along the axle.

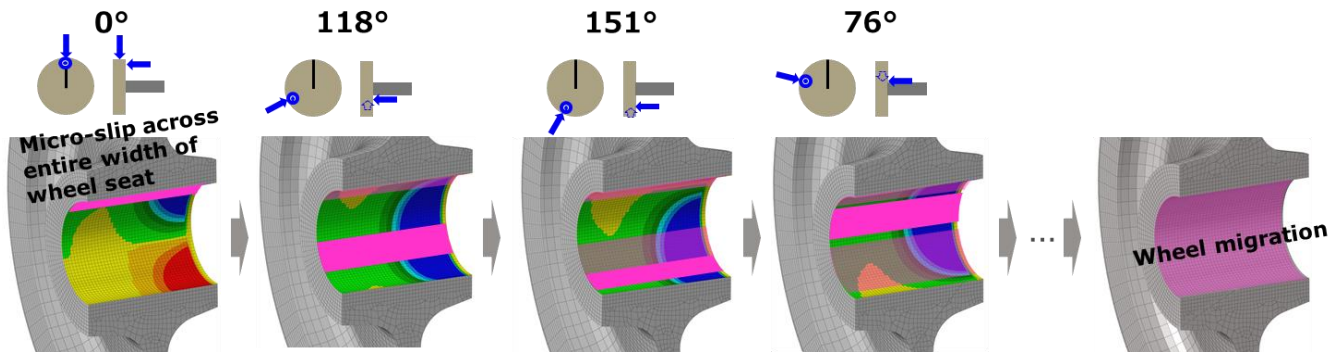
Figure 2: Outward Lateral Forces Applied at Random Angles

Under actual running conditions, significant outward lateral forces are applied at random angles as shown in Figure 2. The pink band represents micro-slip accumulation.

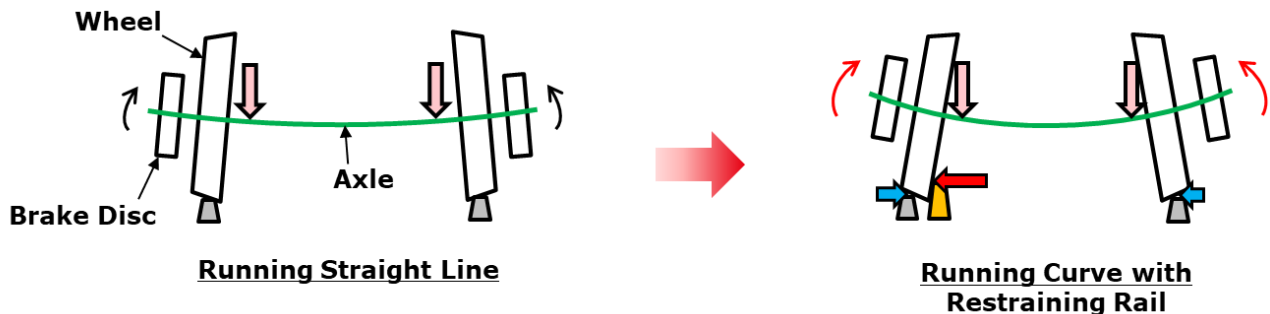
Figure 3: Schematic Representation of Bending Stress on Axle

According to the running test results, the bending stress on an axle is increased when a continuous outward lateral force is exerted on the wheel, such as from a restraining rail. A schematic representation of that situation is shown as Figure 3.

Since the 7000 Series truck is what is known as an inboard truck frame type, the axle load is applied between the wheels, which causes the axle to bend convex downward. The restraining rail comes into continuous contact with the flange back of the inner wheel when the railcar runs on a curve, which increases axle bending. The continuous force (i.e., axle bending) condition requires less outward lateral force to cause micro-slippage to occur across the wheel seat than in the case of impulsive force.

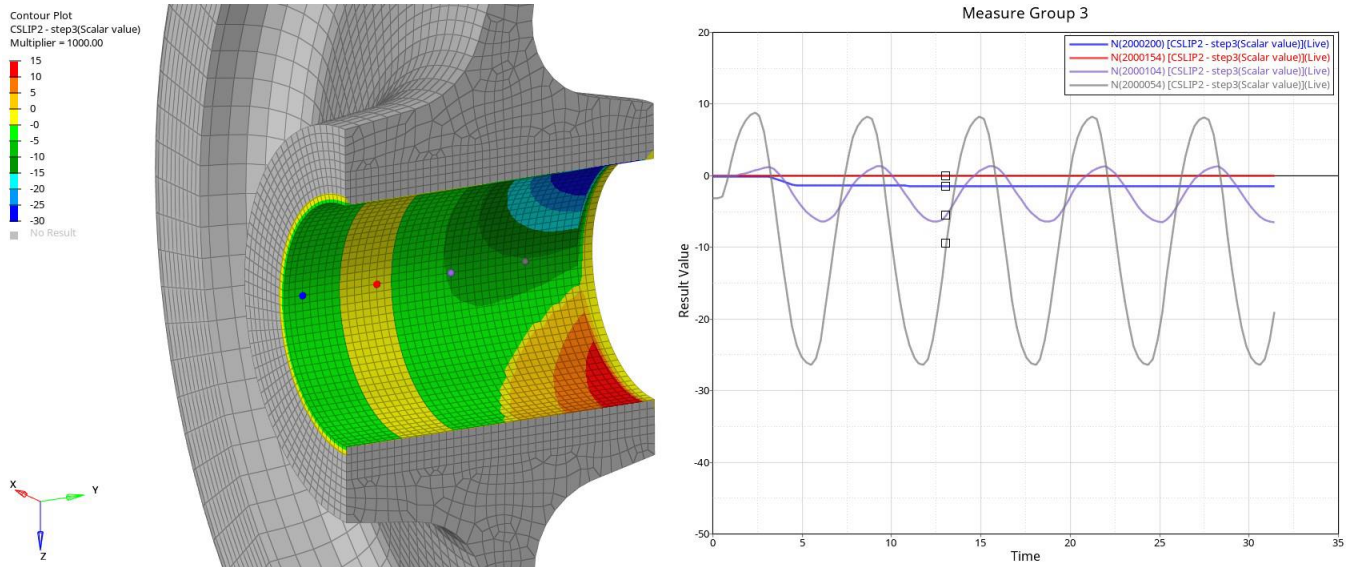
Figure 4: FEA Animation Case 1 – No Wheel Migration  
(animation can be viewed by clicking on figure)

For reference, please view the FEA animations linked to this document, of two continuous force cases. FEA Animation Case 1 illustrates a condition where force is applied continuously but does not reach the Critical Lateral Force<sup>2</sup>. The areas represented in yellow are areas where no relative displacement occurs. FEA Animation Case 2, on the other hand, illustrates a condition where a larger continuous force is applied than in FEA Animation Case 1. In this case, however, when the applied force exceeds the Critical Lateral Force, the area represented in yellow (where no relative displacement occurs) is lost in the first

cycle. The graphs in Figures 4 and 5 also shows a difference in wheel migration behavior. At least some wheel migration occurs within a few revolutions when Critical Lateral Force is reached in cases of continuous force.

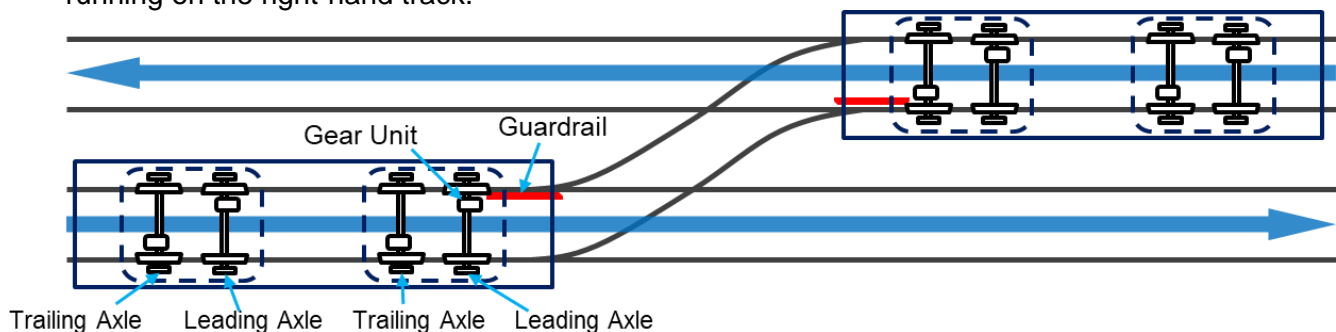
Figure 6: Relationship of Guardrail, Axle/Gear Unit and Train Direction

It was noted that most of the wheel migration occurred on the left (gear side) wheel. According to the running test results using the 7000 Series, almost all the significant outward lateral forces were measured on the left wheel and the measured locations were either turnouts or crossovers. Kawasaki investigated this phenomenon and believes that it can be explained as follows:

- Generally, wheel lateral forces are higher on the leading axle than the trailing axle.
- The gear unit on the leading axle is always located at the left-hand side.
- Turnouts and crossovers in the mainline are located in the left-hand side because the train is always running on the right-hand track.

Furthermore, after investigating the running test results in detail, Kawasaki has noticed that when moving straight through turnouts or crossovers (i.e., not crossing over to the other track), the flange back of the left wheel hits the guardrail/restraining rail located near the turnout or the crossover. Because of the high speed when travelling straight at the turnout/crossover, significant impulsive force is likely applied to the wheel flange back.

For these reasons, Kawasaki is of the opinion that most of the wheel migration occurs on the left (gear side) wheel because the significant impulsive force causing migration is predominantly applied to the left wheel flange back.

**Thus, it is Kawasaki's recommendation that guardrails and restraining rails should be reset, especially near turnouts and crossovers, in order to reduce the outward lateral force that would adversely impact the wheelsets of the railcars running through them.**
