NATIONAL TRANSPORTATION SAFETY BOARD

RRD22LR002

OPERATIONS FACTUAL REPORT

Type: Watco Dock & Rail, L.L.C. Employee Fatality
Date and Time: October 29, 2021, at 4:02 a.m. CDT
Location: Houston, Texas
Carrier: Watco Dock & Rail (In-Plant Switching)
Job: Watco-202

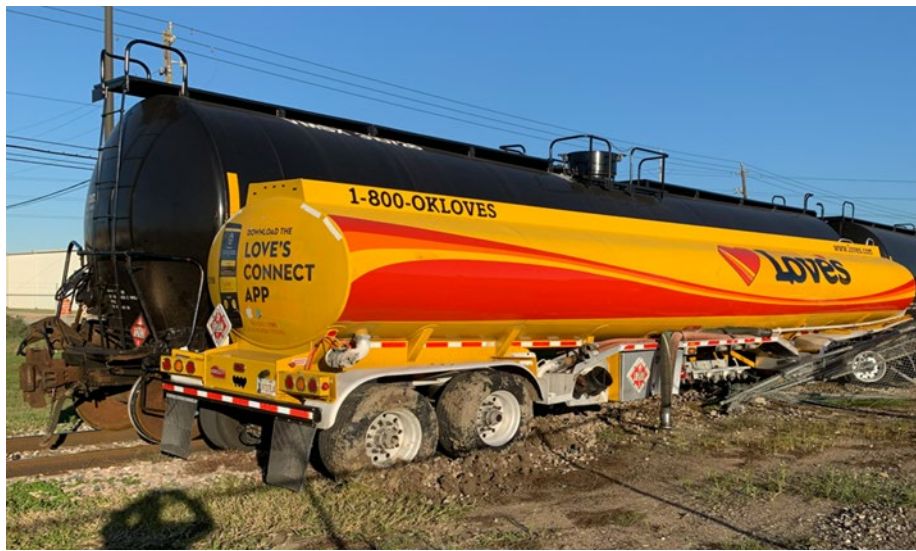
then called Conductor #2 and told him to go check. The engineer remained on the locomotive until he was notified of what happened and, at that point, secured the train and went inside the yard office. At 4:17:53, EMS arrived on scene, followed by the Harris County Sherriff's Department at 4:18:57, and the Galena Park Fire Department at 4:21:07.

Figure 1. Final resting position of combination vehicle and the train.

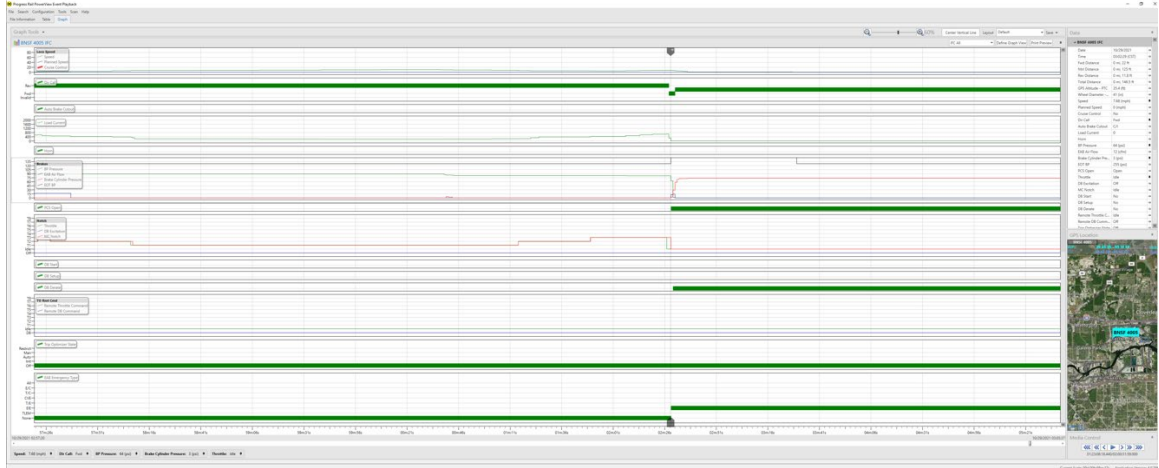
Figure 2: Snapshot of event recorder data

On October 31, 2021, the investigative group conducted a review of the event recorder data from the lead locomotive. The group determined that the train handling method utilized was consistent with normal train handling methods utilized during switching operations and not believed to be causal or a contributing factor in this accident. Note: The event recorder data was viewed by the investigative team while on-scene, and it was determined that all pertinent information was obtained. Therefore, no additional review was warranted.

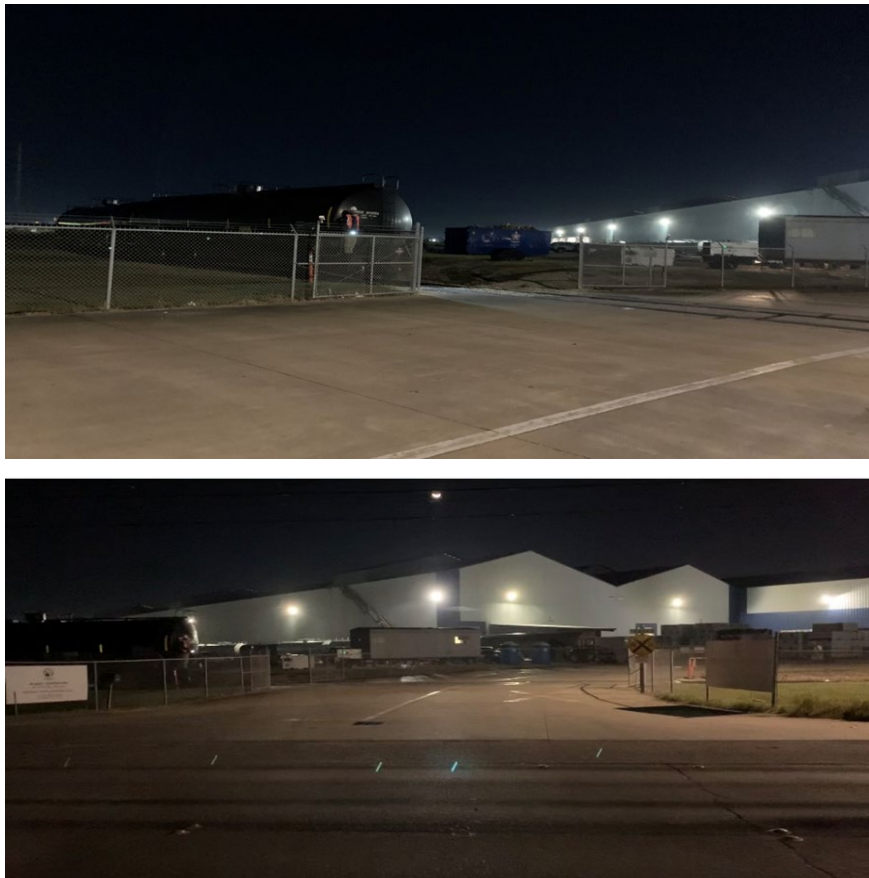
The railroad crossing is outside of the gated perimeter of the Greensport Industrial Park on property leased to Musket Corp. It has pavement markings, flashing lights, a multiple tracks ("4 tracks") sign, no trespassing sign, and advance warning signage facing Federal Road. A sight distance/partial reenactment conducted at 4:00 a.m. revealed that the south side of the Musket driveway was well illuminated by a private flood light located south of the drive. During the sight distance, it was noted that the north side driveway did not have a flood light and it was found to be fairly dark, however, the employee and tank cars could still be seen. During the sight distance analysis, multiple Gemini combination vehicles entered and exited the facility. The photos in figure 3 were taken during the site distance test and provide an accurate depiction of the amount of lighting observed during

the site distance conducted at 4:00 a.m. at the crossing with the train stopped inside the chain-linked fencing that borders the entry driveway.

Figure 3: Photos taken during the site distance test conducted at 4:00 a.m. local time. Note: The approach photographs and video do not represent a complete view from the perspective of the driver since the tank cars remains still.

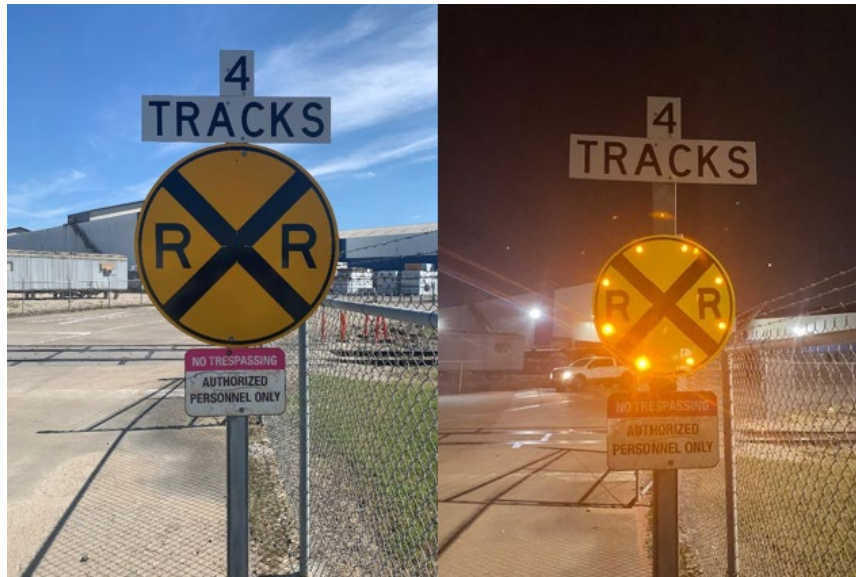
Figure 4: Looking in the direction of the movement of the combination vehicle, the two photos display the advance warning signage before and after the modification. The photo on the left was taken October 29, 2021, during the on-scene portion of the investigation. The photo on the right was taken on December 2, 2021, after completion of the modification to the advance warning signage.

WDRL modified Musket’s grade crossing’s advance warning signage with LED lights. The intent was to make the signage more visible while truck drivers enter the driveway that intersects with the crossing. WDRL indicated that it will be installing a flashing light stop sign when the private crossing is in use as well. WDRL is waiting on the sign to arrive from the vendor. WDRL indicated that it is identifying other crossings within the Greensport Industrial Park that could benefit from this added protection.
