**National Transportation Safety Board
Office of Railroad, Pipeline and Hazardous Materials Investigations
Washington, DC 20594**

Mechanical Group Factual Report

**Railroad Contractor Fatality
Norfolk Southern Railway Buffalo Line near
Reed, PA on
December 8, 2021**

RRD22LR003

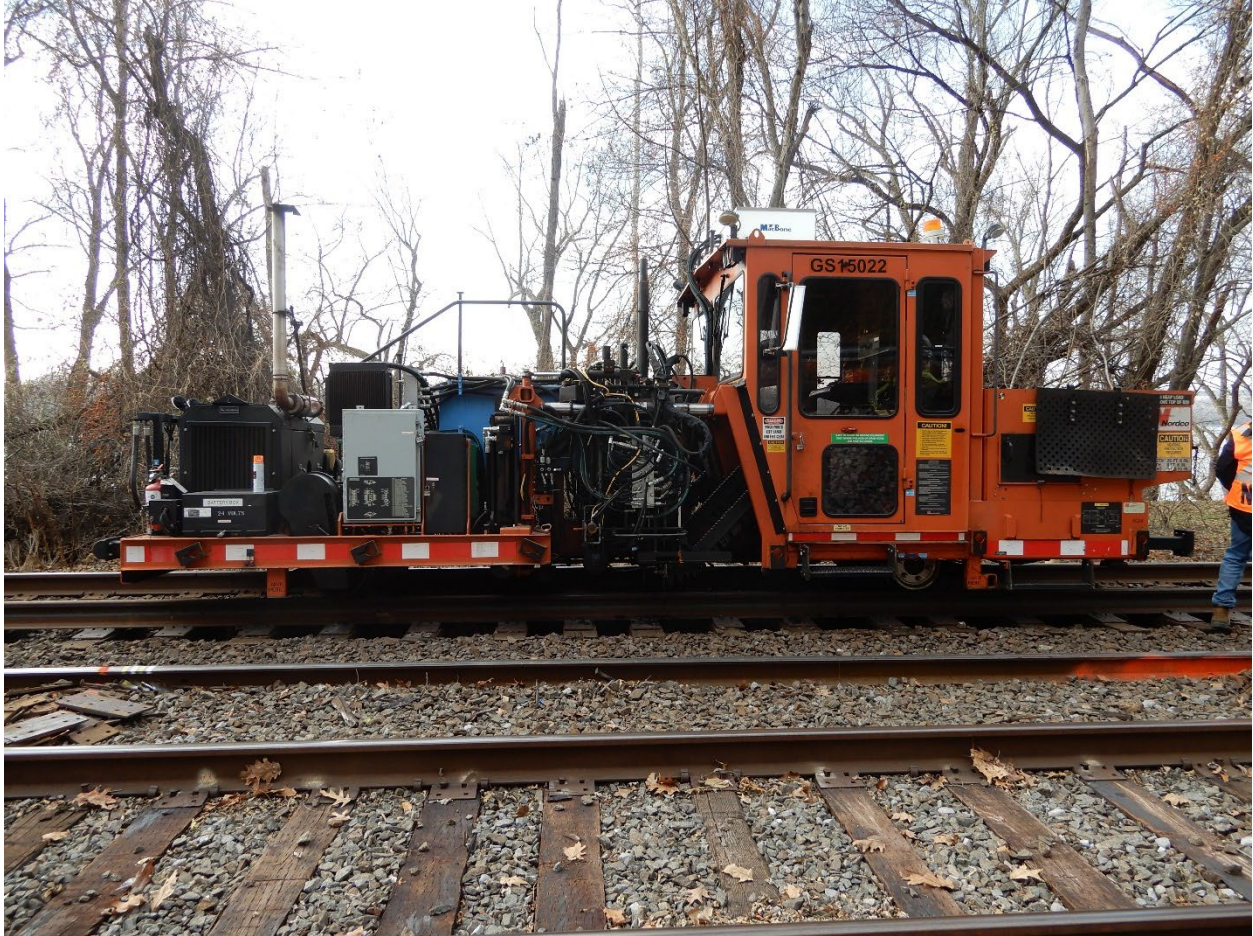
Figure 1. Photograph of NS Spiker GS 15022 near its post-accident resting position (NSTB Photo)

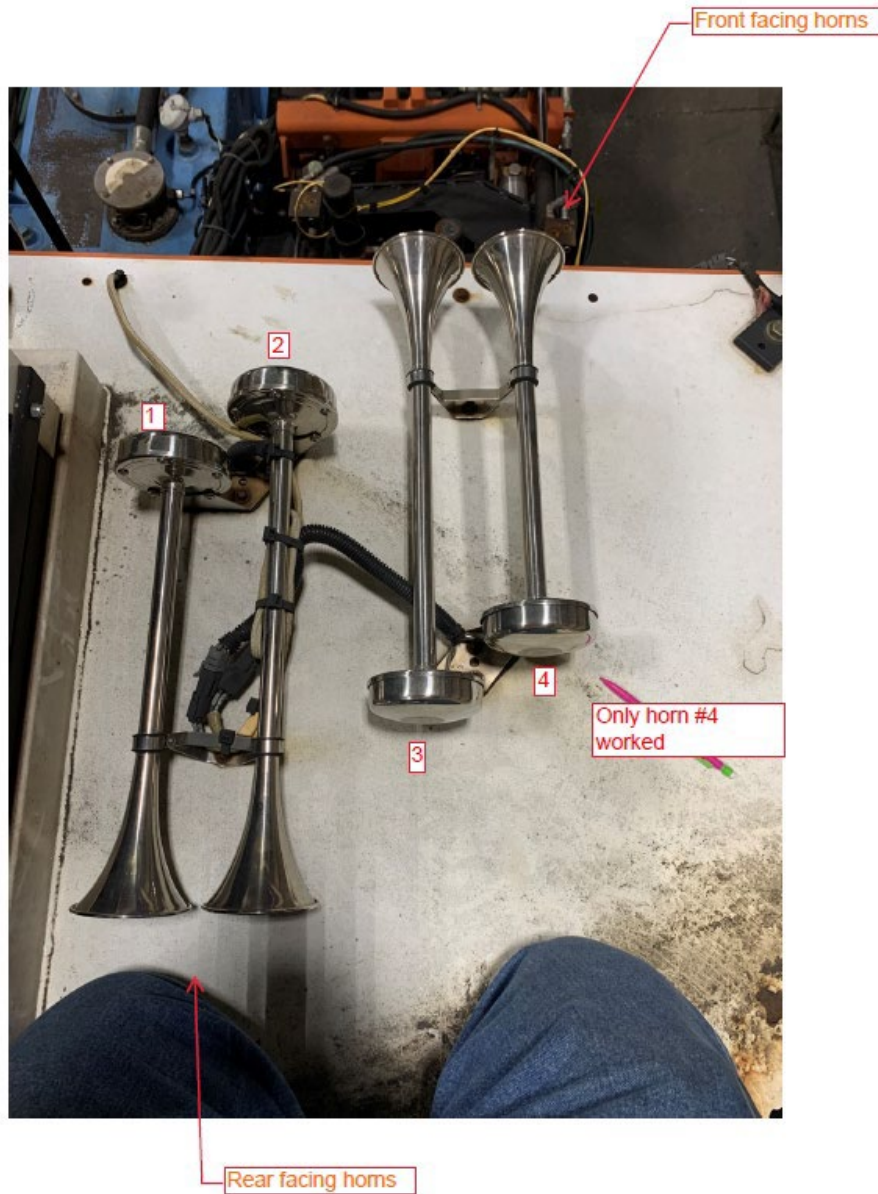
Spiker. The horn system consists of four trumpets, two facing forward and two facing backwards. Investigators cycled through each button in the cab for horn activation. It was determined that only one trumpet produced sound, a front facing trumpet. The other front facing trumpet, and both rear facing trumpets, did not produce any audible sound.

Figure 2 Spiker GS 15022 Horn System (FRA photograph and annotations)

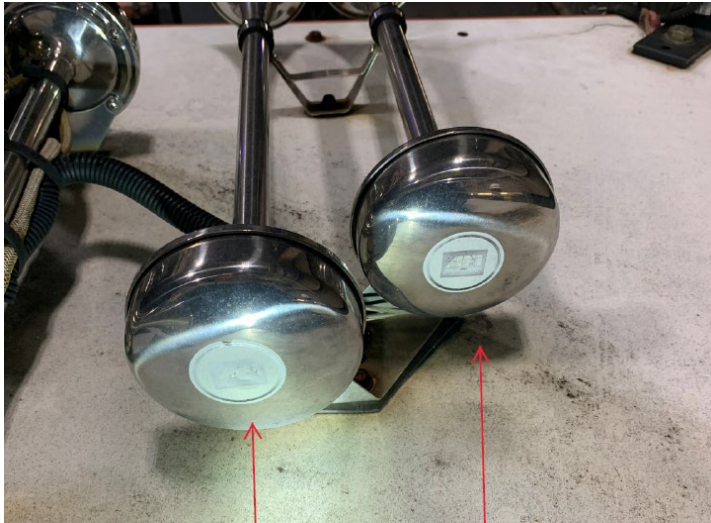
Investigators also noted that a sticker covered a screw on the front facing trumpets.

Figure 3 Spiker GS 15022 Front facing trumpets with screw covered (FRA Photograph and annotations)

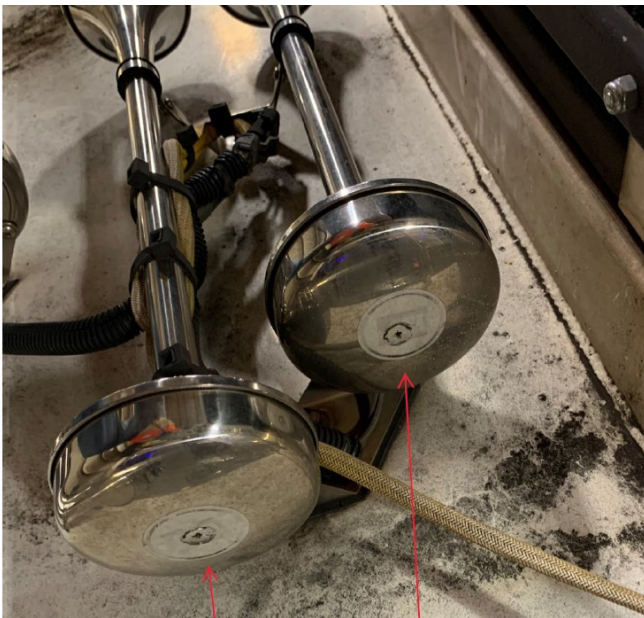
The rear facing trumpets did not have a sticker over the screw.

Figure 4 Spiker GS 15022 Rear facing trumpets with screws accessible (FRA Photograph and annotations)

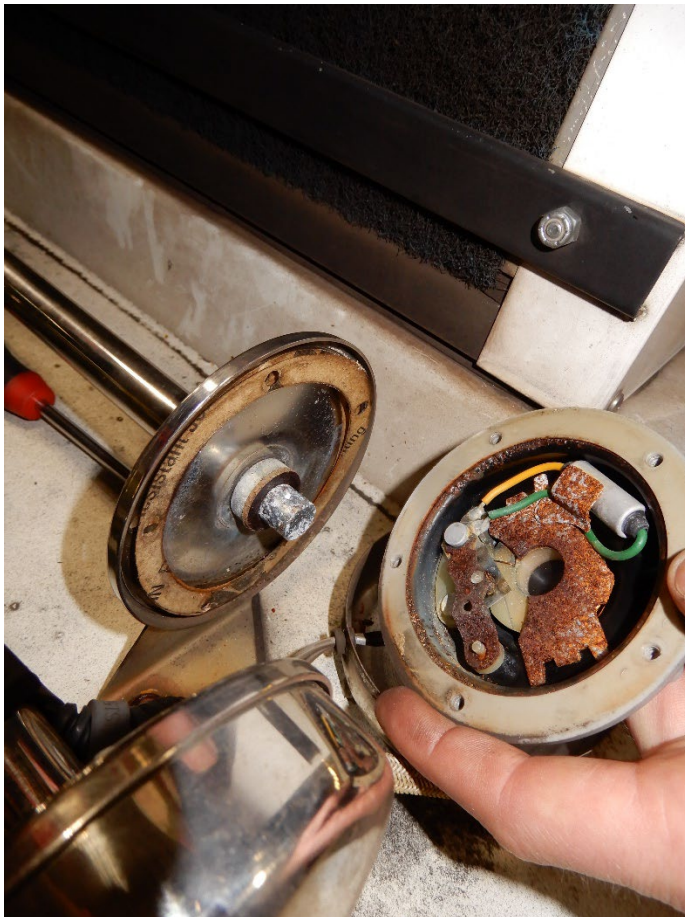
Investigators returned to the Spiker on January 25, 2022. The rear cover of the leftmost, rear facing horn was removed. The interior of the horn motor coil, contacts,

and plate were photographed. All these internal parts were heavily corroded and rusted. The horn was then reassembled. Both the forward facing and the rear facing banks of horns were unplugged from the roof mounted connectors.

A new, known working set of horns was temporarily connected to each horn connector (one for forward facing bank, one for rearward facing bank). The horn circuit was tested from a horn button in the cab; the new horns functioned correctly while plugged into each of the connectors.

Figure 5. The interior condition of a horn trumpet.

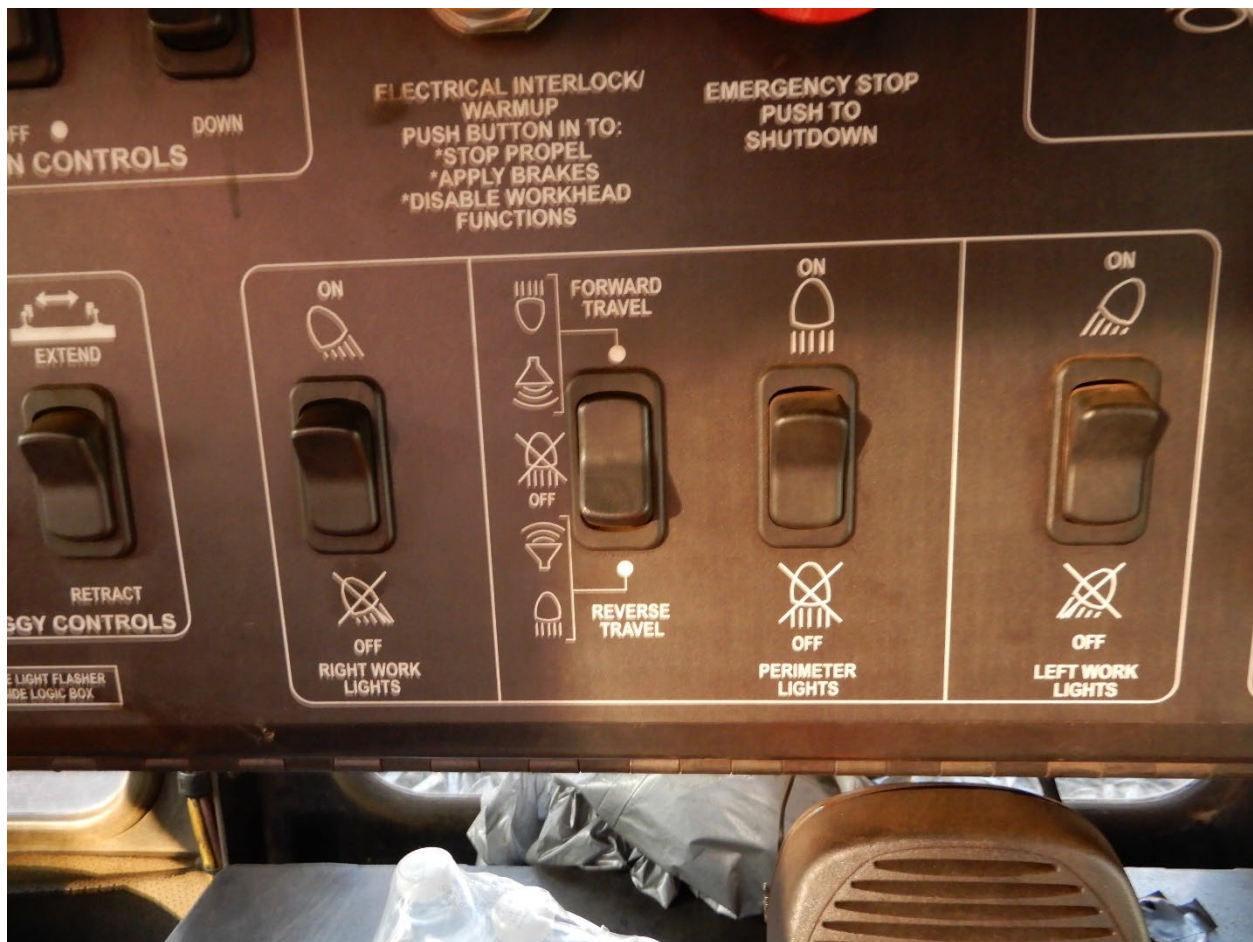
Figure 6. GS 15022 MCC with Forward/Reverse Travel Switch located in the center of the photograph. Icons indicate the intended function of lights/alarms. (NTSB Photograph)

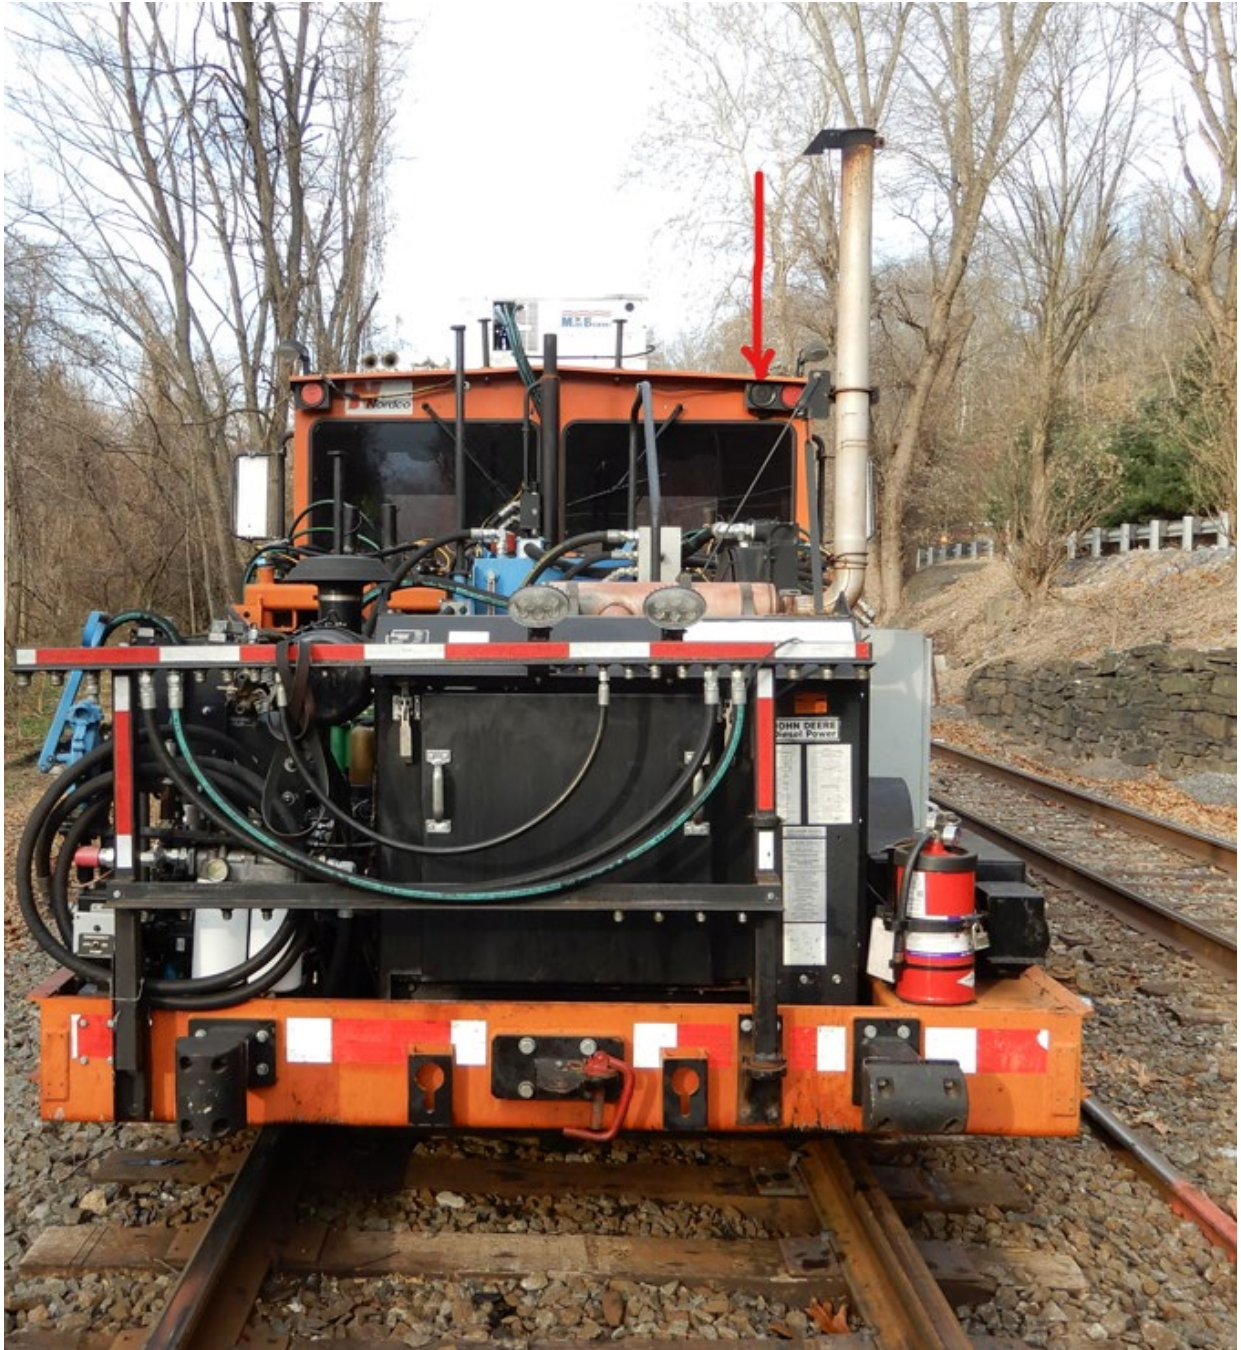
Figure 7. Spiker with arrow pointing to front facing change-of-direction alarm speaker (NTSB Photograph and annotations)

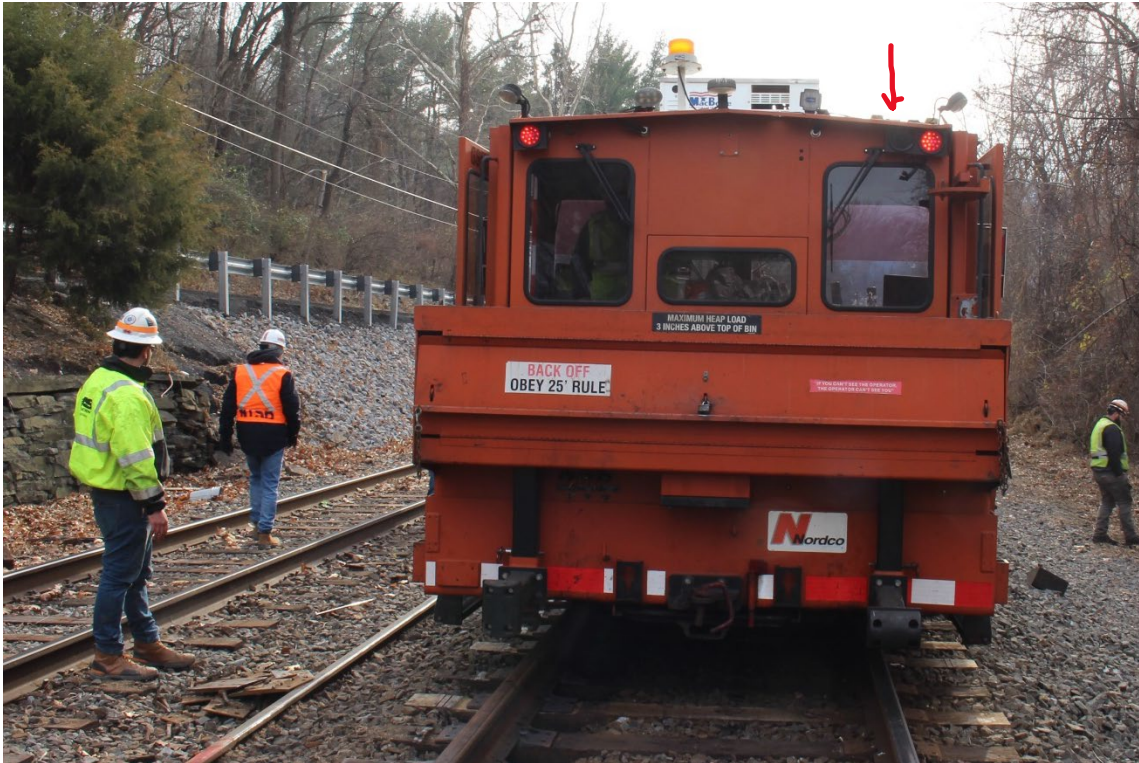
Figure 8. Spiker GS 16043 with an arrow pointing to the rear facing change-of-direction alarm speaker. The disconnected speaker plug can be seen below the speaker. (NTSB Photograph and annotations)

- Spiker 1, GS 16043, behaved in a manner consistent with a non-functioning rear speaker. The speaker appeared to be plugged in and there was no obvious damage.

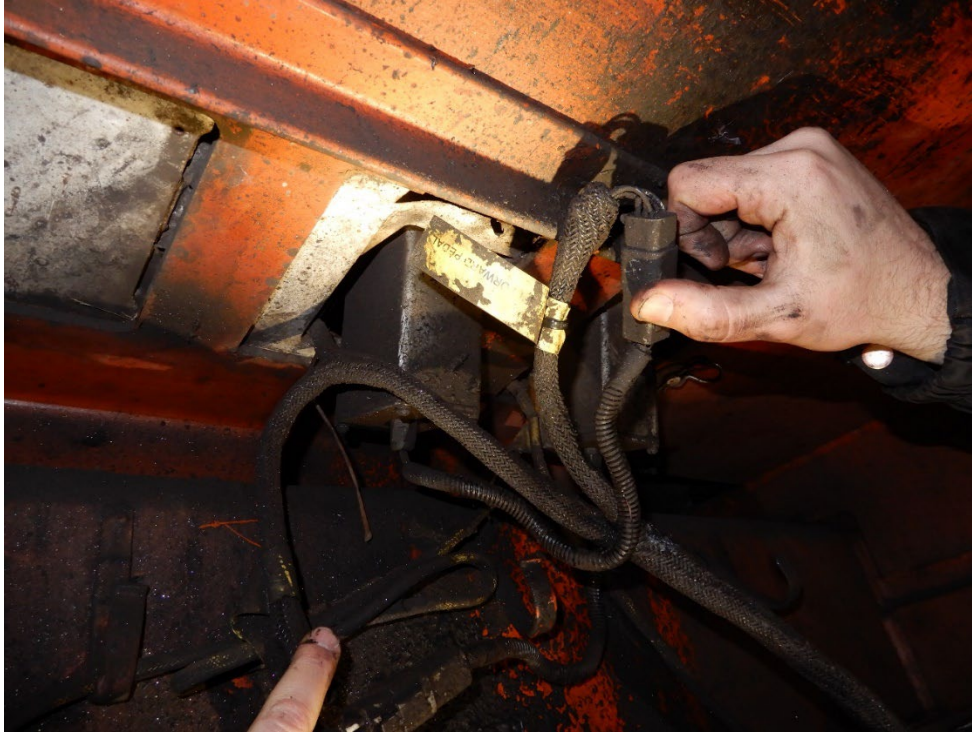
The conditions described here were for the left side of the cab pedals. The pedals at the center and right positions had the same condition. It was determined that the reverse pedal (PED 2206 on the schematic) was plugged into the plug for the forward pedal (PED 2202). The forward pedal was plugged into the plug for the reverse pedal.

Figure 9. Under the cab, looking at the plugs for the left side pedals. They are reversed (as found) in this photo.

The pedal plugs were swapped on the left side and the inputs were checked on the diagnostic screen. The computer now showed that the forward pedal sent a forward travel input to the computer. The reverse pedal now sent a reverse travel input to the computer.

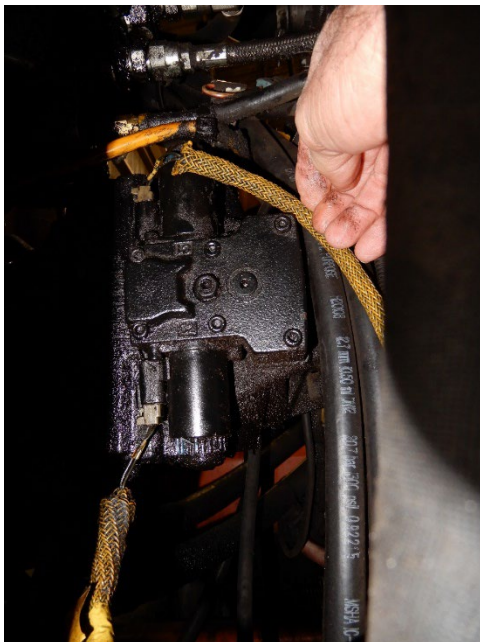
The hydrostatic pump was inspected. The pump has two solenoids. Electrical input to one for forward travel (SOL 2813) and one for reverse travel (SOL2816). It was determined that the plug intended for the forward travel solenoid was plugged into the reverse solenoid. The plug intended for the reverse travel solenoid was plugged into the forward solenoid.

Figure 10. The electrical cables plugged into the hydrostatic pump solenoids, labeled C1 and C2.

The solenoid plugs were swapped by the investigative team.
