**SIGNAL & TRAIN CONTROL GROUP -
FACTUAL REPORT**

**Crossing collision between CSX freight train and SEPTA trolley with injuries in
Darby, Pennsylvania on
December 9, 2021**

RRD22LR004

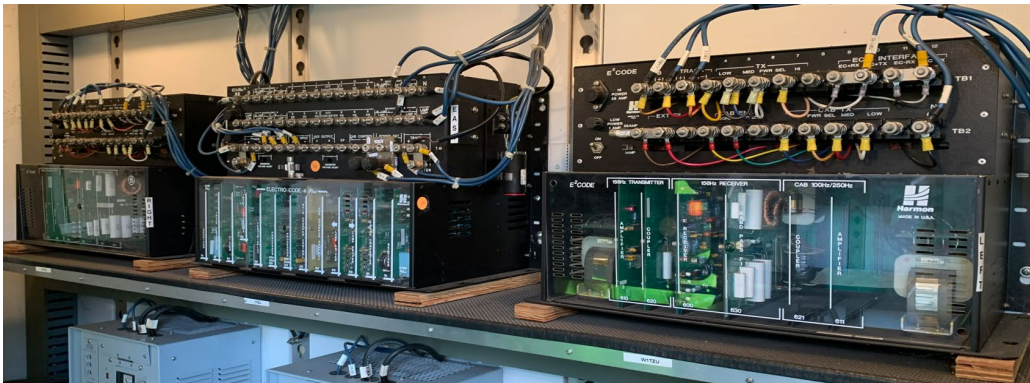
Photo shows the multiple Electro Code units used to detect track occupancy for the signal system

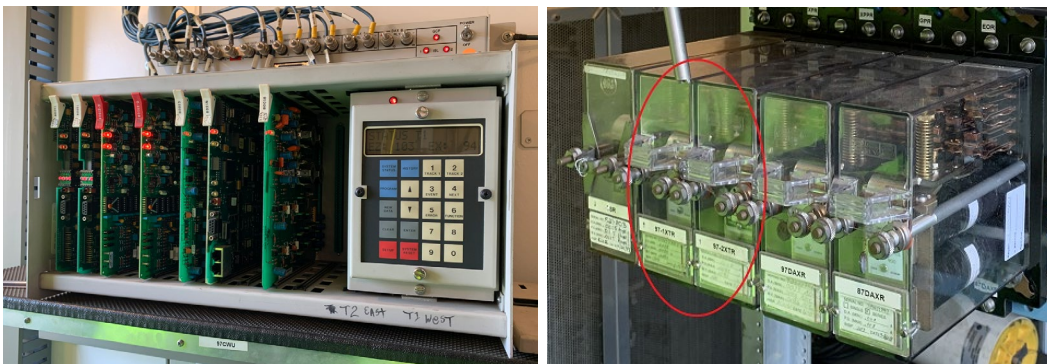
The crossing investigated uses a unidirectional Safetran 3000 units along with two D.C. track relays to detect train occupancy for approaching trains. T1 of the Safetran unit looks west and T2 of the Safetran unit looks east. There are two D.C. relays that monitor the island circuit which happens to be a railroad diamond (crossing at grade) where the CSX freight line crosses the SEPTA trolley line.

Photo to the left shows Safetran 3000 unit. Photo to the right shows the 2 D.C. track relays
