National Transportation Safety Board

RRD22LR012

OPERATIONS

Group Chair's Factual Report

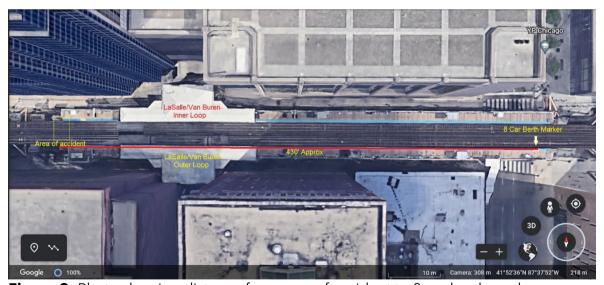
In examining the distance, train 3285 traveled approximately 430 feet from the point it first contacted the CSA until it came to a final stop at the 8 Car Marker.

Figure 2: Photo showing distance from area of accident to 8 car berth marker.

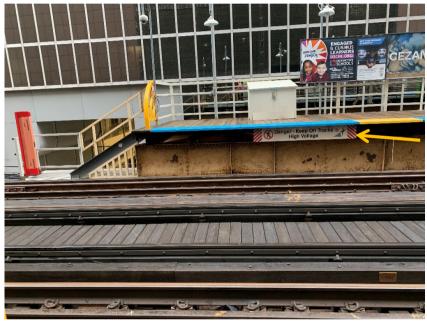
Figure 3: Photo showing high voltage on side of platform

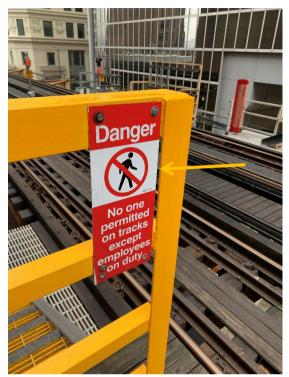
Figure 4: Photo showing no one permitted on tracks

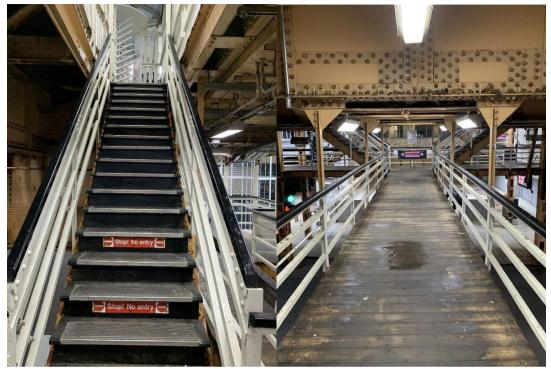
Figure 5 and 6: Photos show the steps up to platform from the mezzanine level and mezzanine level walkway between the outer and inner loop above street level.

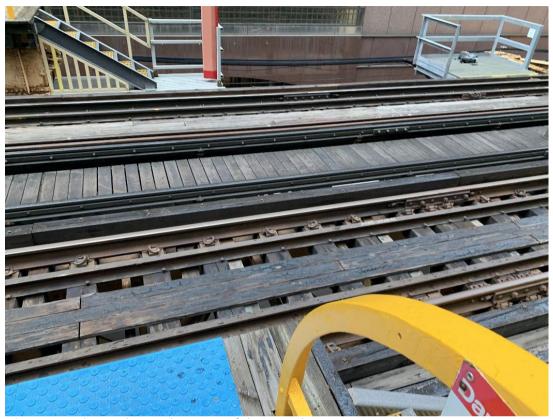
The accident occurred on the west end of station on the right of way. At the end of the platform there is a barrier and steps down to the right of way. The two third rails are located between the tracks. There is a wooden walkway between the third rails. The walkway is not a place of safety, as it is not adequately wide for a person standing on it to be in the clear of passing trains.

Figure 7: Photo shows the area of the accident.
