National Transportation Safety Board

RRD22MR007

ONBOARD IMAGE RECORDERS

Specialist's Factual Report

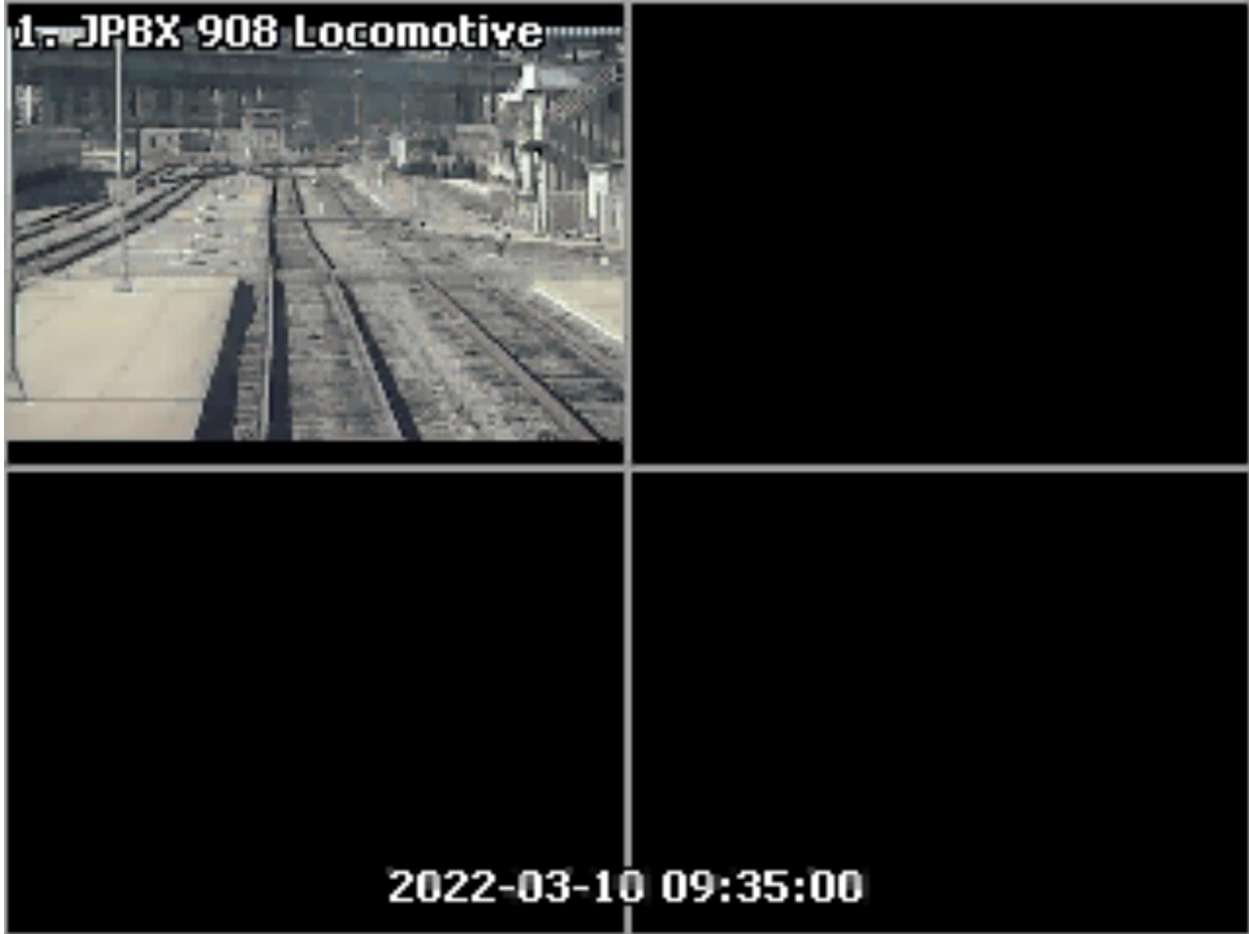
The recording began at approximately 9:35:00 when the train departed Caltrain Depot station at 4th and King streets in downtown San Francisco, as seen in figure 1. The train proceeded south uneventfully and transitioned onto the parallel main track 1 at 09:51:15. The train then passed the working crew located on the parallel main track 2 at approximately 09:59:40, as seen in figures 2 and 3.

Figure 1. Beginning frame of the preceding train.

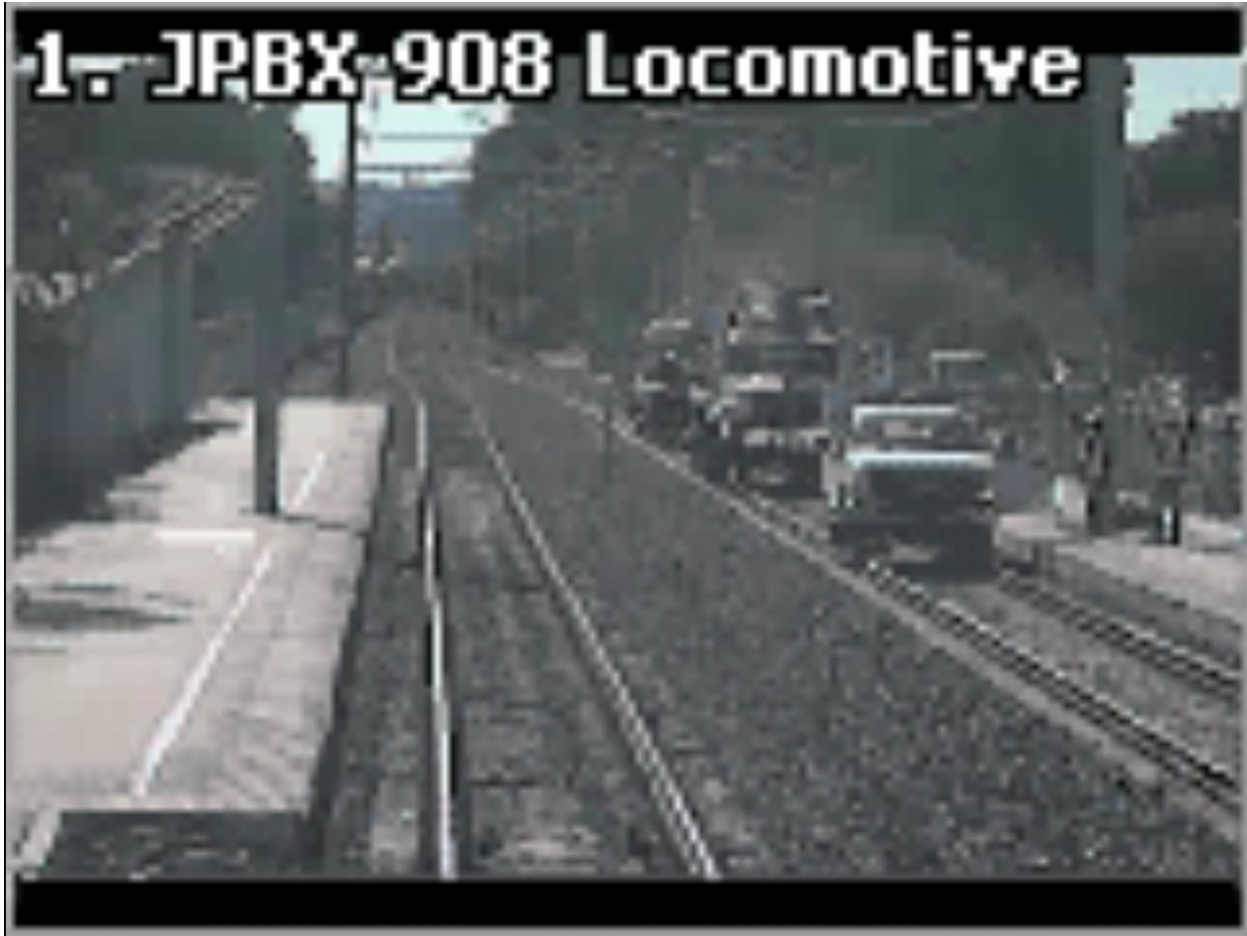
Figure 2. View of the work convoy on the parallel track.

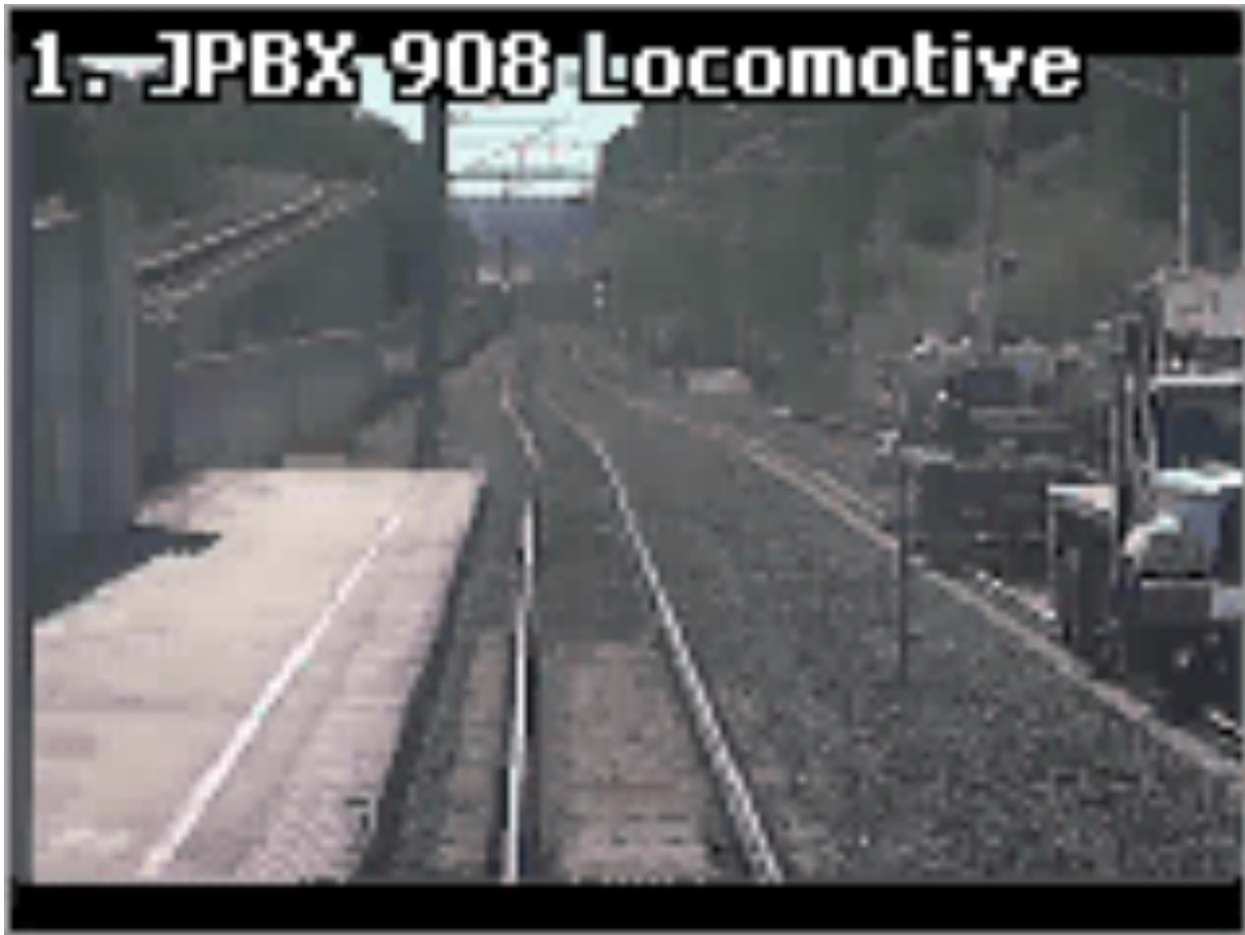
Figure 3. View of the rear of the work convoy on the parallel track.

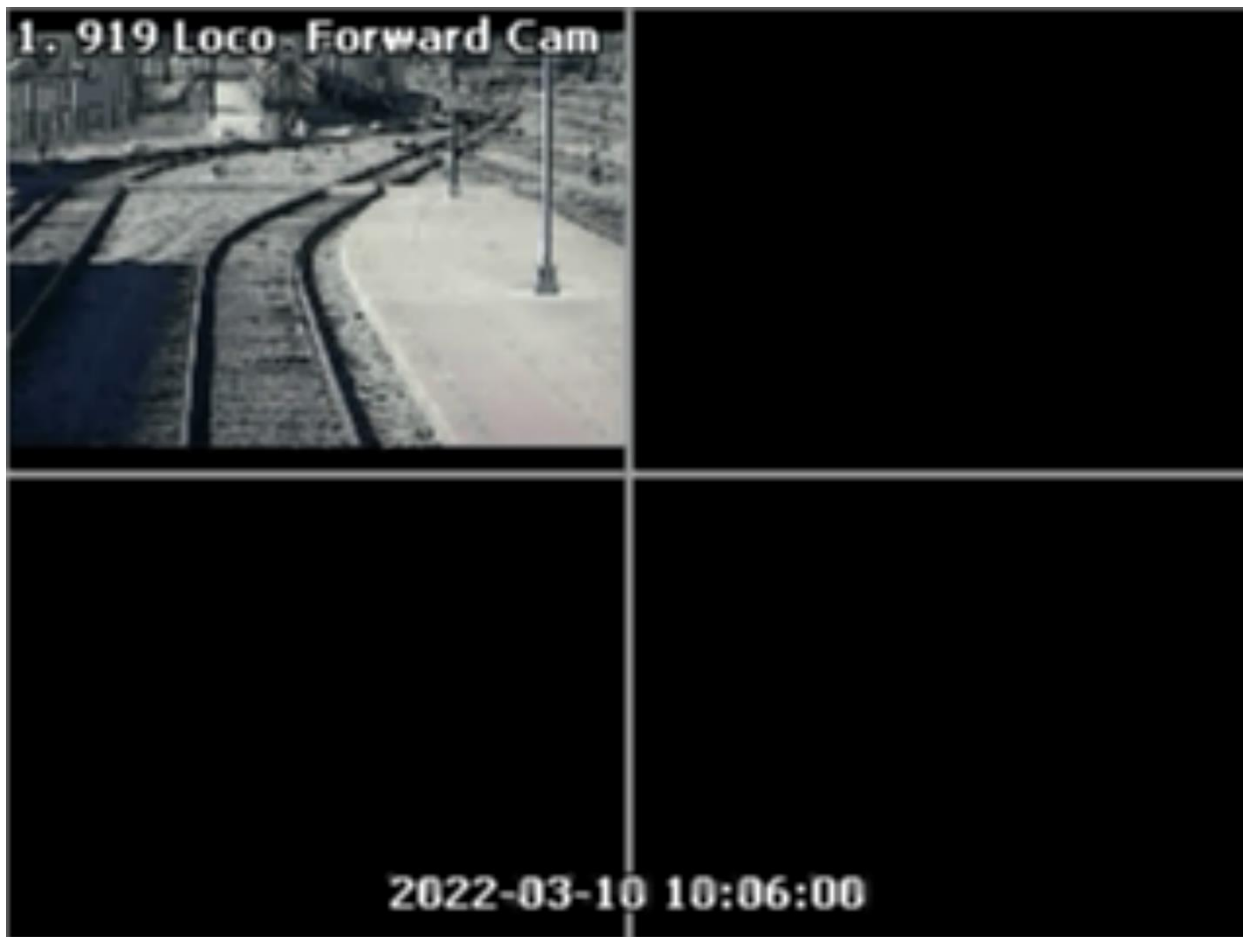
The recording began at approximately 10:14:57 with the train departing Caltrain Depot station at 4th and King streets in downtown San Francisco, as seen in figure 4. The train proceeded south uneventfully and transitioned onto the parallel main track 1 at 10:28:05, as seen in figure 5. At 10:31:23, the train transitioned back onto main track 2, as seen in figure 6.

Figure 4. Beginning frame of the accident train's video.

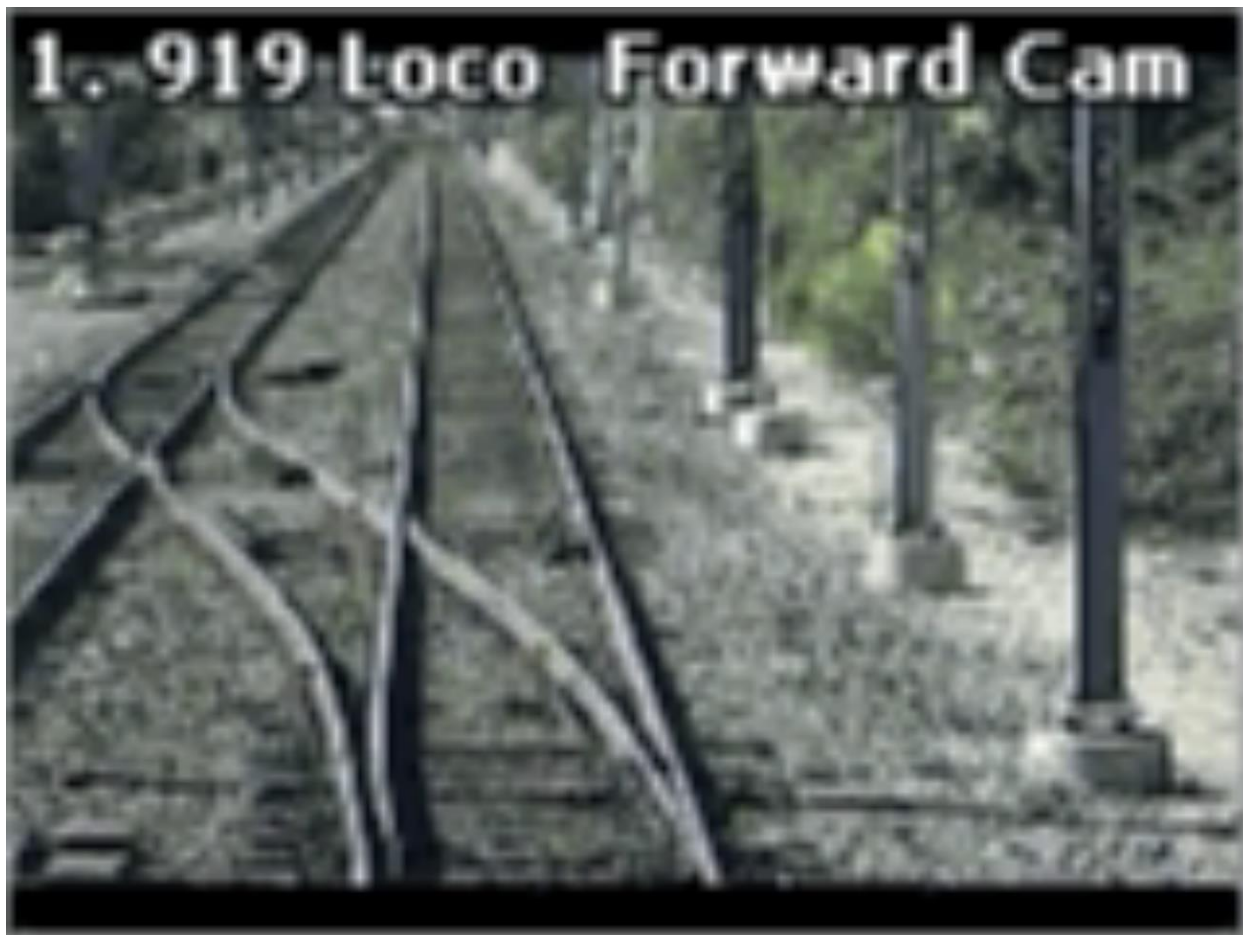
Figure 5. The view from the accident train approaching the crossover onto main track 1.

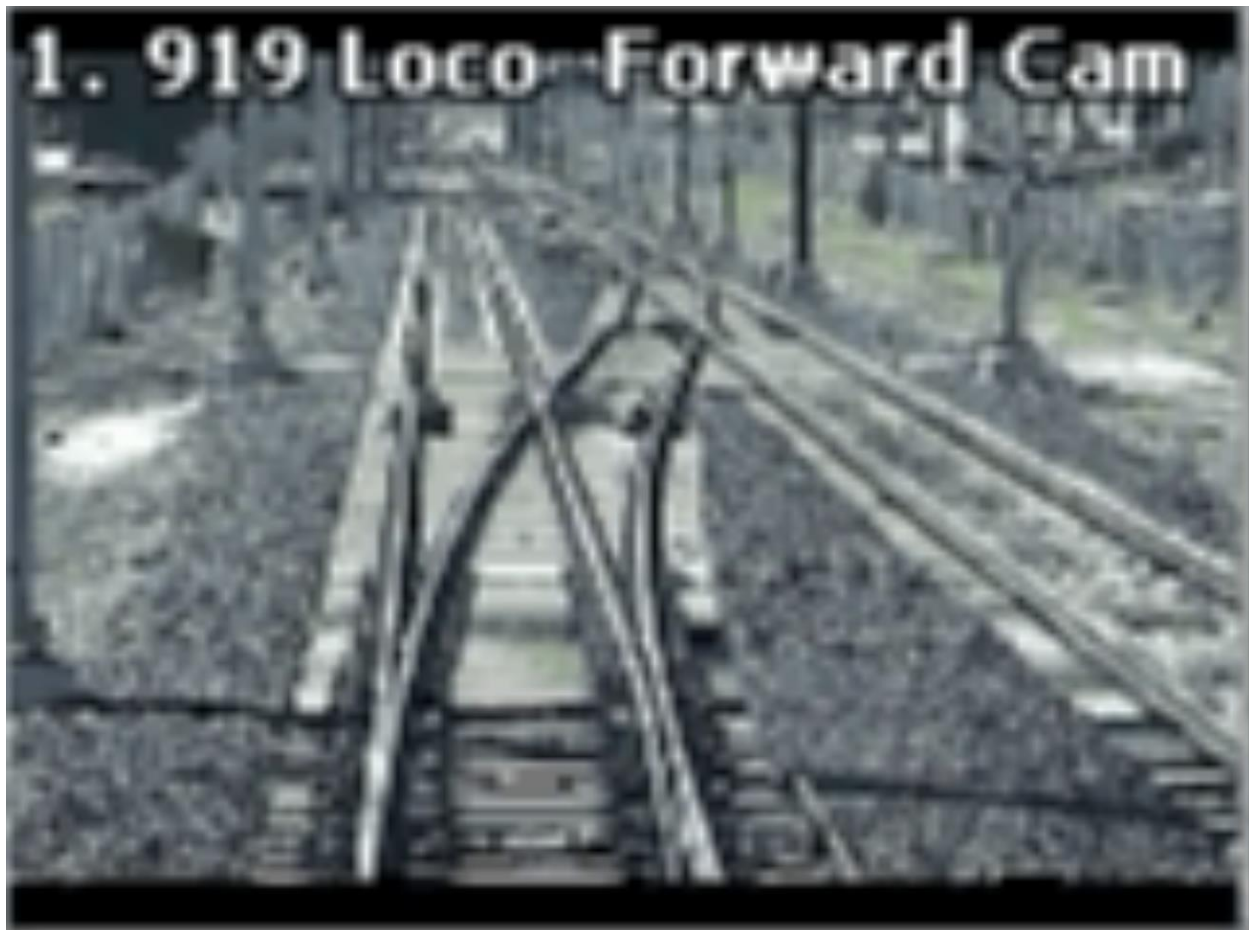
Figure 6. The view from the accident train approaching the crossover back onto main track 2.

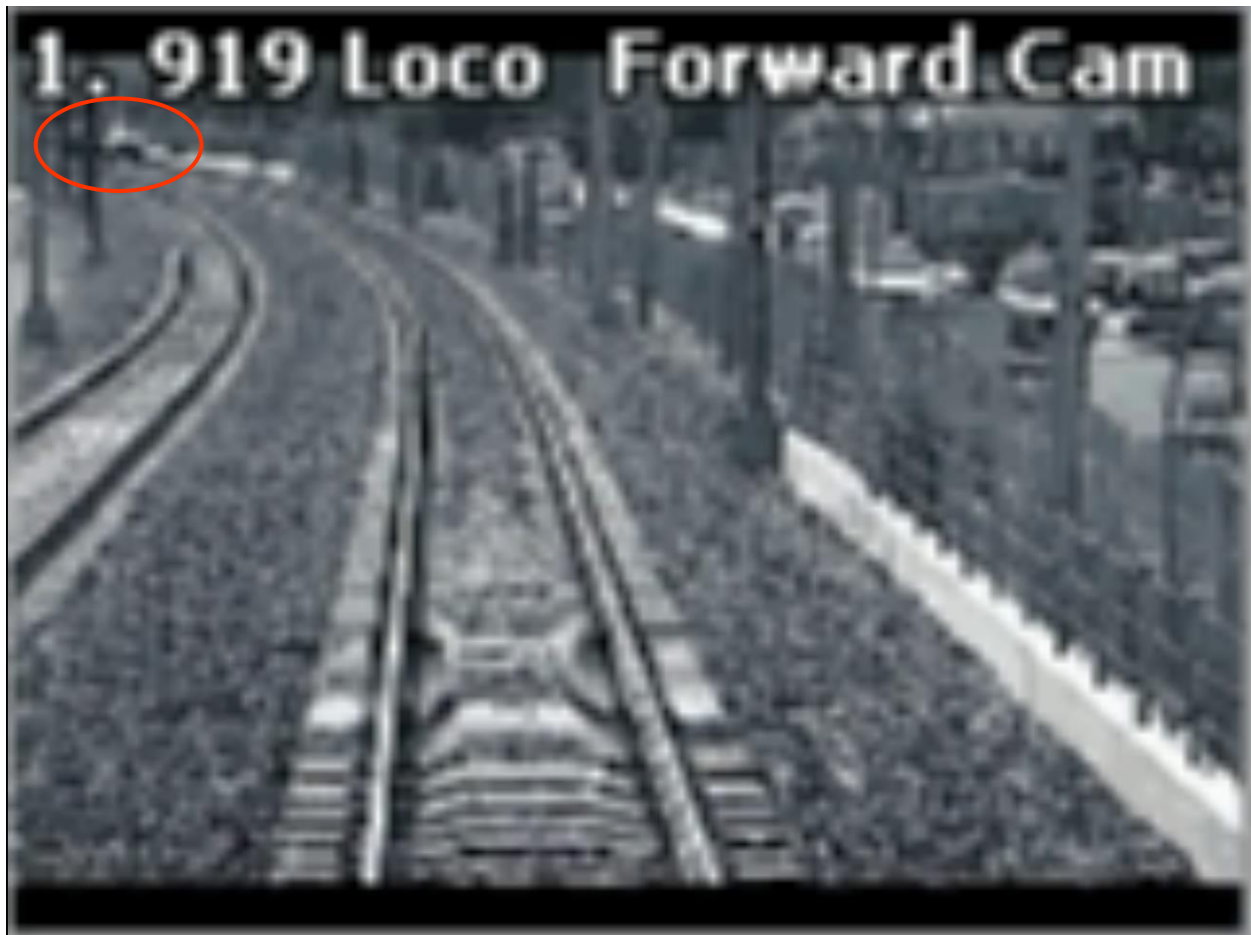
At 10:32:44, the convoy became barely visible on the far left of the video frame, highlighted in red in figure 7. As seen in figure 8, at 10:32:51, the convoy became increasingly visible as the train continued to round the corner, approaching the point of impact. The moment before impact is shown in figure 9. The train impacted the convoy at 10:33:00. The train quickly stopped at 10:33:13, in the position shown in figure 10, and remained there for the rest of the recording. The video subsequently showed fire and various emergency response activities, and ended at 11:14:58.

Figure 7. View of the convoy as it first becomes visible, as highlighted in red.

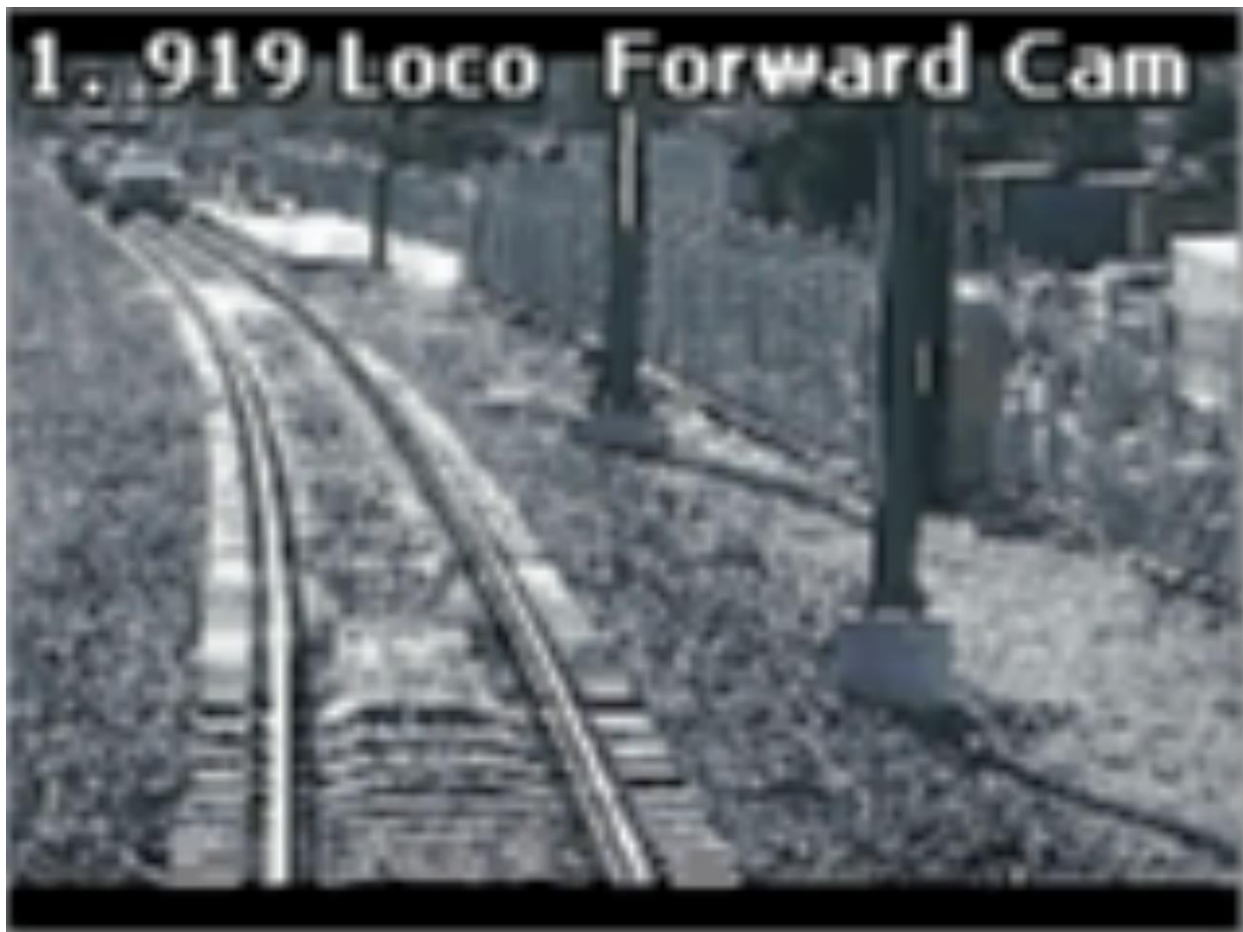
Figure 8. View as the train approached the convoy.

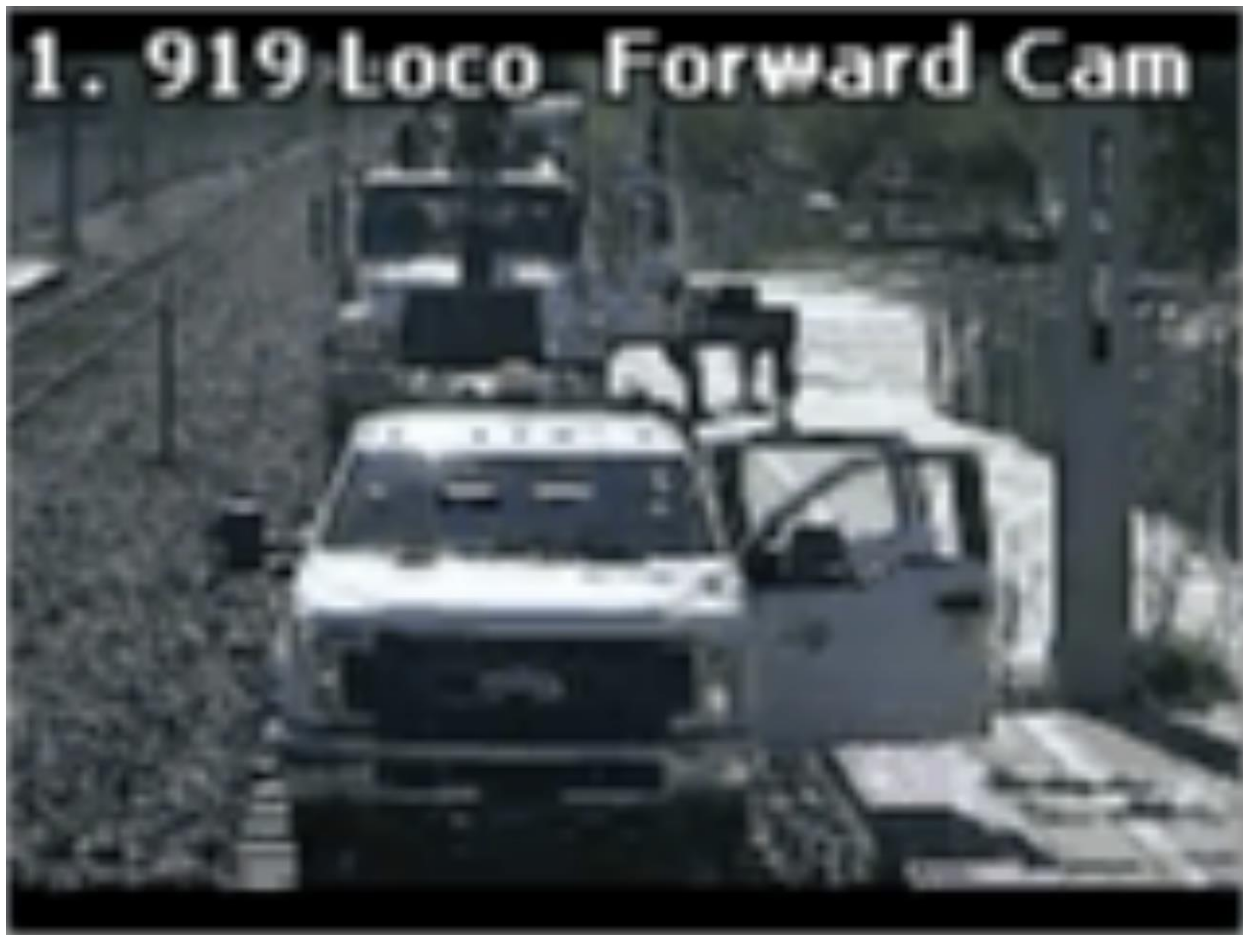
Figure 9. View moments before impact with the convoy.

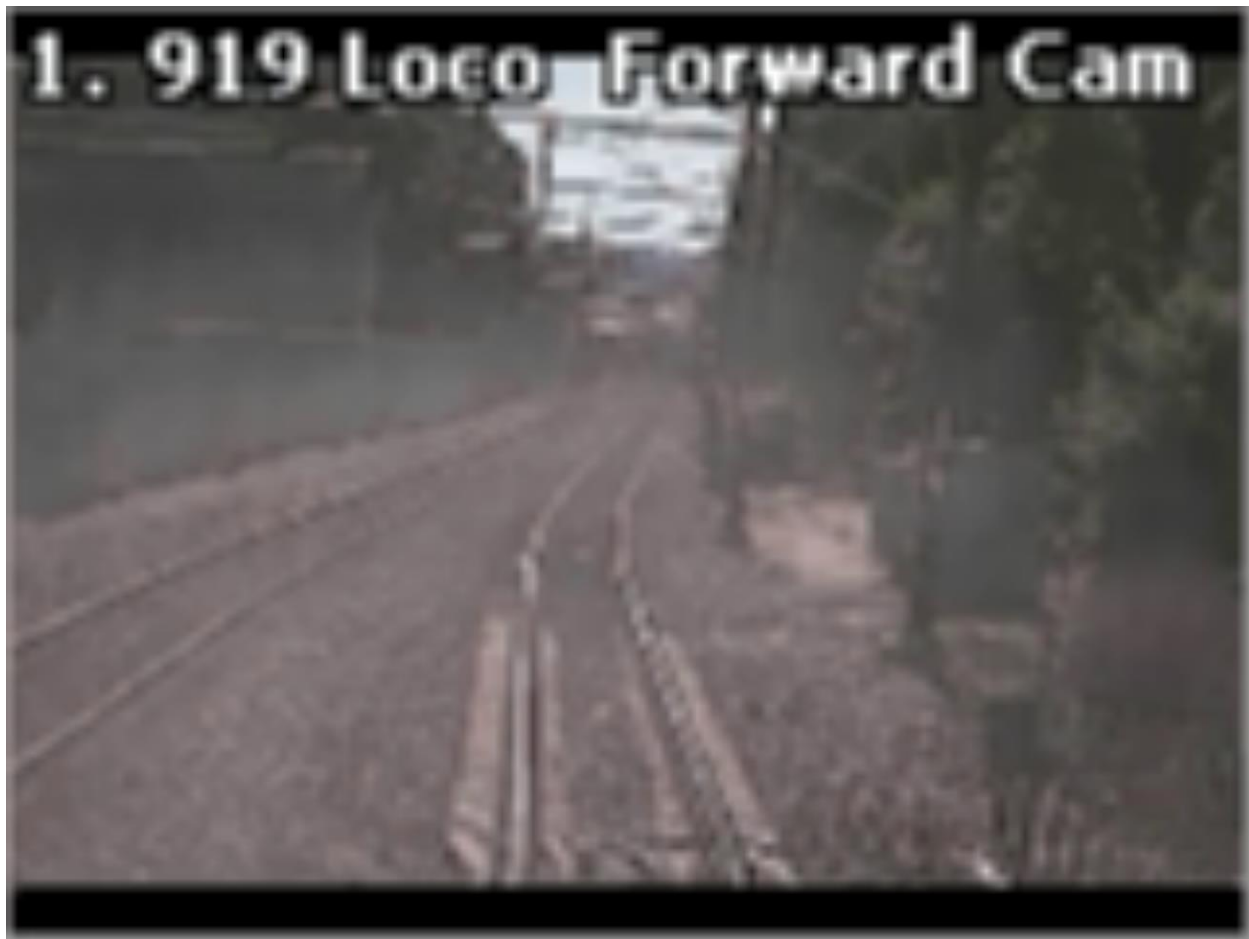
Figure 10. View of the final position of the train.
