National Transportation Safety Board

RRD23FR002

COMBINED FACTUAL

Group Chair's Factual Report

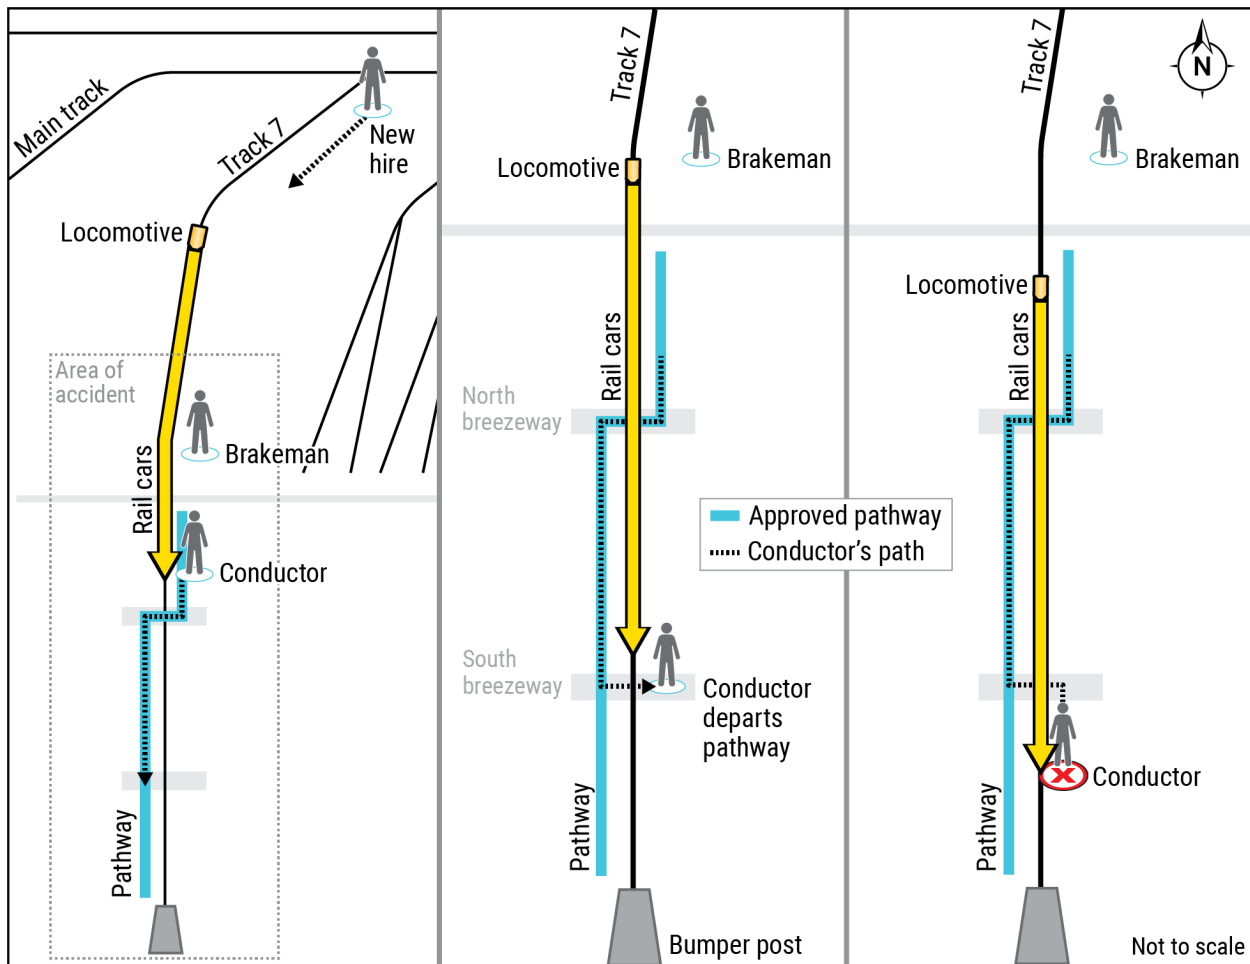
According to the PSC Group Rack Operations procedure in place at the time of the incident, employees will walk on the west side of the track between spots 7-1 through 7-11. They will then walk on the east side of the track between spots 7-12 through 7-20. This is to make sure the employees walk on the safest side of the track. The conductor was found on the east side of the track at spot 7-1.

Figure 2: Diagram showing the walking path of the conductor and the PSC group approved pathway.

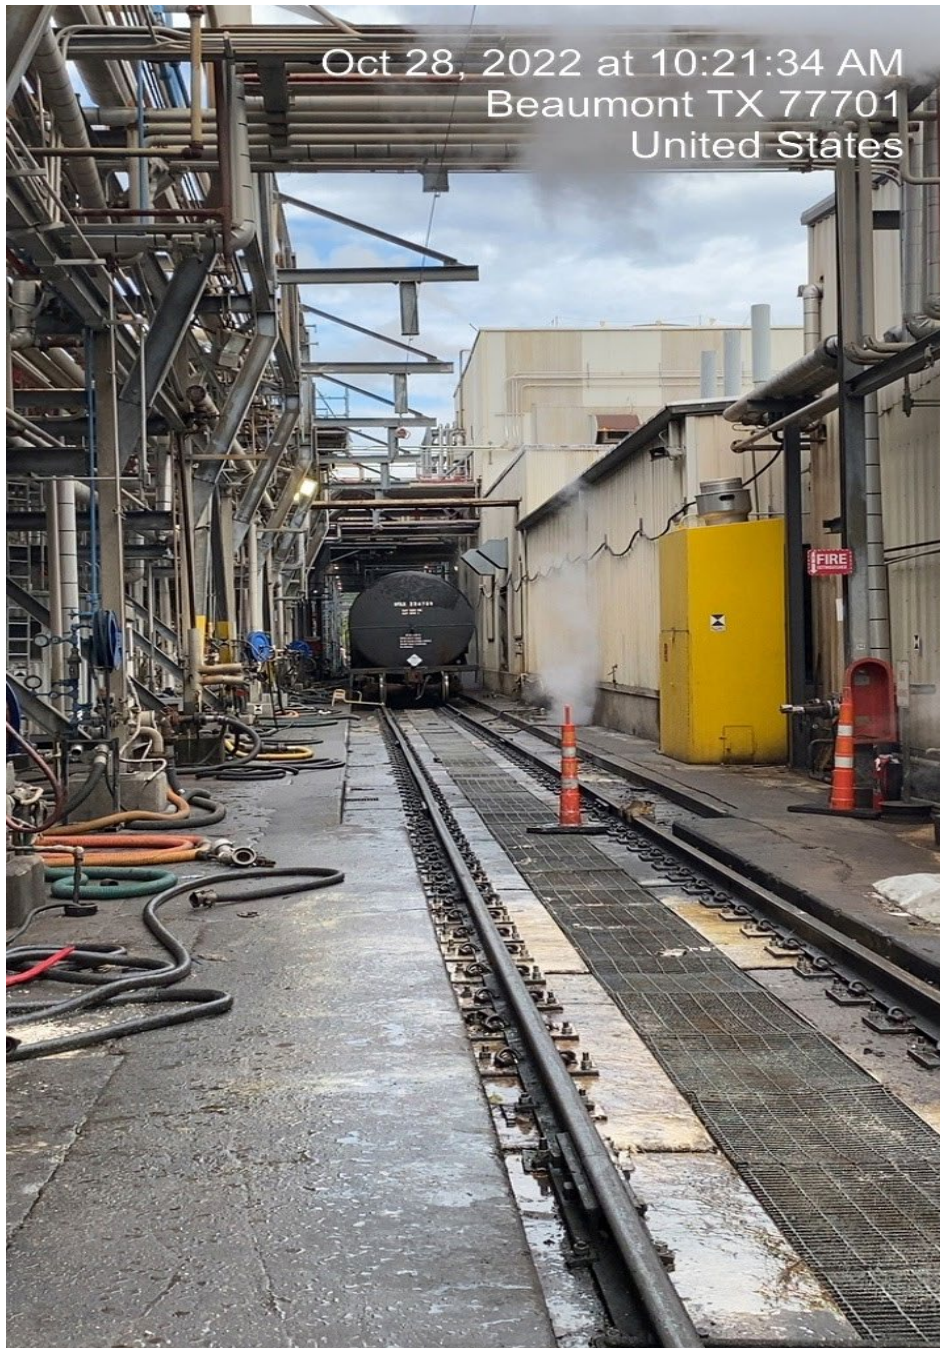
We were, however, able to walk the entire facility and observed the following walking conditions (slick surfaces due to rain, hoses, couplings on ground, chocks left in walkway) of the area. The lighting in the area between the #1 spot where the

fatality occurred and the location the brakeman would have been standing was decent enough for the ground crew members to make each other out if they were looking in that general direction. The steam from the hoses in the facility did lessen visibility for each member of the crew on the ground. The team also was able to measure the distance from where the rail car stopped to the end of the track which was a distance of 35 feet.

Figure 3: Photo looking south from the end of the track showing the walking conditions from our on-site visit on October 28, 2022.

ExxonMobil conducted the following postaccident actions as a result of the accident: (1) conducted safety stand down with all crews working at Beaumont Lubricant Blending & Packaging Site and sent safety communication to all rail related employees across U.S.; (2) increased PSC interfaces and reinforced safety expectations; (3) developed a one-page summary of the incident for sharing internally and externally; (4) addressed housekeeping at identified walking areas at the site (e.g., installed brackets for hanging train wheel chocks, created more room for hose storage when hoses not in use by several different means such as shortening or removing piping and redirecting piping and hose reels, pressure-washed walking

area, removed unused scaffolding); (5) executed additional facility enhancements (e.g., installed rail crossing signs at 7 track breezeways, addressed lighting); and (6) working to develop additional materials to share learnings from the incident and evaluate additional potential actions the ExxonMobil investigation team requested be evaluated.

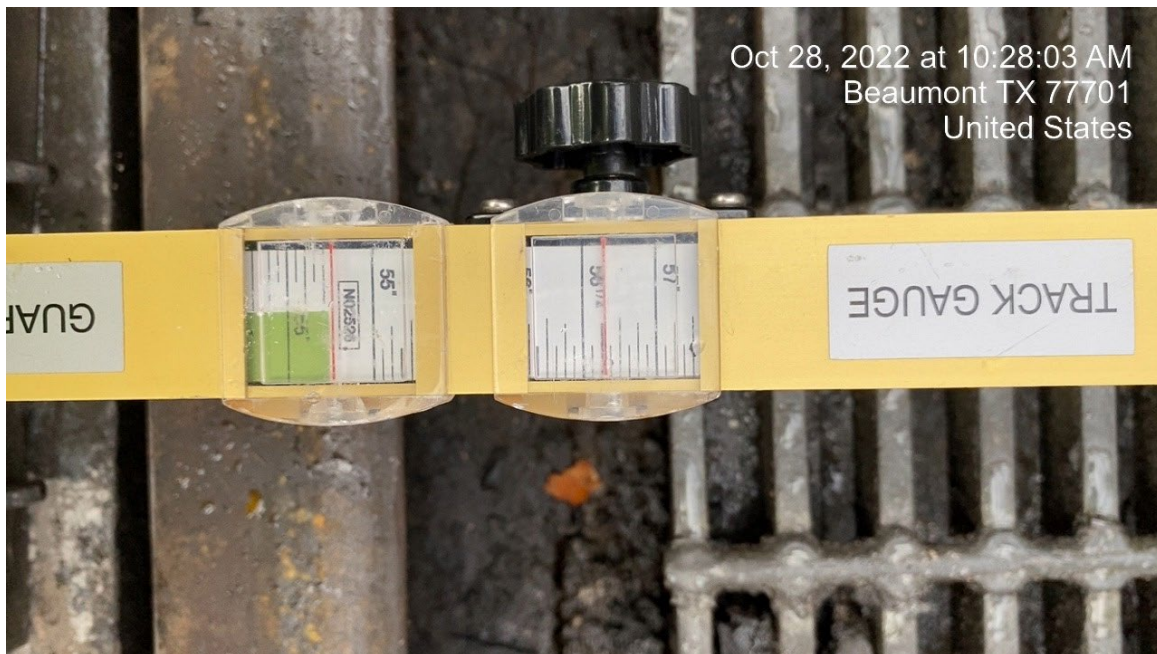
between the first and second wheel, and partially wedged underneath the truck set. The crew, including the DI was spotting the #7 track with empty cars to be loaded while holding onto 19 cars total. The track they were shoving into at the time the incident occurred was completely tangent with no curves or grade. Both rails were secured into the concrete using permanent concrete style fasteners, with bolts and locking nuts applied at the base of the rail, along with intermittent, 1 inch thick all thread, which was bolted on both sides through the web of the rail. Using his FRA calibrated level board, he measured a loaded gauge measurement at the incident scene on both ends of the rail car, that measured 56-5/8" on the B end (north), and 56-3/4" on the A end (south) incident end). The gauge measurement underneath of the rail car also measured 56-1/4" static with 1/4" base of rail movement for a total gauge measurement of 56-1/2".

Figure 4: Gage Measurement showing 56-1/2"

All of the gauge measurements taken were well within the allowable amount for FRA Class 1 track. The rail on #7 track was made in 1953 in the month of June manufactured by the Tennessee Coal & Iron company, (TCI a subsidiary of US Steel Corp) and is 115-pound RE. The loaded measurable cross level on the B end of the car was almost at zero and showed a .32" on my FRA calibrated level board. The loaded measurable cross level on the A end of the car (subject end) measured 3/16". All track measurements taken clearly indicated that track was not a contributing factor in the incident, the track measurements taken were well within the allowable amount for FRA class 1 track or greater. The track speed at the incident location was less than 10 mph. If this portion of track were to be regulated, it would be considered FRA class 1.

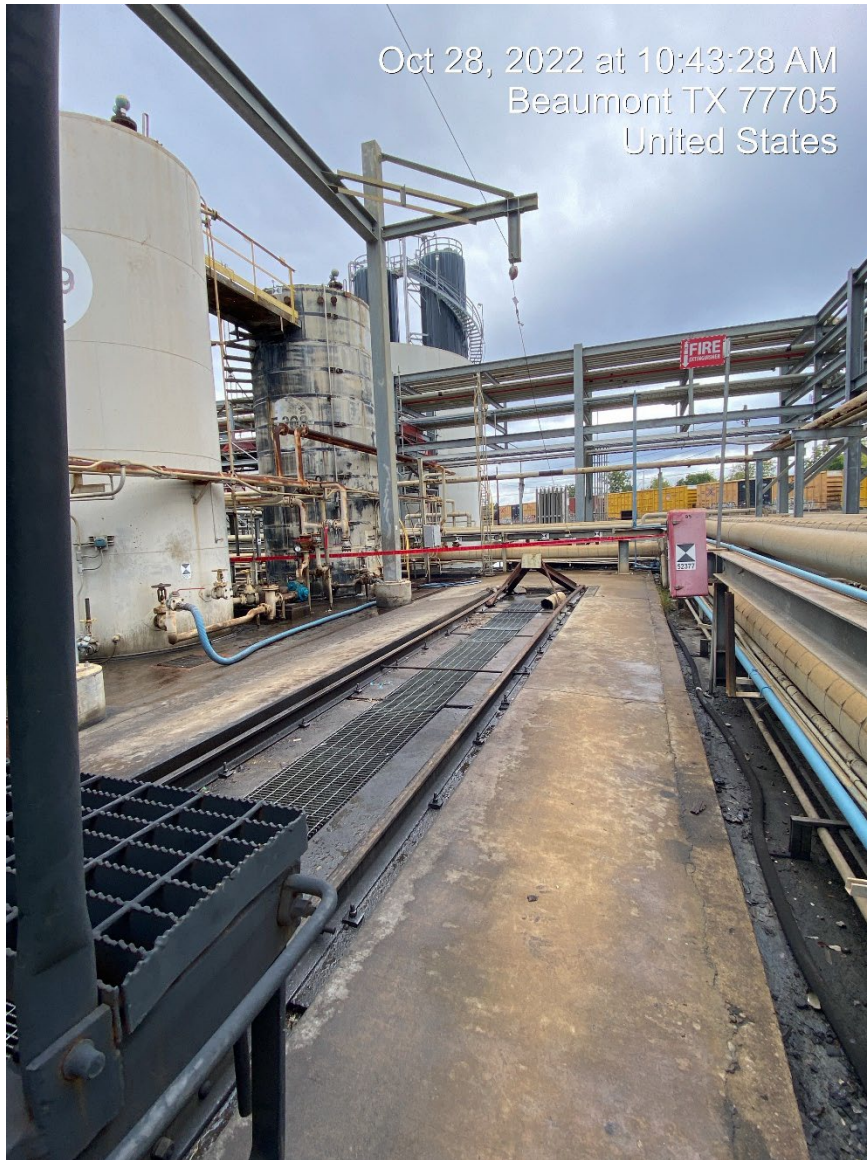
The DI was struck approximately 59 feet away from the bumper block at the end of the track, after being ran over the DI was shoved, approximately 24 feet until the car's resting point. The incident end (A) of the car was 35 feet away from the bumper block. The rail car had not yet reached its intended spotting location (spot 1). The FRA Track Inspector was able to determine the point of impact (POI), due to marks on the top of the rail, and the fact that the rail head had been swept clean of grease and other debris by the DI being drug underneath the car.

Figure 5: Distance from rear car to bumping post was measured at 35 feet.
