Preliminary Report RRD23FR011

# Norfolk Southern Railway Derailment

New Castle, Pennsylvania

May 10, 2023

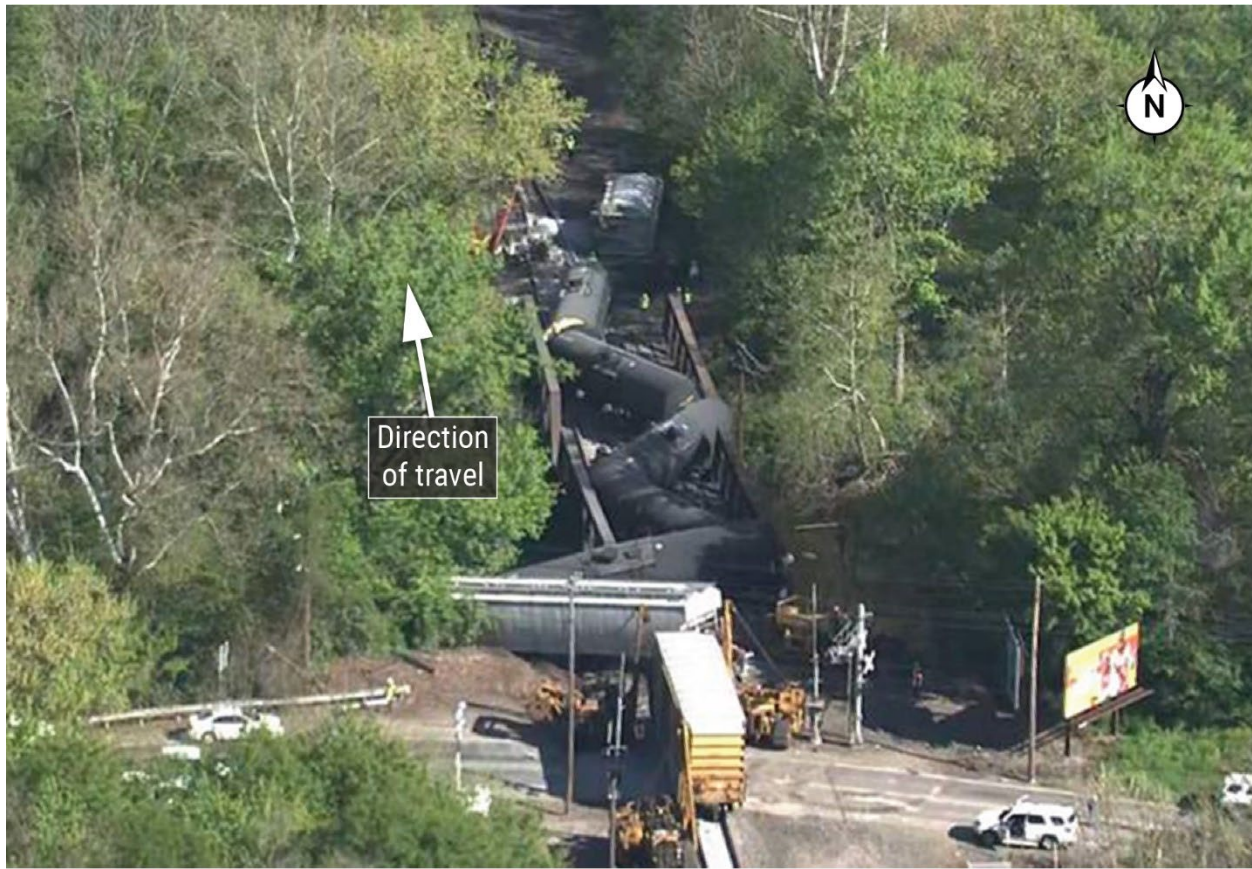
On May 10, 2023, about 10:57 p.m., northbound Norfolk Southern Railway (NS) general merchandise freight train 14M derailed nine mixed-freight railcars on the Youngstown Line at milepost (MP) 76.56 in New Castle, Pennsylvania.<sup>1</sup> (See figure 1.) The derailed equipment included one hazardous material tank car, which was not breached, that contained paraffin.<sup>2</sup> There were no reported fatalities or injuries. NS estimated damages to equipment and track infrastructure to be about \$6.1 million. At the time of the accident, visibility conditions were dark and clear; the weather was 52°F with no precipitation.

**Figure 1.** Aerial photograph of derailment site. (Source: WPXI Pittsburgh.)

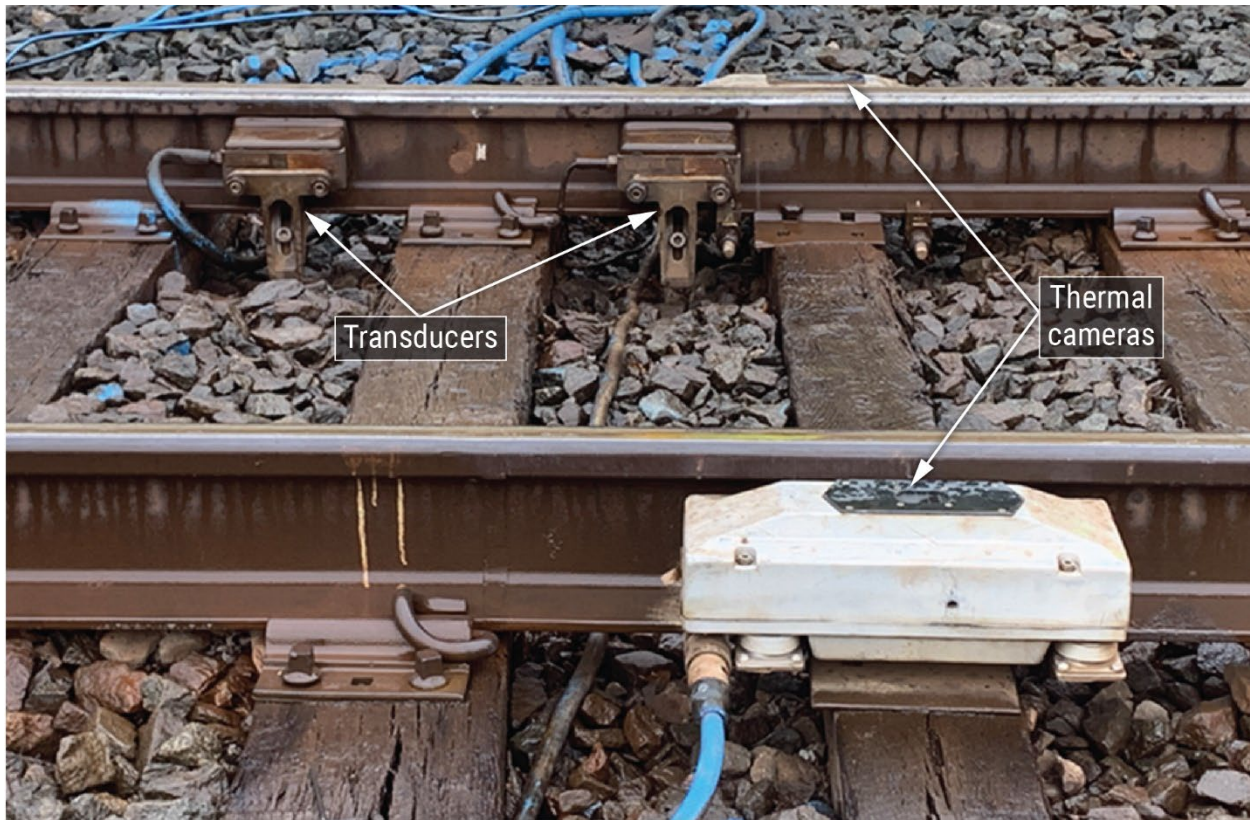
During review of signal data logs, NTSB investigators found that signal maintainers had performed maintenance on the Youngstown Line between Conway Yard and New Castle, Pennsylvania, on May 8, 2023. Maintenance activity included detaching and re-attaching track-mounted components of the HBD at MP 91.9.<sup>10</sup> Postaccident on-scene testing showed that the HBD's transducers were attached incorrectly and reporting reversed train travel directions (that is, a northbound train would be reported as southbound).<sup>11</sup> (See figure 2.) NS's ATC system requires an accurate report of train travel direction to interpret HBD data. Under NTSB investigators' direction, signal maintainers corrected the transducers' positions. In subsequent tests, NS technicians at the ATC desk in Atlanta confirmed that they had received usable HBD data.

**Figure 2.** Photo of the HBD at MP 91.9 on rail track.

Postaccident examinations did not identify conditions that would have prevented the HBD from transmitting an alarm message. However, NTSB investigators reviewed the inward-facing image recorder and audio data from the head-end locomotive of train 14M and did not find evidence of an audible alarm being broadcast over the locomotive radio.
