Preliminary Report RRD23FR012

# CSX Transportation Conductor Trainee

## Fatality

Baltimore, Maryland

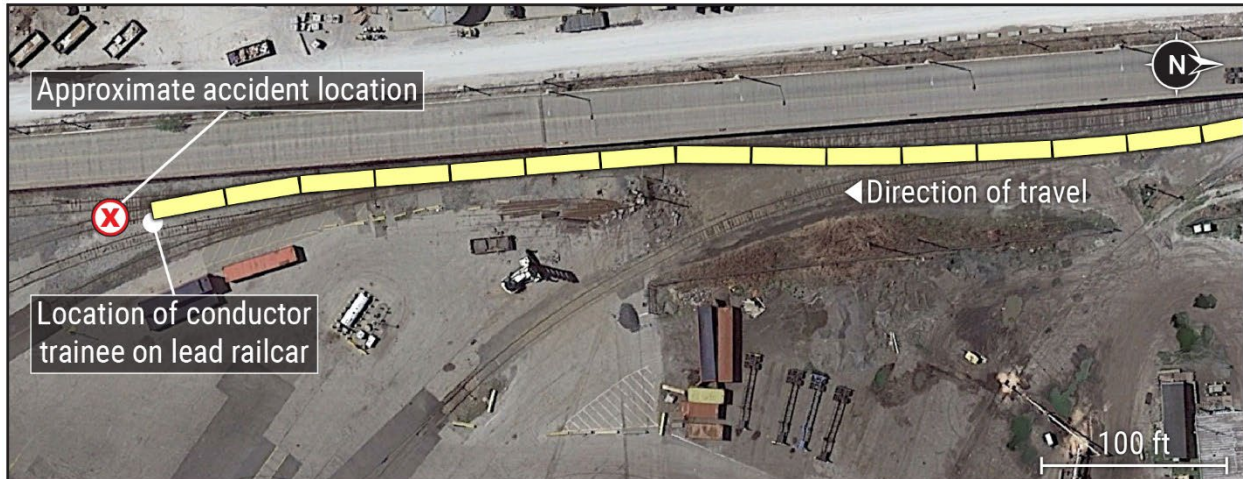
On June 26, 2023, about 8:05 p.m. local time, a CSX Transportation (CSX) conductor trainee on CSX yard job Y231 was killed while riding the lead railcar during a shoving movement at Seagirt Marine Terminal in Baltimore, Maryland.<sup>1</sup> (See figure 1.) The conductor trainee fell from an intermodal railcar during the movement and was struck by the train.<sup>2</sup> Visibility conditions at the time of the accident were daylight and clear; the weather was 84°F with intermittent rain showers earlier that day.

**Figure 1.** Illustrated aerial view of accident scene. (Source: Google Earth.)

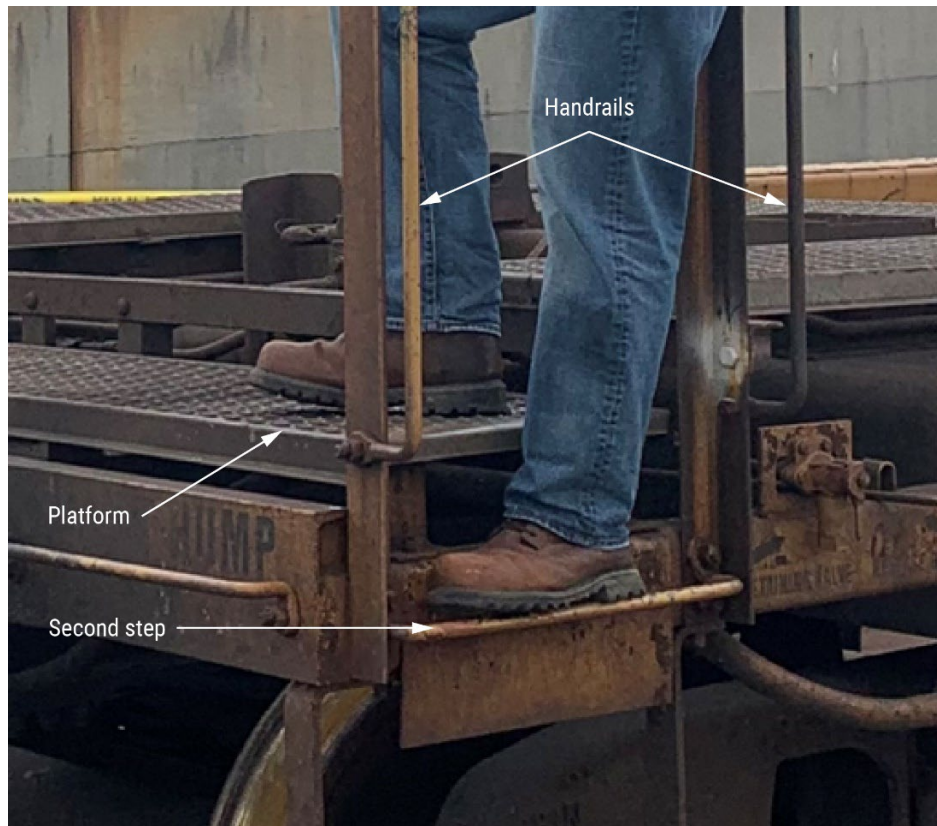
The crew of yard job Y231 consisted of an engineer in the locomotive cab, a conductor, and the conductor trainee. The train was composed of 2 locomotives and 15 empty intermodal railcars. Seagirt Marine Terminal surveillance camera data reviewed by National Transportation Safety Board (NTSB) investigators showed that the crew was in the process of shoving the railcars around a curve, with the conductor and conductor trainee protecting the shoving movement.<sup>3</sup> The conductor was on the west side of the lead railcar (the right side in the direction of travel). The conductor trainee was controlling the shoving movement from the east side of the lead railcar (the left side in the direction of travel) with one foot on the second step of the railcar and one foot on the platform.<sup>4</sup> (See figure 2.) The conductor trainee communicated instructions using his handheld radio that they needed to stop within 5 railcar lengths.<sup>5</sup> As the train slowed, the conductor trainee fell from his position and was struck by the train.

**Figure 2.** Photo of investigator on the intermodal railcar during reenactment of the accident.
