Preliminary Report: RRD23FR013

Norfolk Southern Railway Derailment

Elliston, Virginia

July 6, 2023

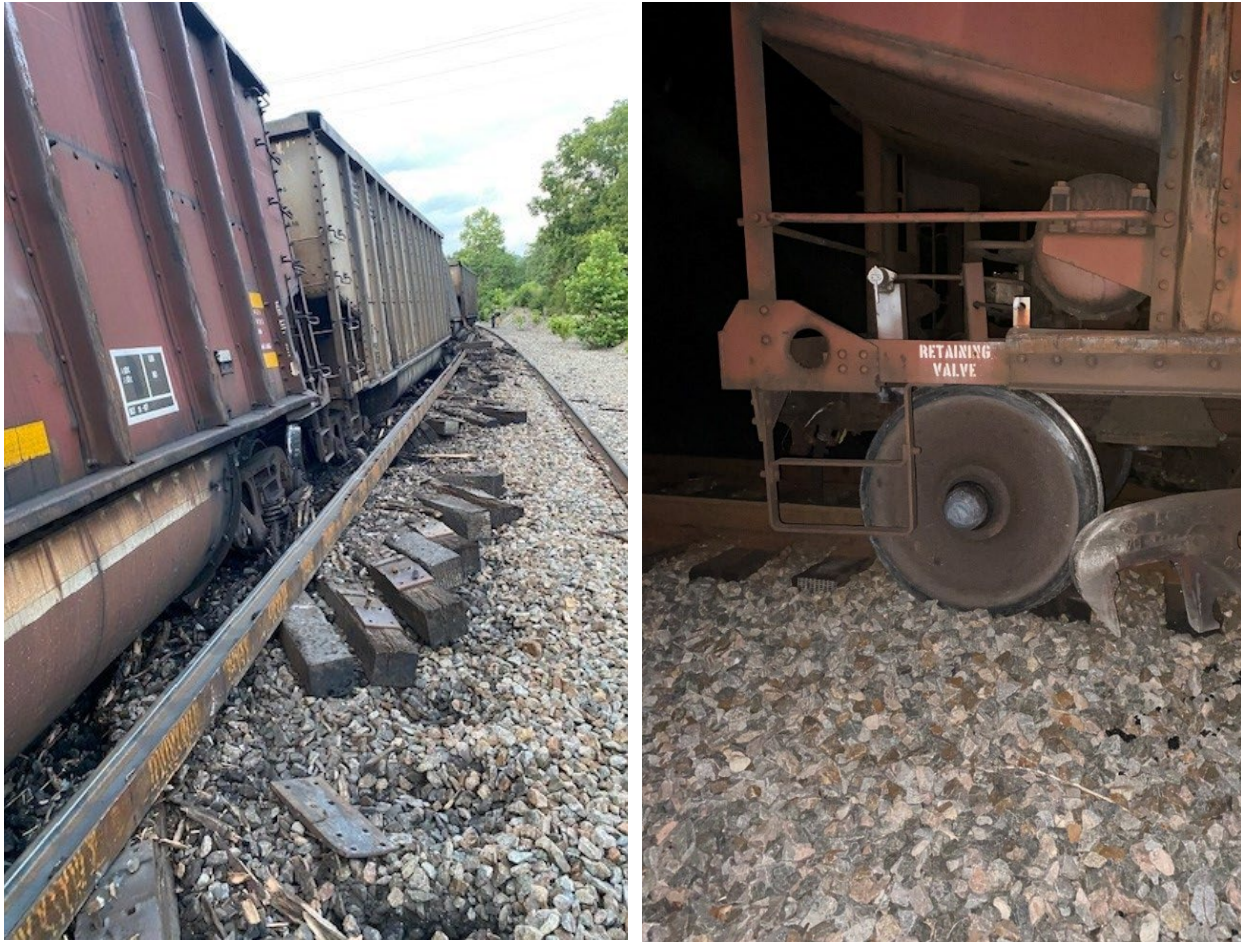
Figure. Derailed gondola cars (*left*) and a wheelset with a burned-off bearing (*right*).
(Sources: NS (*left*); Federal Railroad Administration (*right*).)

About 5:29 p.m., an HBD at milepost 276.3 transmitted a critical alarm message for an axle on the 71st railcar of train 814V404. After the crew stopped the train, the conductor inspected the railcars and told the ATC desk that the axle's temperature indicator stick had melted slightly, indicating a measurement of 169°F or higher, and that some grease was coming from the back of one of the axle bearings.⁶ The ATC desk advised the crew to confer with the train dispatcher, who directed them to set out the railcar for inspection. The dispatcher gave the crew permission to move the train about 13 miles east to the Riverside siding to set out the railcar; as the crew was moving the train to this location, the derailment occurred.

While on scene, National Transportation Safety Board (NTSB) investigators recovered burned-off bearing components, wheels, and axles from the 71st railcar.

On July 7, the day after the derailment, NS issued an operations bulletin providing clarification of the requirements for responding to hot bearing and dragging equipment alarms.⁷ The bulletin states that upon receiving a critical hot bearing alarm, the crew must immediately stop the train for inspection. If the overheated condition is confirmed, the crew must inform the ATC desk and seek guidance on moving to the next available set out location. Any authorized movement must not exceed 10 mph, and the defective railcar must be reinspected at least every 3 miles until set out. The bulletin further states that a visual inspection of the indicated bearing and its associated components must be performed. If this inspection reveals exceptions (for example, leaking grease or visible damage), the ATC desk must be notified, and NS mechanical department personnel must perform an inspection before the railcar is moved.
