National Transportation Safety Board

RRD23FR014

Group Chair's Factual Report

January 26, 2024

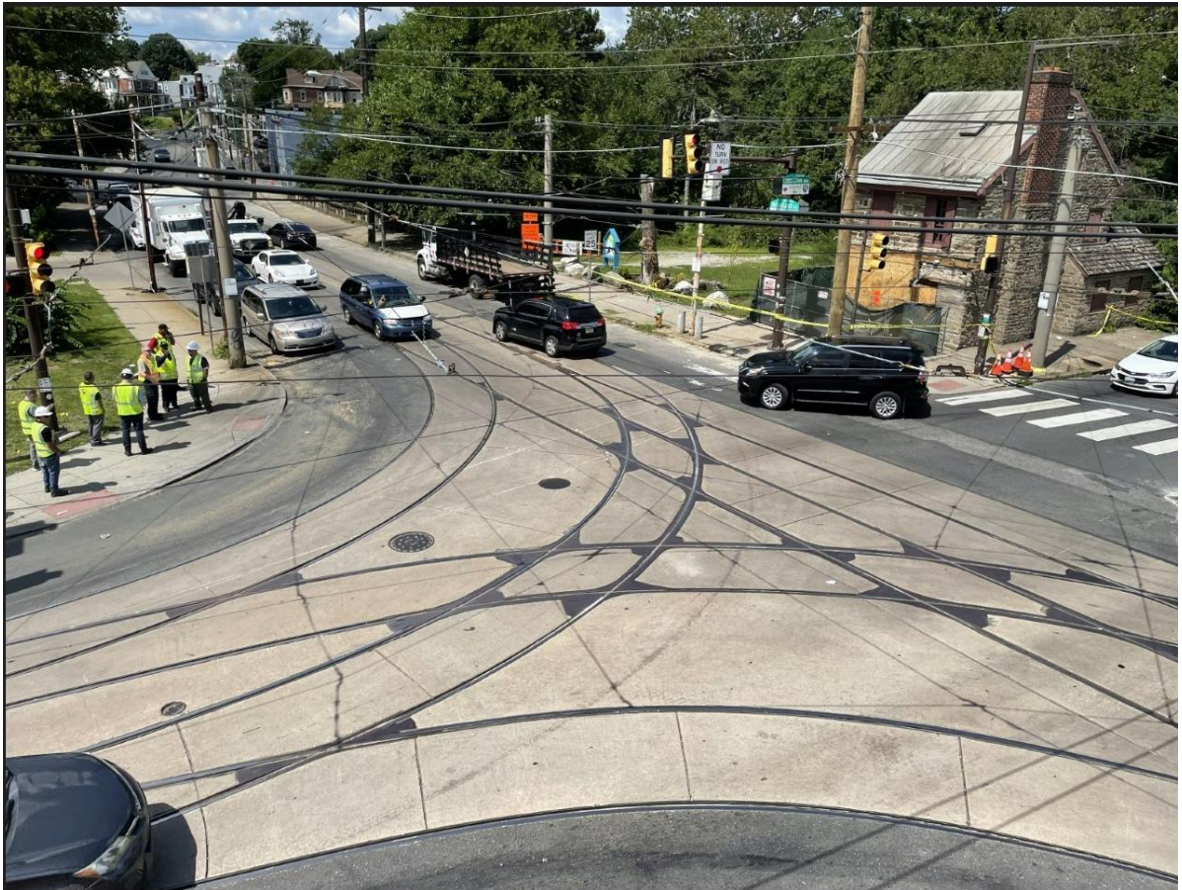
Figure 2. Intersection of Island and Woodland Aves., with the Blue Bell Inn in the top right corner.

Trolley Number 9107 stopped when it impacted the south side of the Blue Bell Inn. At the time of the accident a caretaker for the property resided in the building. The caretaker did not report any injuries, but the building sustained substantial damage.
