Preliminary Report: RRD23FR016

CSX Transportation Conductor Trainee Fatality

Cumberland, Maryland
August 6, 2023

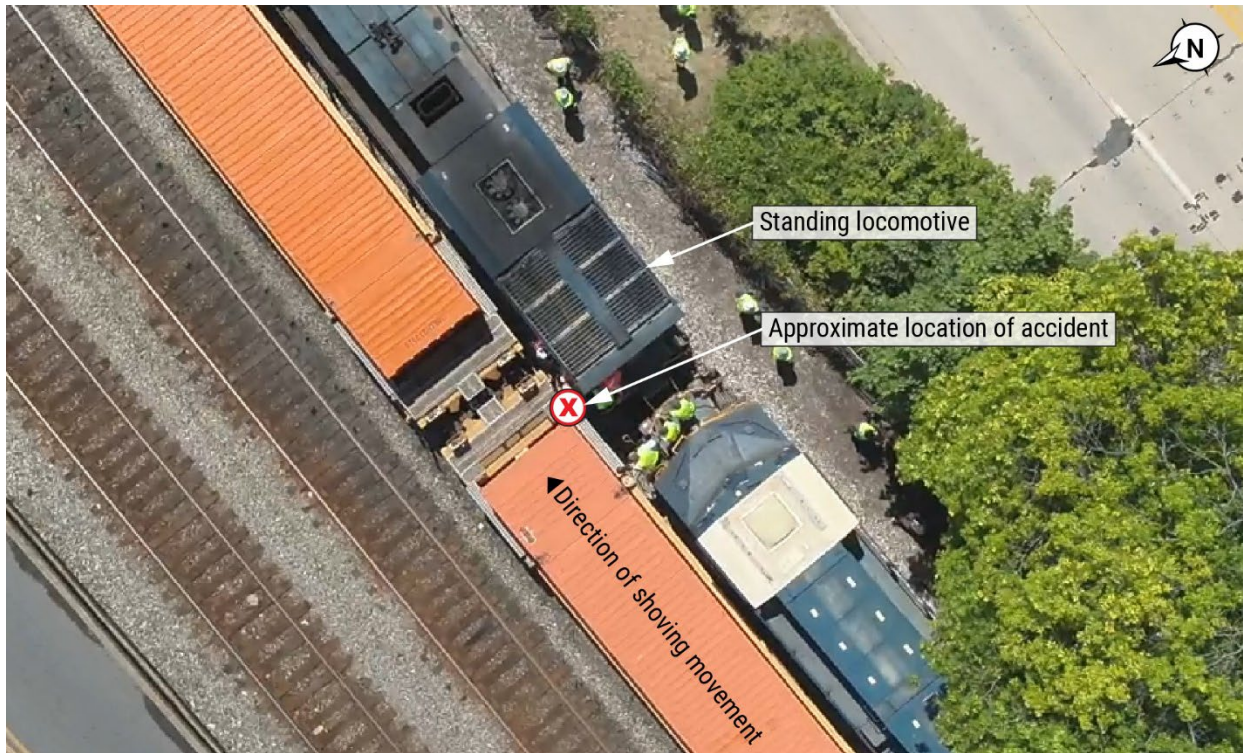
Figure 1. Aerial view of the accident scene. (Source: CSX.)

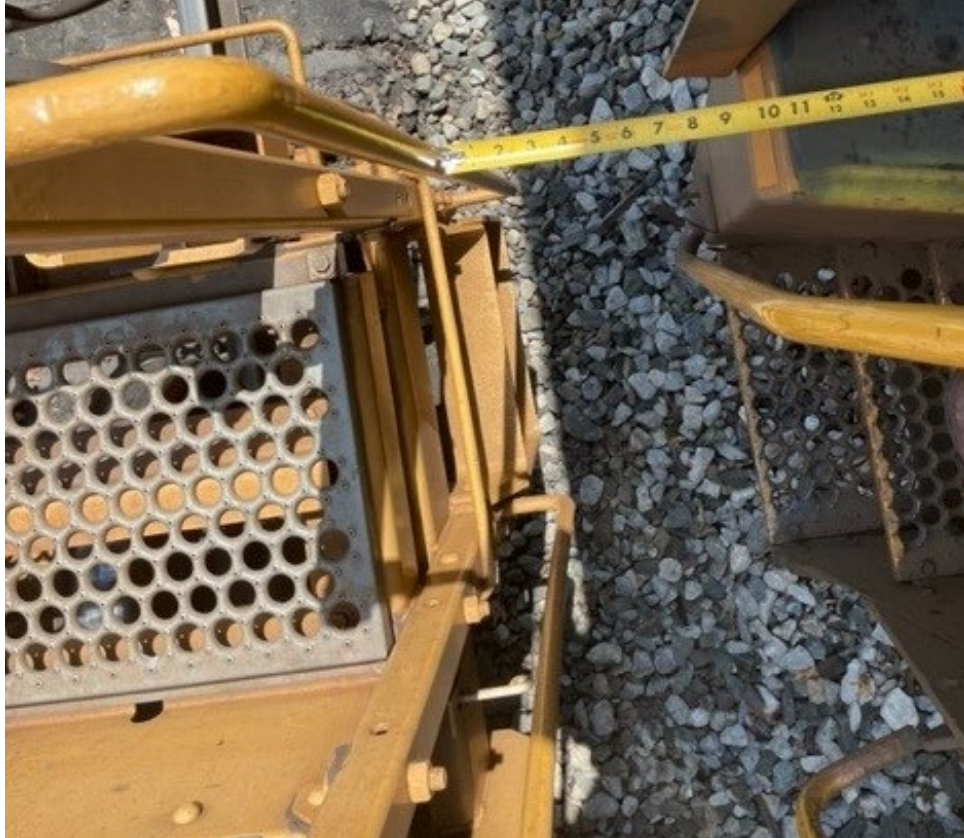
Preliminary information indicates the conductor was directing the eastward shoving movement by radio to the engineer, who was in the locomotive cab. The conductor was positioned at the leading end of the movement, riding on a ladder on the south side of the final railcar in the consist. The conductor trainee was riding on the next ladder back on the same side of the same railcar. As the train reversed down the track at approximately 9 mph, it approached three locomotives parked on an adjacent track, and the accident occurred. Postaccident measurements taken by the National Transportation Safety Board (NTSB) on scene indicated about 7 inches of clearance between train I13706 and the standing locomotives. (See figure 2.)

Figure 2. Clearance between the intermodal car and standing locomotives. (Photo: CSX.)

As a result of this accident, on August 11, 2023, the Switching Operations Fatalities Analysis Working Group issued an alert advising railroad employees to remain vigilant when mentoring inexperienced employees and to conduct job briefings whenever a job changes.⁴ On August 16, 2023, the Federal Railroad Administration issued Safety Bulletin 2023-05: Shoving Movement Close Clearance Fatality, which urges railroads to review employee training programs that address

riding equipment in close-clearance situations and to consider marking close or no clearance areas with highly visible signs.⁵
