National Transportation Safety Board

RRD23FR016

COMBINED FACTUAL

Group Chair's Factual Report

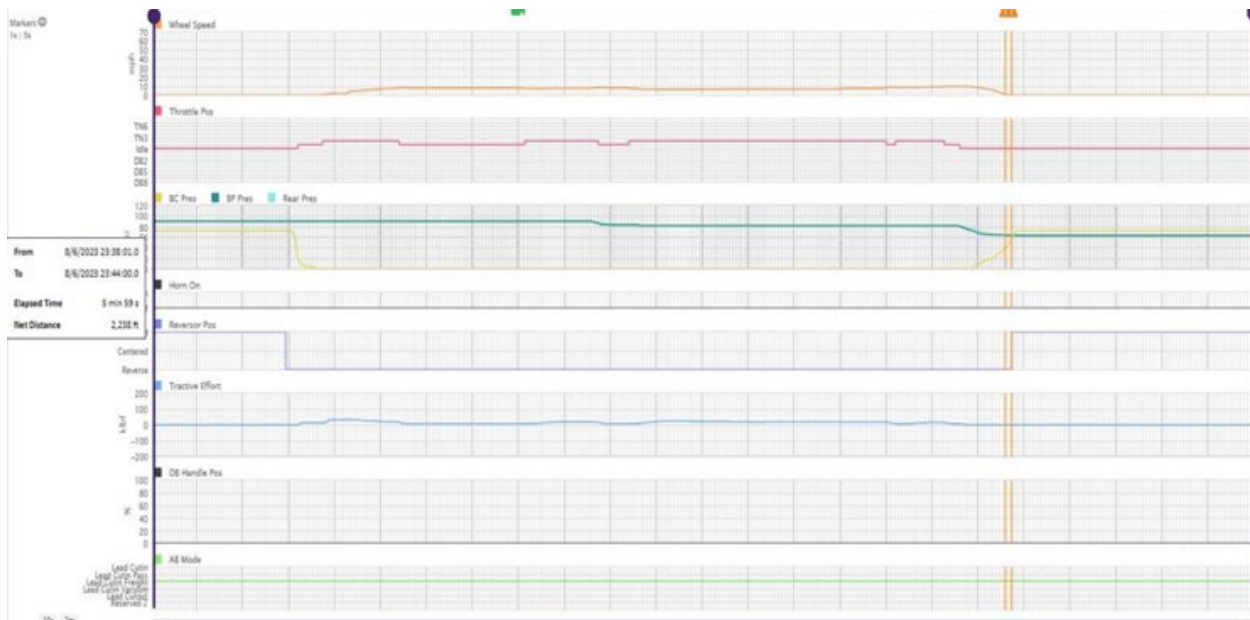
Summary of event recorder download key events, air is set to minimum reduction once bunched, power braking into the movement, indicates a move being made with people riding the rear. Once desired speed is reached, the throttle modulates between notch 1 and 2 before applying a full-service brake, then applying the independent when the movement stops. The operations group did not note any erratic or abnormal manipulations of the operating controls during the review of the event recorder data. The group found that the train handling methods utilized by the engineer prior to the accident were found to be consistent with normal operations for the type of equipment and circumstances.

Figure 2. Snapshot of event recorder data during shoving movement.

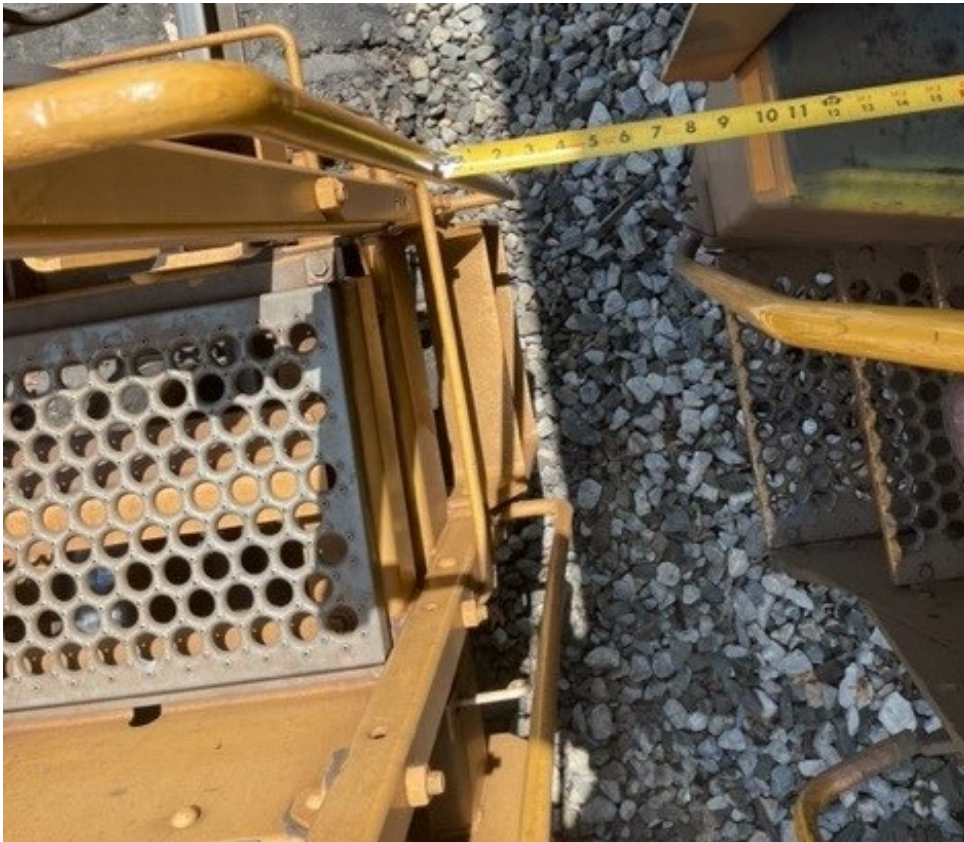
Post accident measurements taken by the NTSB on scene indicated about 7 inches of clearance between train I13706 and the standing locomotives.

Figure 3: Clearance between the intermodal car and standing locomotives.
(Photo: CSX.)
