Preliminary Report RRD23LR006

## Safety Performance of Wheelsets

Springfield, Ohio

March 4, 2023

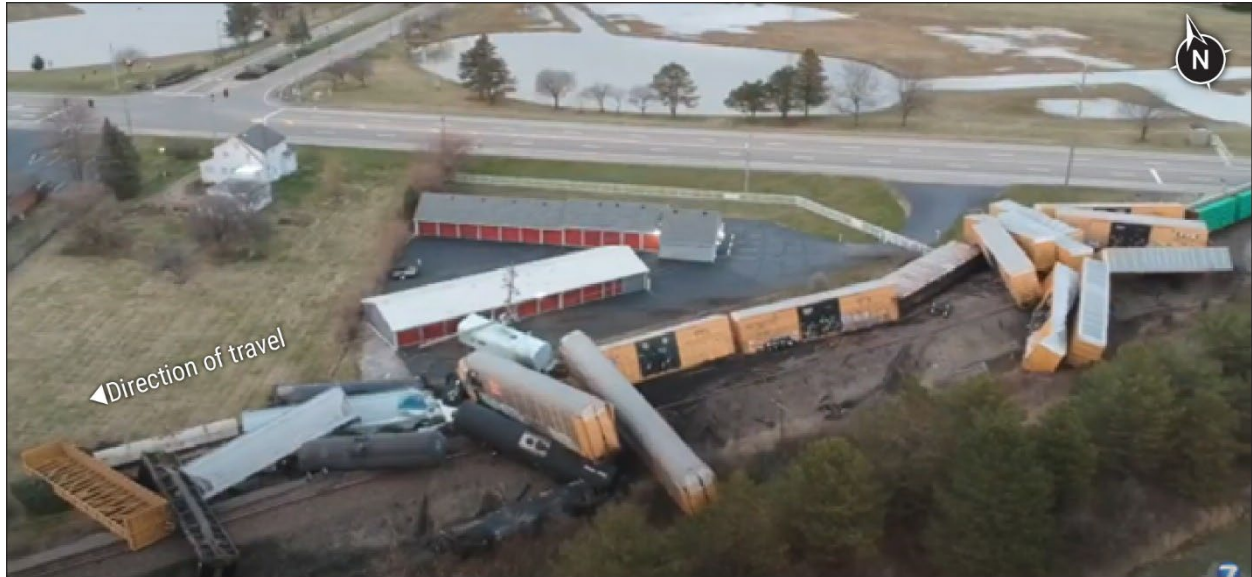
On March 4, 2023, about 4:54 p.m. local time, westbound Norfolk Southern Railway (NS) mixed freight train 179LC04 derailed 28 railcars at milepost 178.85 on the Dayton District near Springfield, Ohio.<sup>1</sup> (See figure.) Twenty-one of the derailed railcars were loaded and 7 were empty; none were carrying hazardous materials. The derailment downed a powerline, which caused about 47 homes to lose power. Local first responders initially ordered residents within a 1,000-foot radius to shelter in place. This order was lifted about 1:00 a.m. on March 5. No injuries were reported. NS estimated damages to equipment, track, and signal infrastructure to be about \$2.6 million. Visibility conditions at the time of the derailment were daylight and clear; the weather was 51°F with no precipitation.

**Figure.** Aerial view of derailment. (Courtesy of Clark County Emergency Management Agency.)
