# National Transportation Safety Board

RRD23LR008 – ANNISTON, ALABAMA

## **MECHANICAL**

Group Chair's Factual Report

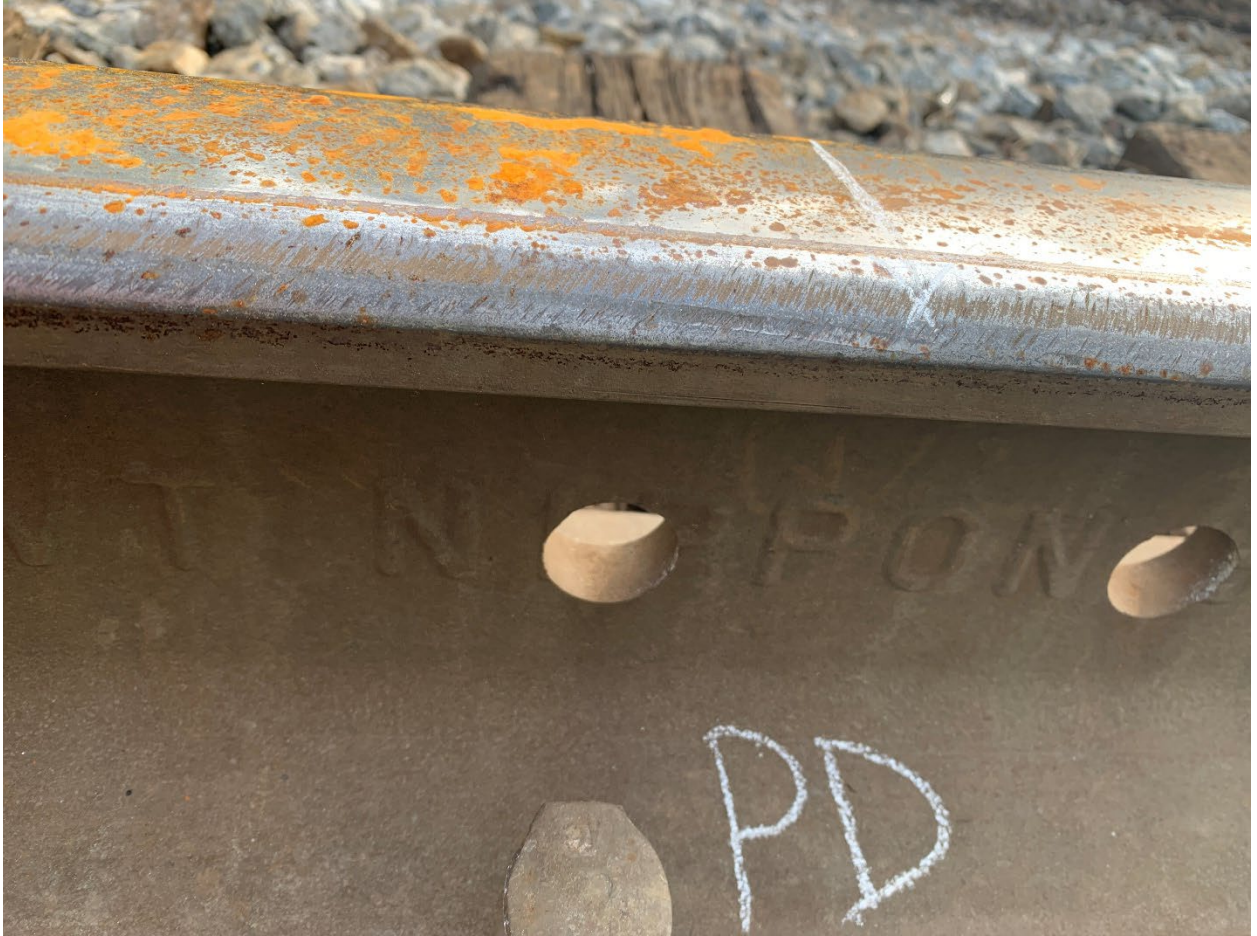
At MP 721.05 the track profile is briefly tangent between a left-hand and right-hand curve. Witness marks indicate that at this point, the south rail experienced a catastrophic lateral force to the south and subsequent rail rollover/gage rupture event. The head of the rail had witness marks consistent with the suspension hanger from a locomotive riding on the rail for approximately 29 feet. Following this mark, wheel flange impact marks from north-rail wheels were found inside the gage on the ties.

**Figure 10. Wheel and wheel tread departure mark near MP 721.05.**

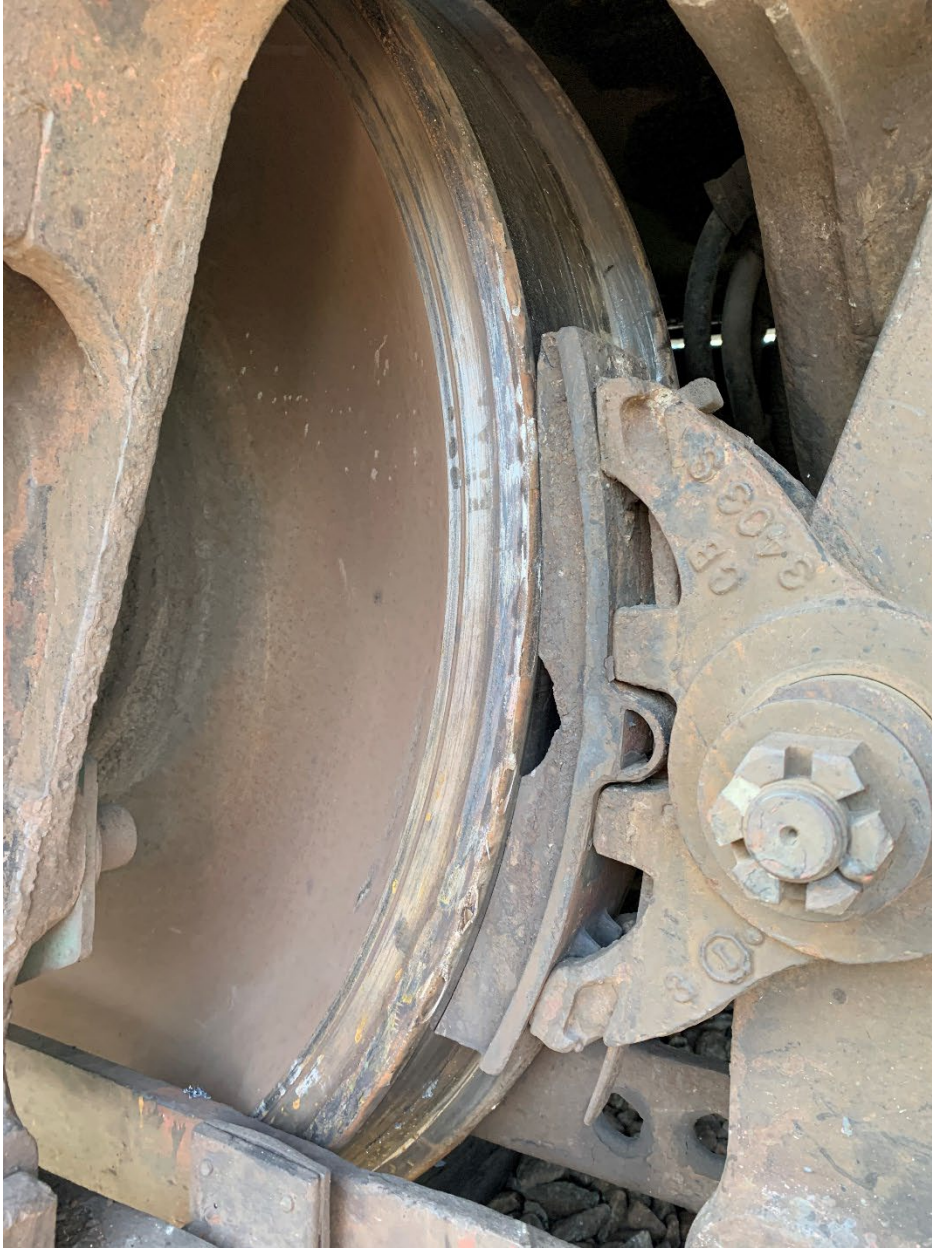
The witness marks found on the track structure matched witness marks found on locomotive RMEX 06. Specifically, the R3 wheel had outside wheel plate/rim scoring and damage. The right-rear (south in the direction of travel) suspension hanger had witness marks from the rail. The witness marks are consistent with the R3 wheel of RMEX 06 being the first wheel to derail in a gage widening/ rail roll over event.

**Figure 11. RMEX 06 R3 Wheel with rail burn witness marks.**

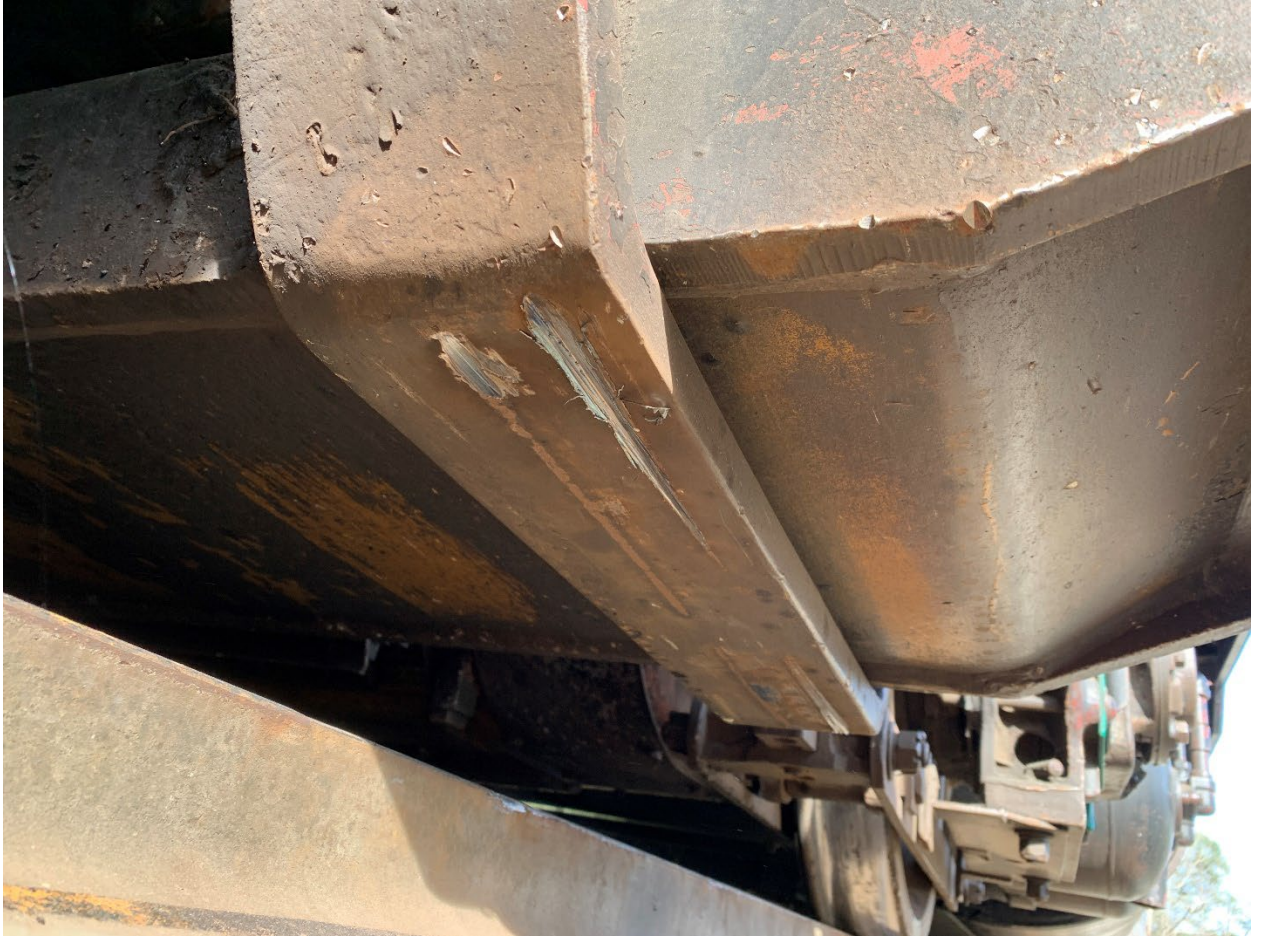
**Figure 12. REX 06 rear right hanger with rail burn witness marks.**

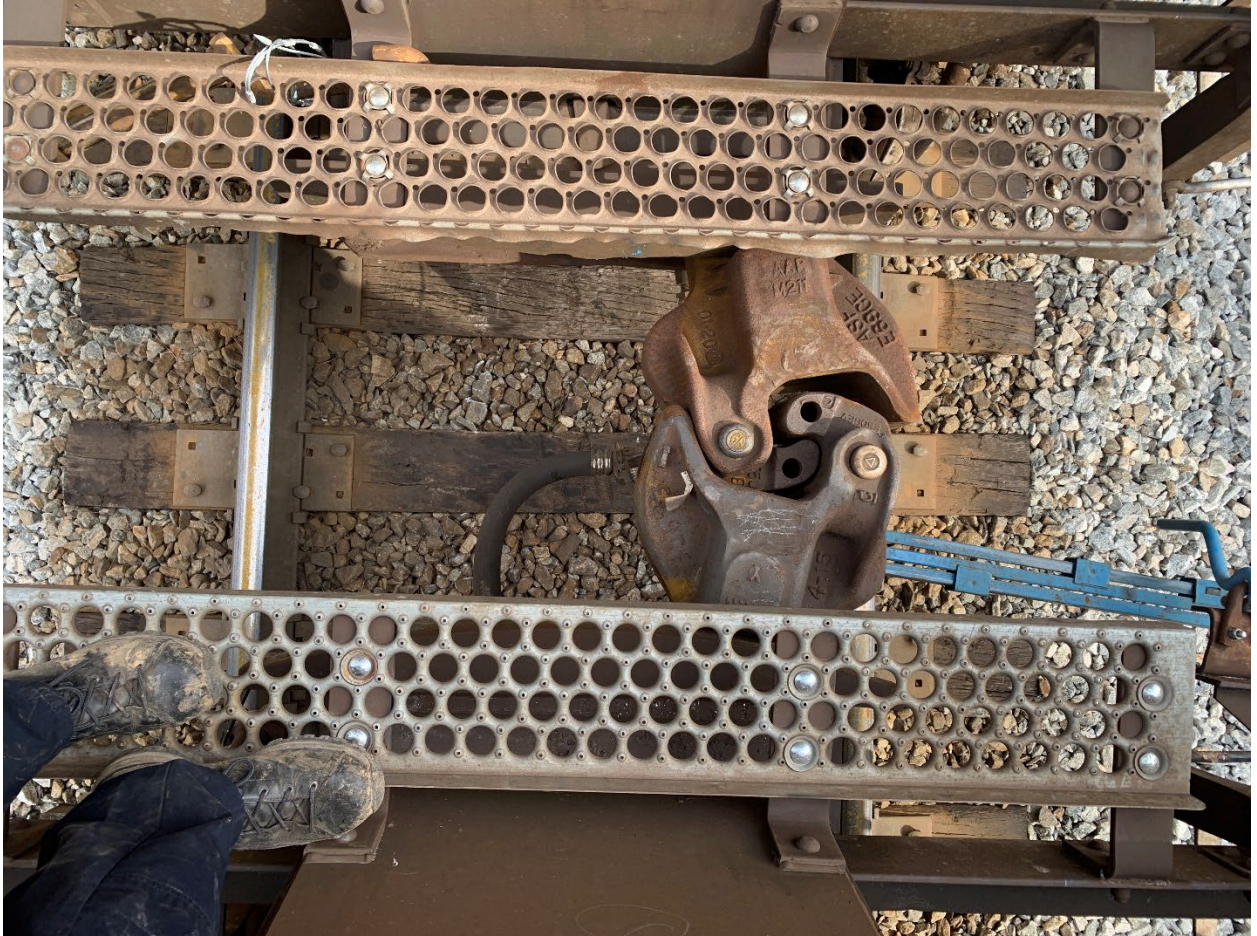
**Figure 13. Cars at rest (post-derailment) near MP 721.05 with jackknifed couplers**

- Near MP 721.05 (post derailment) two bulkhead flat cars, COER 804792 and COER 804785, came to rest with 'jackknifed' couplers pushed to the south. Investigators observed the couplers re-center when the rear portion of the train was pulled away.
- One car had a loose safety appliance, one car had a broken safety appliance
- One car had one brake shoe with the backing plate in contact with the wheel.
- One car had an inoperative uncoupling lever (consistent with derailment damage)
- CALIPI and Miniprof wheel profiles were taken on the locomotive consists.

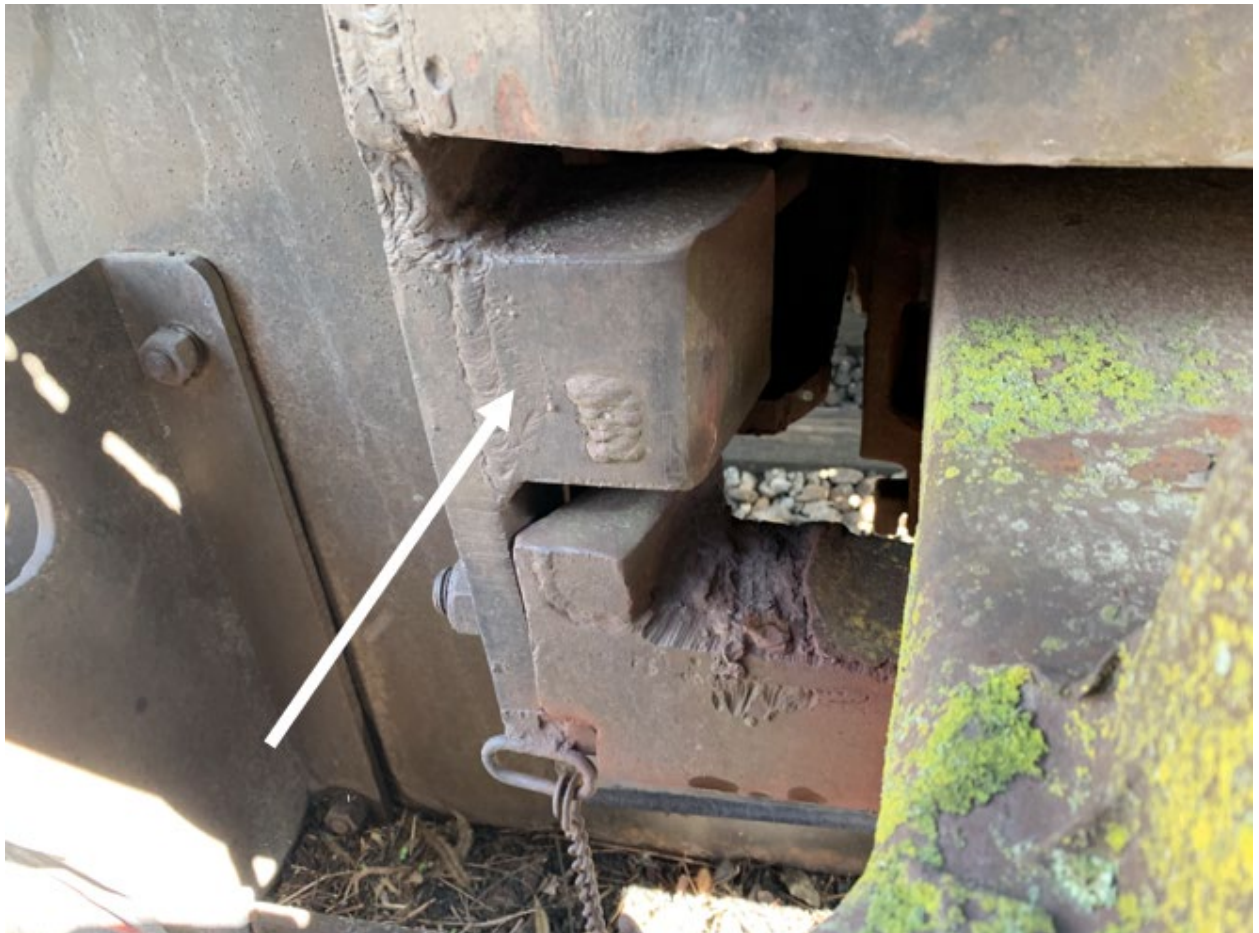
**Figure 18. RMEX 08 non-alignment control coupler alignment block**

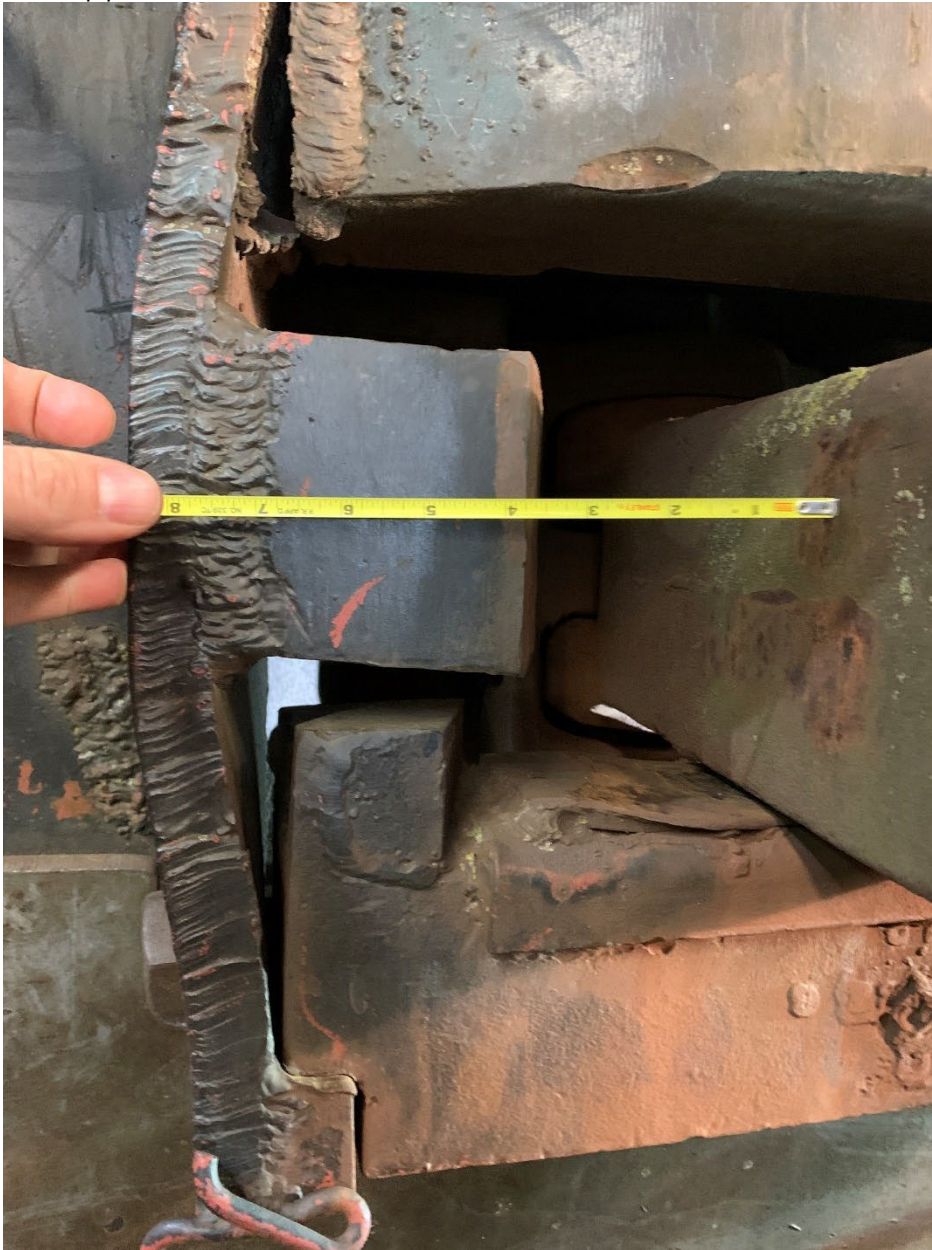
Locomotives RMEX 06 and RMEX 08 were equipped with non-alignment control couplers. The draft pocket of RMEX 08 was bulged out on the left rear side. The rust, wear, and moss found inside the broken weld are consistent with 'old' break. The coupler stop block of RMEX 06 was missing at the right rear location. The bracket that held the rubber stop in place had fracture features consistent with fracture in overstress from outward bending. The fracture surface was relatively flat with the exception of an upward facing shear lip toward the right, outer corner, and a depression with sharp corners on the left. The fracture was rough, with a uniform surface luster. The surface oxide was a light maroon or rust color, consistent with post-fracture oxidation from exposure to humidity or water. (Post-accident, there was significant rainfall in the area) There were no indications of localized areas of discoloration or geometries that would indicate a pre-existing crack. Investigators contacted the Pennsy company via email to ask about the proper installation of coupler stop blocks. In the email, the Pennsy company stated that they have never

**Figure 19. Draft gear pocket of RME8 08, left rear location**

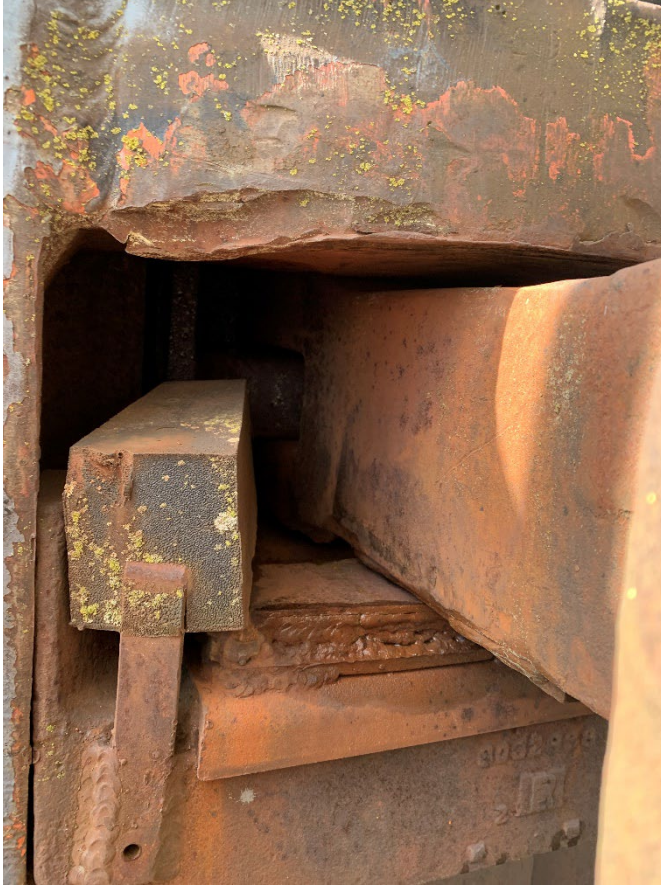
seen the blocks welded to the coupler carrier in this manner. That was an incorrect application. The coupler alignment blocks are shipped assembled with the securement chain bolted to the ends of the vertical tabs, which indicates the correct method of application.

**Figure 20. RMEX 06 Pennsy coupler alignment block, improperly secured with weld.**

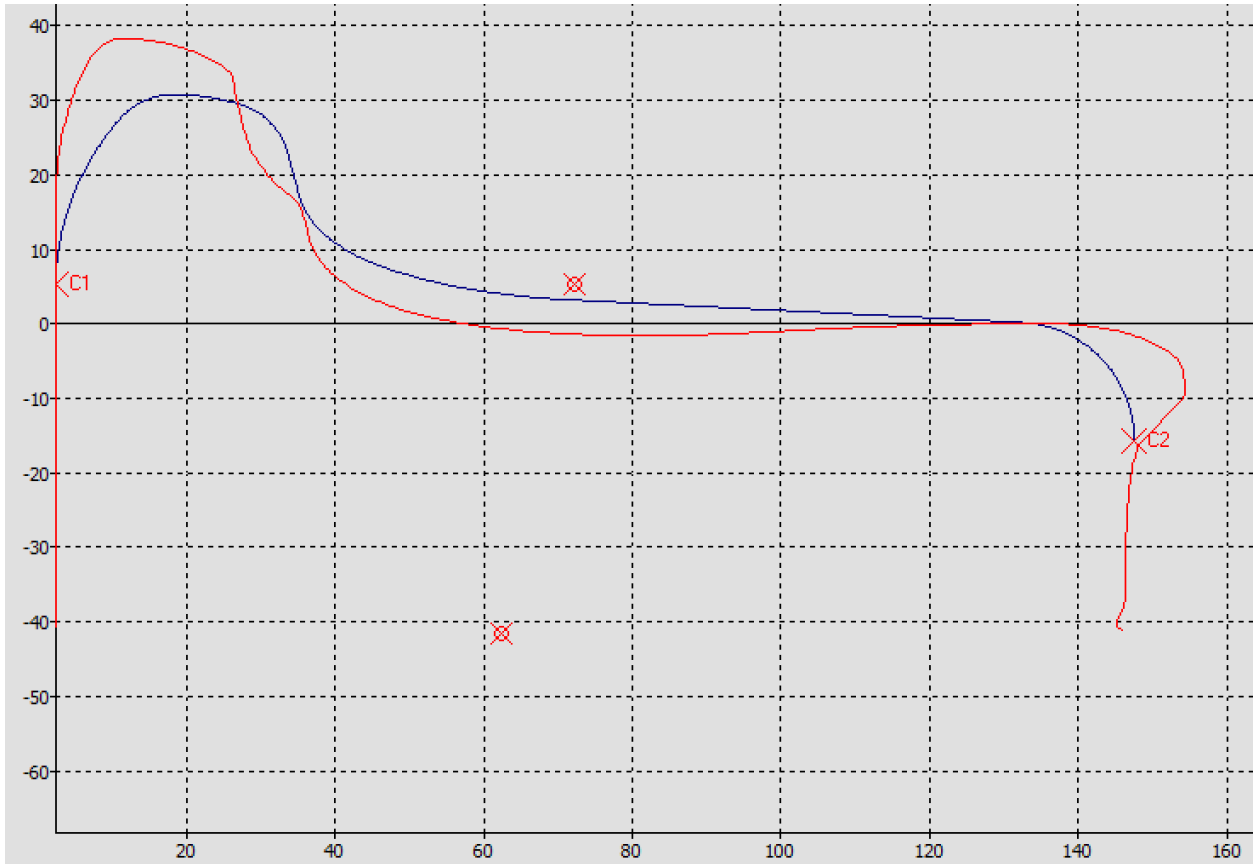
Locomotive RMEX 08 had flanges over 1.5-inches at the following locations. Wheel R2, flange height 1.553 inches. Wheel R4, flange height 1.539 inches. Wheel L4, 1.588 inches. High flanges over 1.5-inches are FRA non-compliant conditions.<sup>4</sup>

Wheel numbers R3 and R2 had a distinctive, non-standard, flange root shape.<sup>5</sup> The shape of the flange root is consistent with non-standard wheel lathe procedures, and not normal wear from wheel/rail contact.

**Figure 27. RMEX 08 R2 Wheel profile(Red) and new wheel profile (Blue)**

Investigators noted that the wheel profiles of RMEX 08 R2 and L4 had non-standard 'grooves' in the wheel flange profile. These grooves are consistent with the effects of wheel truing and not normal wheel-rail wear.

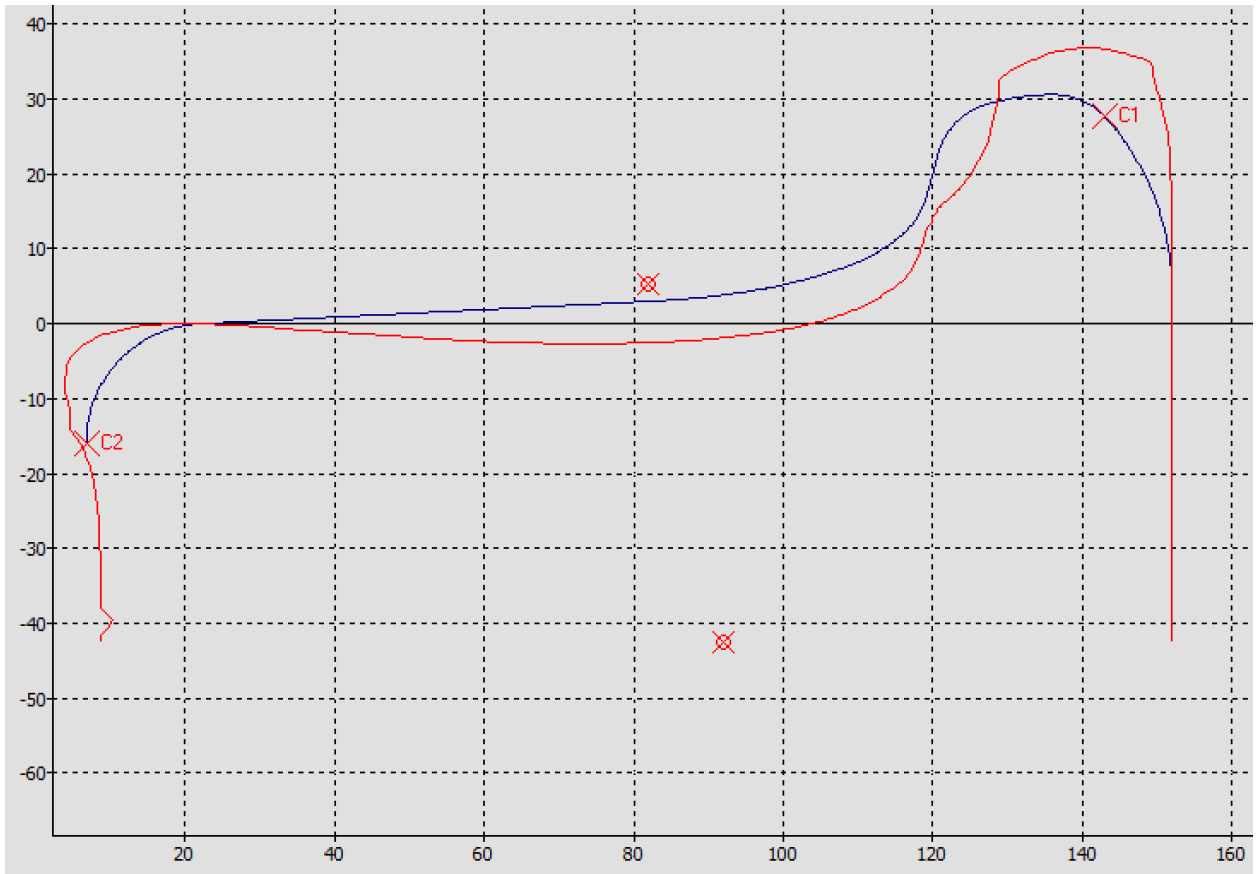
**Figure 30. REX 08 L4 Wheel profile(Red) and new wheel profile (Blue)**

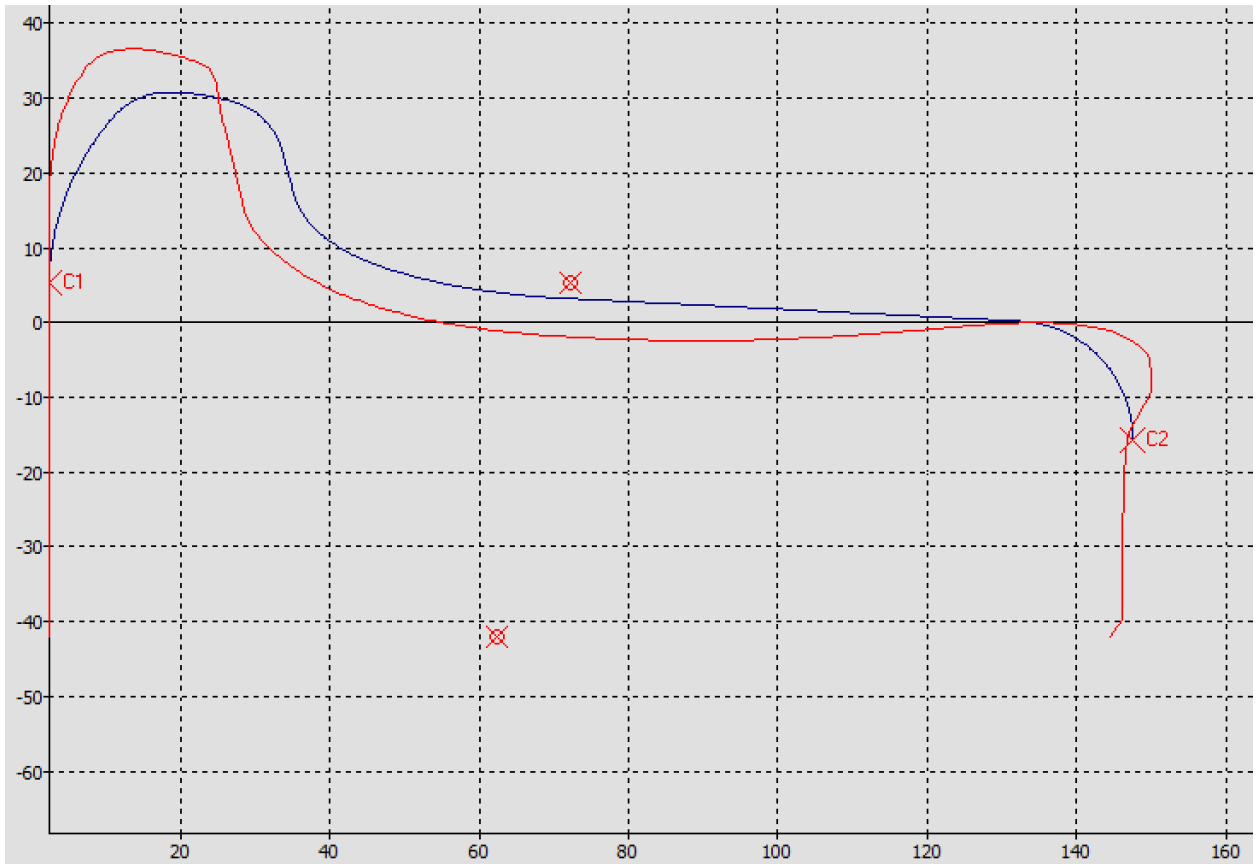
**Figure 31. RMEX 08 R4 Wheel profile(Red) and new wheel profile (Blue)**

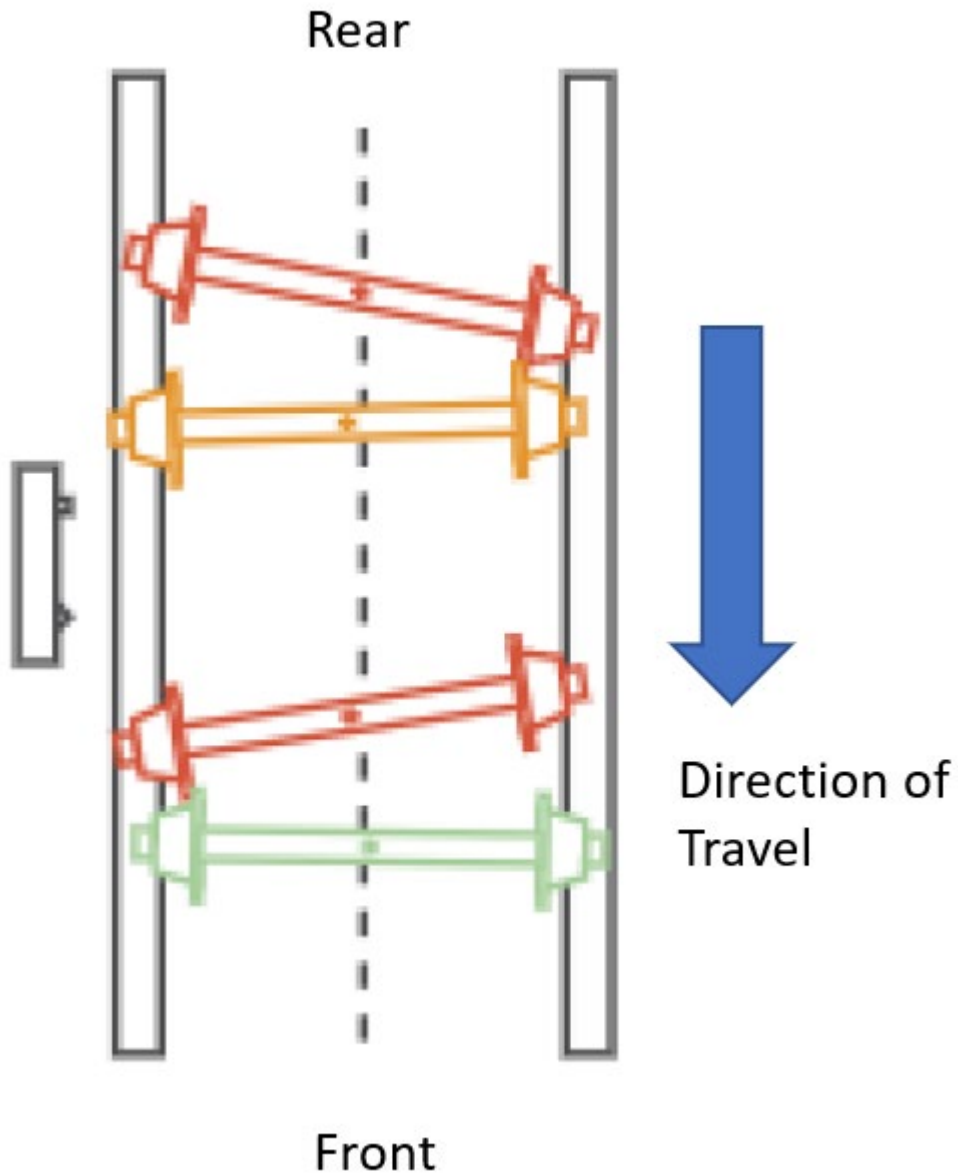
Following the accident, NS officials provided the TBOGI data for RMEX 08 and RMEX 06. There were no exceptions noted with RMEX 06. For RMEX 08, TBOGI identified large angles of attack on axle numbers 4 and 2, -9.5 milliradians and 7.9 milliradians respectively.<sup>7</sup> Additionally, axle number 3 displayed a tracking position

error of 12.9 millimeters. These conditions are not subject to Federal regulations or industry standards and are therefore not considered "defective" on their own. Rather, the railroad uses these measurements for maintenance scheduling and post-accident analysis to make improvements as needed.

**Figure 38. RMEX 08 TBOGI Data**

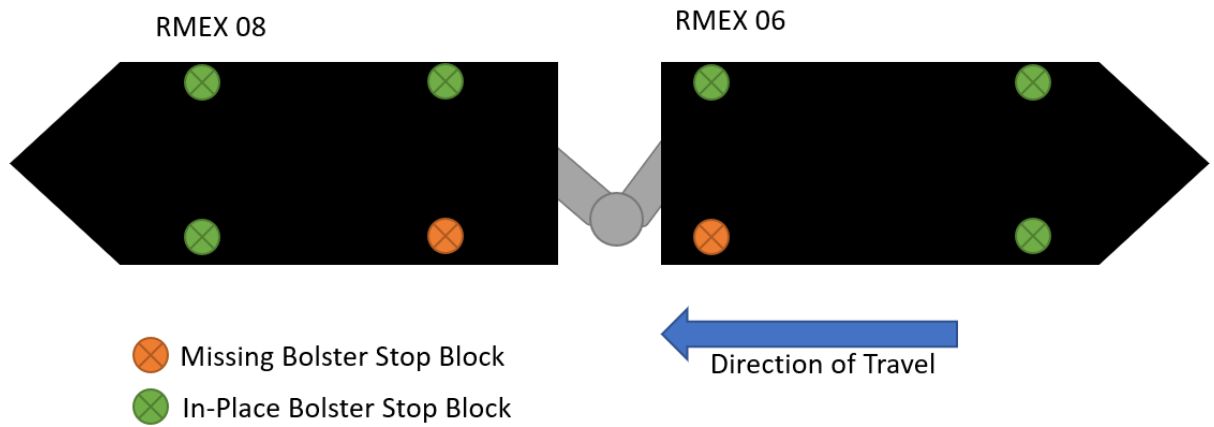
Locomotive RMEX 06 was missing the stop block at the right rear location. Locomotive RMEX 08 was missing the stop block at the left rear location. The brackets holding the stop blocks were broken at the 90-degree bend. The rusty and worn condition of the brackets is consistent with 'old' break. The mechanical working group determined the bolster stop blocks were broken/missing before departure of the train from Atlanta.

**Figure 39. Location of missing bolster stop blocks**

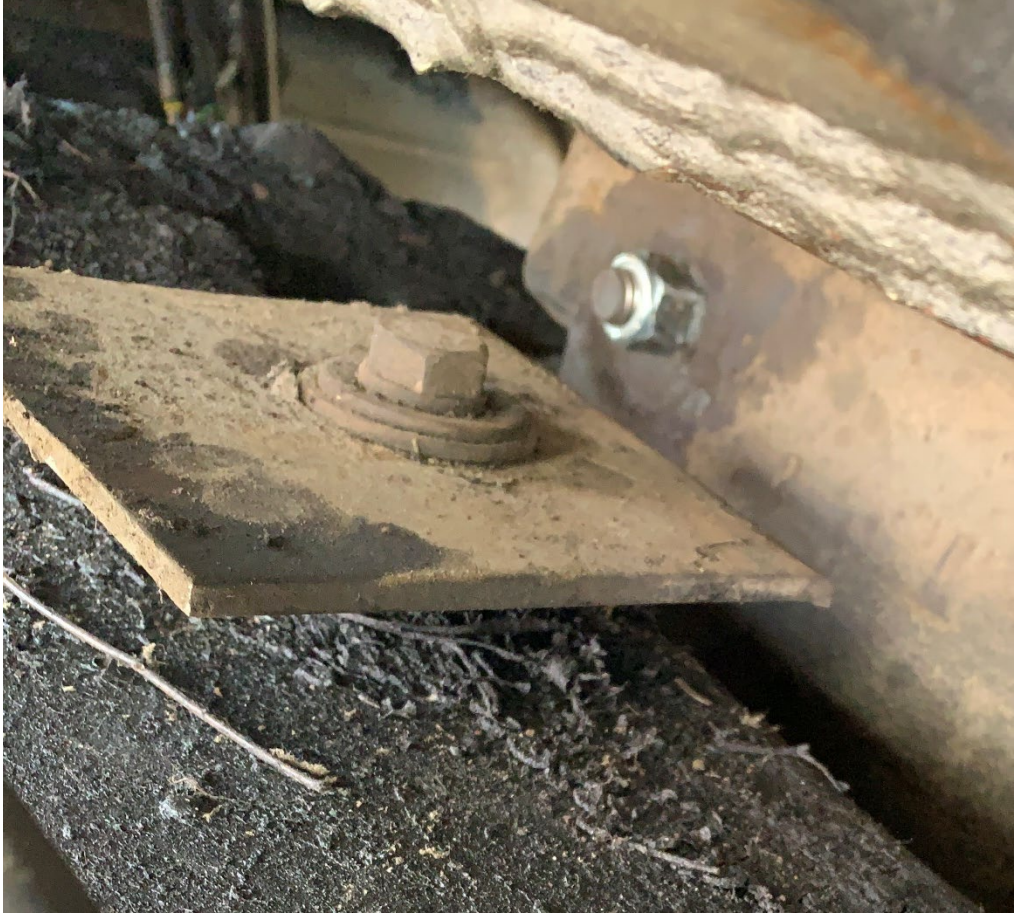
**Figure 41. RMEX 08 broken bolster stop block**
