Preliminary Report RRD23LR009

BNSF Railway Train Derailment

Raymond, Minnesota

March 30, 2023

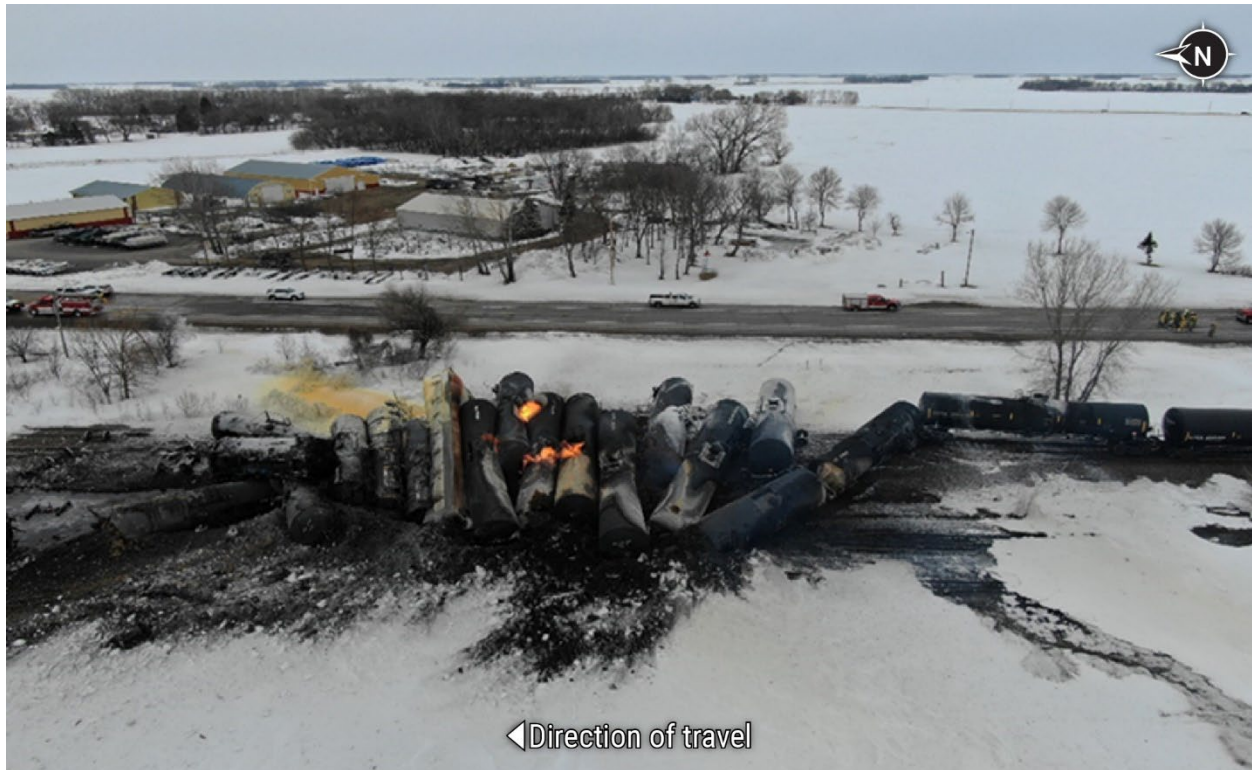
On March 30, 2023, about 12:58 a.m. local time, northbound BNSF Railway (BNSF) freight train L-TWI8801-29I derailed 23 mixed freight railcars on the Marshall District at milepost 11.871 in Raymond, Minnesota. (See figure.) Train L-TWI8801-29I included 14 hazardous materials tank cars, 10 of which derailed.¹ The derailed tank cars contained denatured ethanol, some of which was released and contributed to a fire.² The incident commander implemented a precautionary 1/2-mile evacuation radius, which affected about 800 residents. According to BNSF officials, the fire was extinguished on the morning of March 31, 2023. There were no reported fatalities or injuries. BNSF estimated damages to equipment and track infrastructure to be about \$1.9 million. Visibility conditions at the time of the derailment were dark and clear; the weather was 3°F with no precipitation.

Figure. Aerial view of the derailment site. (Courtesy of BNSF.)
