# National Transportation Safety Board

RRD24FR001

## TRACK

Group Chair's Factual Report

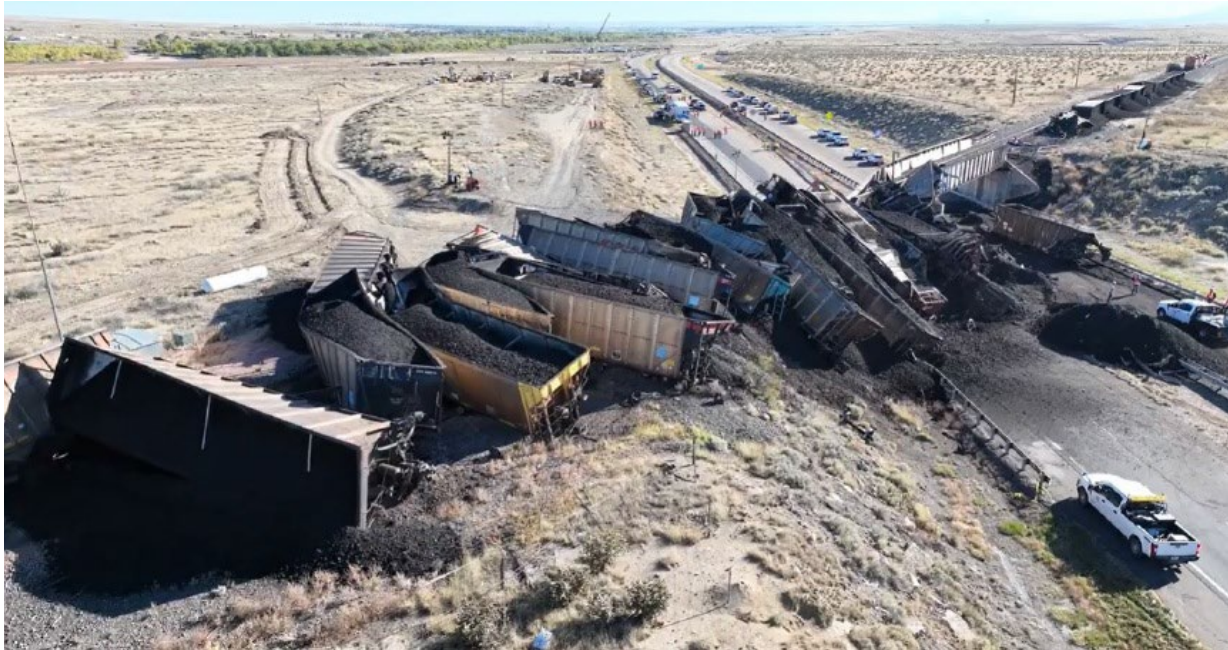
On October 15, 2023, at approximately 3:24 PM MDT, southbound BNSF Railway (BNSF) freight train C-ATMCRD0-31 derailed 31 cars at Mile Post 109.656 on the BNSF Pikes Peak Subdivision. The derailment occurred about 5 miles north of Pueblo, Colorado. The derailment occurred as the train approached a railroad bridge. As a result of the derailment, the bridge collapsed onto the southbound lanes of Interstate 25, causing one fatality to a semi-truck driver who was trapped under the collapsed bridge. A large quantity of coal spilled onto the north and southbound lanes of I-25.

Figure 1. Aerial photo of the point of collision site. (source: BNSF Drone footage)

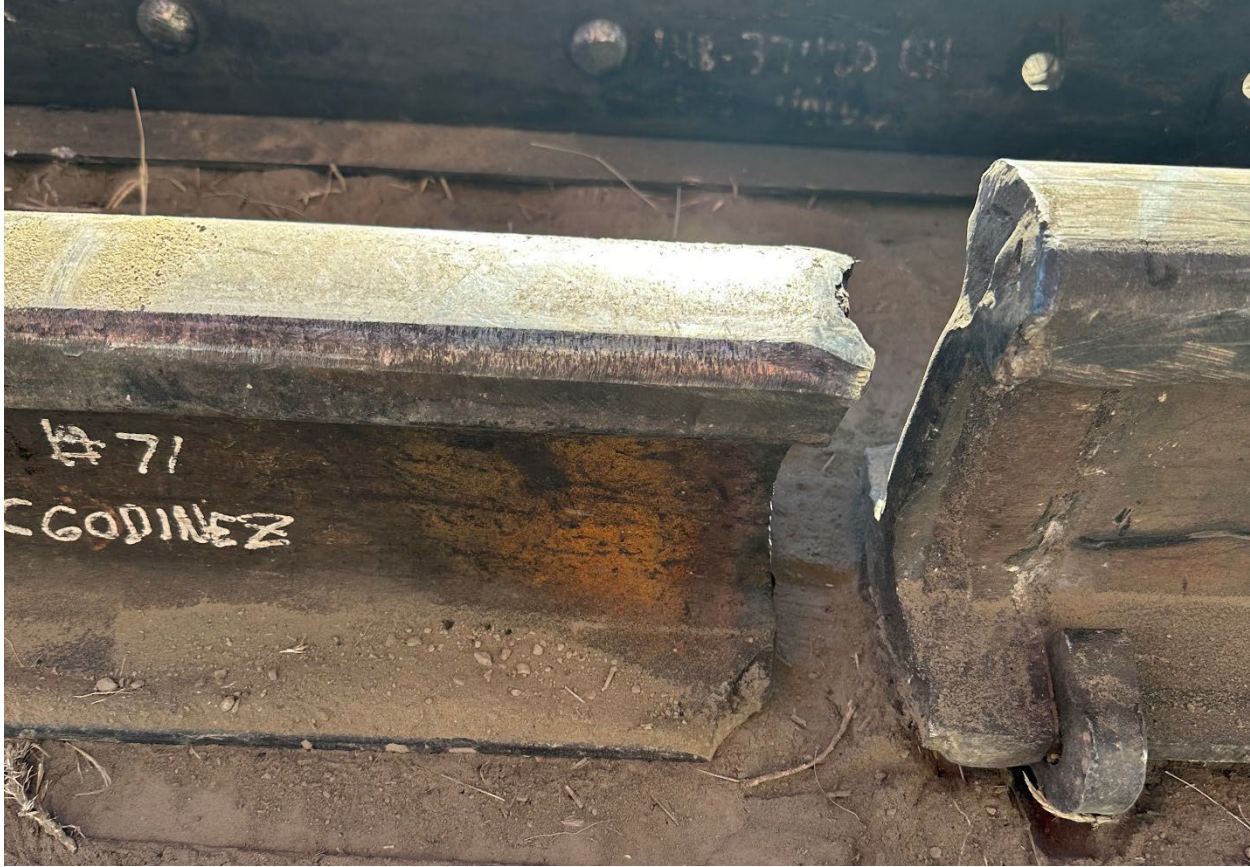
Figure 2. Thermite Field Weld #71 MP 109.656 made on 5-29-2023 (Source: NTSB)

BNSF's Thermite Welding Manual<sup>1</sup>, 7.9 (Appropriate Welding Molds), states that welding 136 lb. rail ends which have a height differential of 1/8" through 1/4" require the use of a 132/136 compromise welding kit. Goldschmidt's (manufacturer of Orgo-Thermit®) procedures<sup>2</sup> also require (Table 7.1) that rail ends with greater than 1/8" of rail height difference, utilize a compromise welding kit to properly weld the joint and joining rails with height differences of greater than 1/4" is prohibited. The Orgo-Thermit® welding kit used for weld #71 was a standard 136 lb. welding kit. The rails joined at this weld were not previously drilled for joint bars and had a difference in rail height of 3/16"<sup>3</sup>.

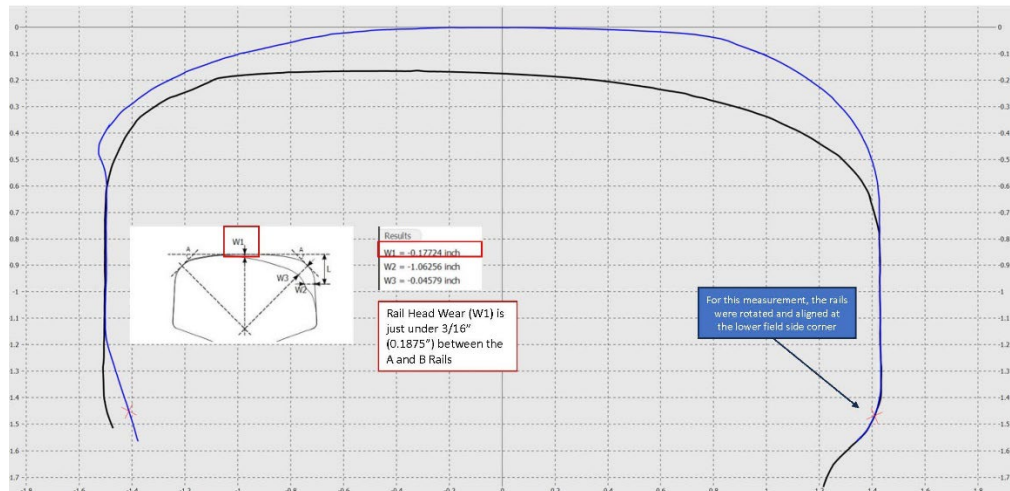
## “A-Rail” (Blue) vs. “B-Rail” (Black)

<sup>3</sup> Figure 4. Rail Profile measurement diagram.

Rail profile measurements of rails that were joined at weld #71 were taken during the examination. There was a height difference of 0.17724 (3/16") between the north rail (A-Rail) and the south rail (B-Rail).

Figure 4. Rail wear references (Source: Miniprof / NTSB)

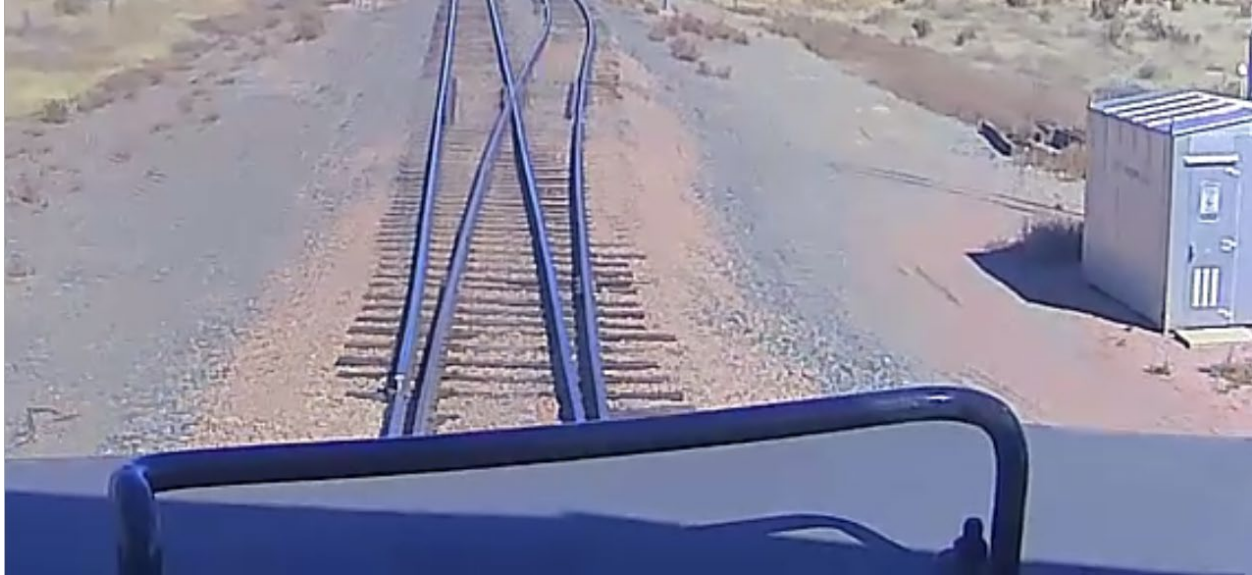
Investigators determined that the point of derailment (POD) was at MP 109.656 on the West rail (Main 1 straight lead) between the frog section and the heel block. This location was approximately 21 crossties North of the switch points. Witness marks were located on the East rail at this location and video footage captured from the rear locomotive of the previous train shows a broken rail.

Figure 5. Still photo captured from the rear locomotive on BNSF train C-BTMSP50-33D, at 1:30 p.m. on 10-15-2023. The image shows a broken rail on the left stock rail that was not present on head-end video footage (Source: BNSF)

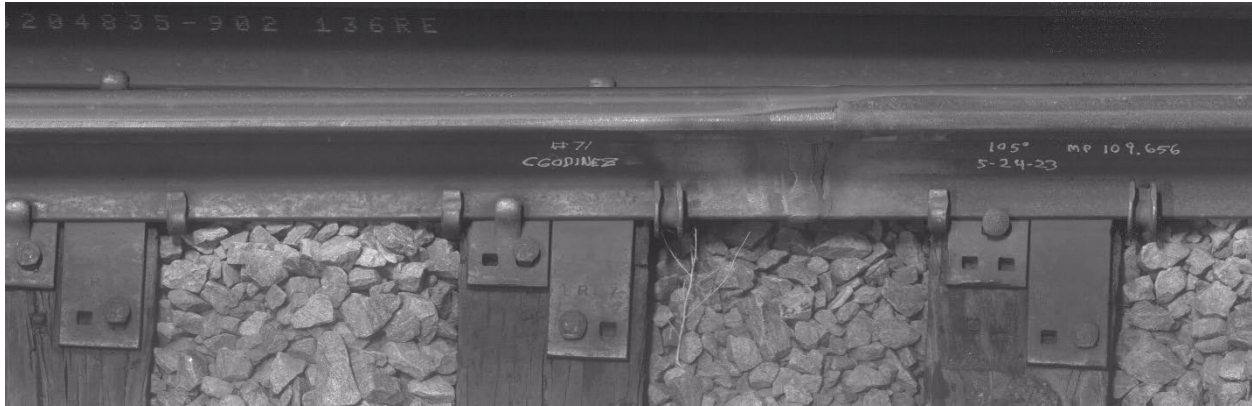
BNSF provided photo images from train C-BTMSPS0-33D, which previously traversed the derailment location before the derailing train. Images were taken from both the lead and rear locomotives of this train and analyzed as part of this investigation. Video from the leading locomotive and a locomotive positioned mid-train were also reviewed. BNSF provided high-definition imagery of the two welds that were taken on June 9<sup>th</sup>, 2023, using a BNSF track imaging system.

Figure 6. Image of thermite weld #71 on June 9th, 2023 (Source: BNSF)
