Preliminary Report RRD24FR001

BNSF Railway Derailment with Bridge Strike

Pueblo West, Colorado

October 15, 2023

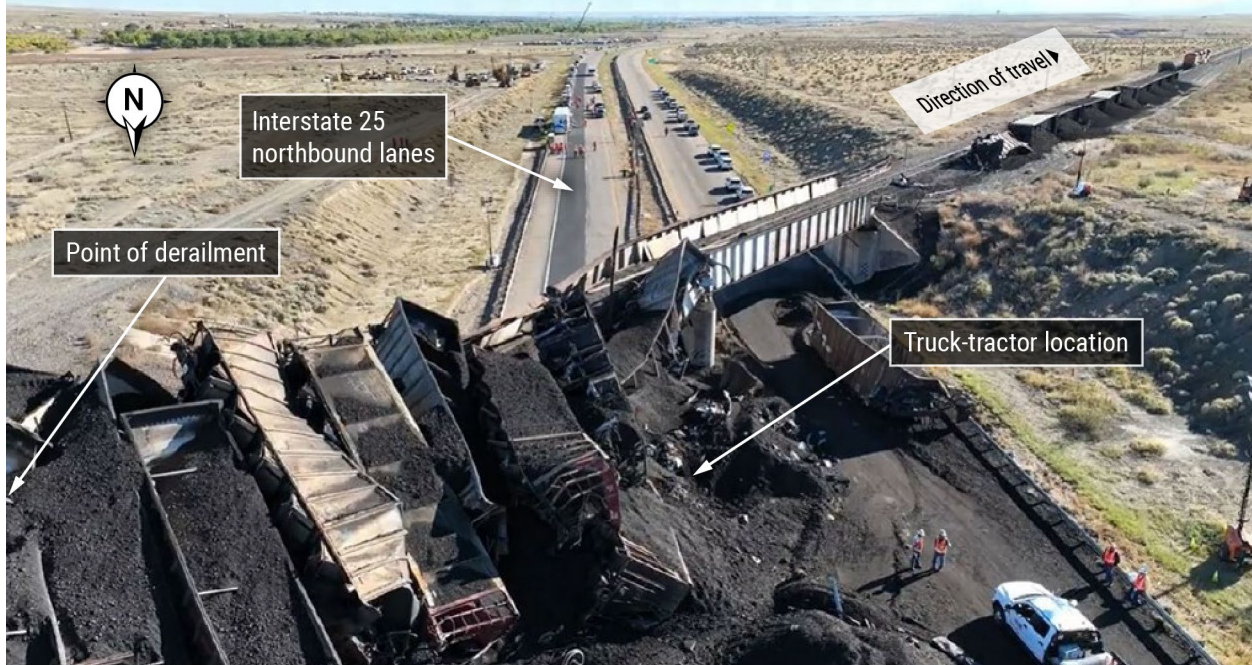
On October 15, 2023, about 3:24 p.m. southbound BNSF Railway (BNSF) coal train CNAMCRD0-31D derailed 30 railcars at milepost 109.654 on the Pikes Peak Subdivision in Pueblo West, Colorado.¹ The derailment occurred near a track switch east of a railroad bridge that crossed over Interstate 25.² Derailed railcars struck the bridge, six dropping to the interstate below and one or more striking a northbound truck-tractor in combination with a utility trailer (combination vehicle).³ The eastern span of the bridge partially collapsed over the interstate's northbound lanes. The combination vehicle came to rest beneath the collapsed bridge span, derailed railcars, and lading. (See figure.) The truck driver was killed; no members of the train crew were injured. At the time of the derailment, visibility conditions were daylight and clear; the weather was 71°F with no precipitation.

Figure. The derailment site. (Courtesy of BNSF.)
