National Transportation Safety Board

OPERATIONS

Group Chair's Factual Report

BNSF derailment near Pueblo, Colorado
October 15, 2023

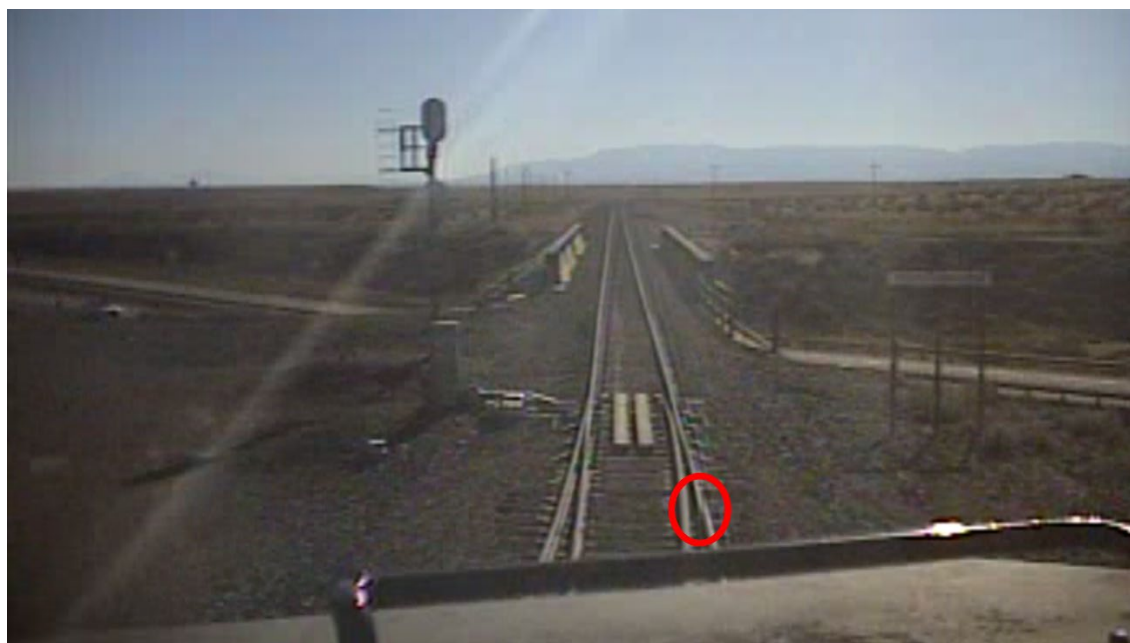
6.3 Lead locomotive Outward Video.

On 18 October 2023, the operations group conducted an Outward Facing Camera review from Train C NAMCRD0 31D Leading Locomotive. During this review Investigators identified a possible broken rail on the North side of main track 1 that proceeded the accident train.

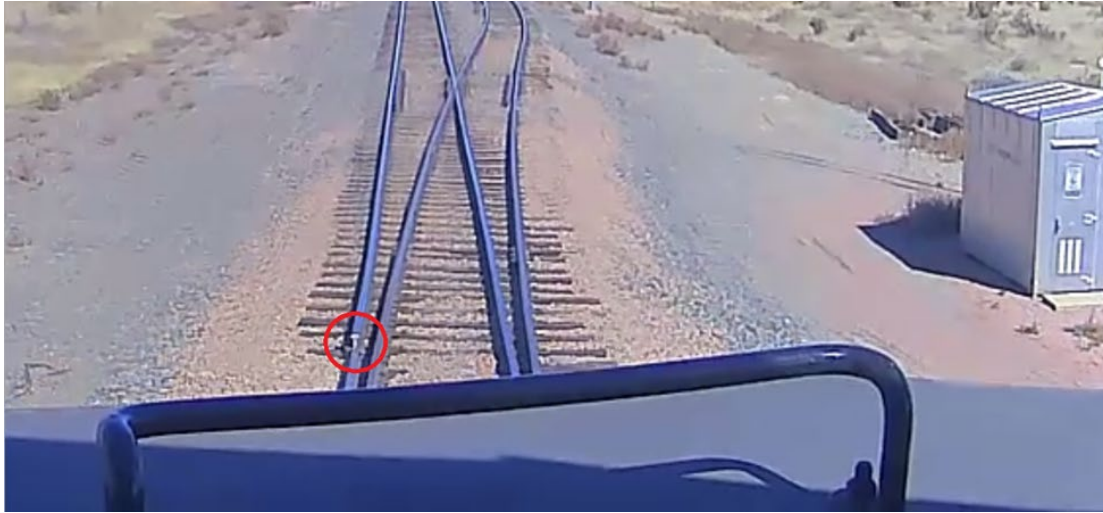
6.4 Lead locomotive Outward Video.

On 18 October 2023, the operations group conducted an Outward Facing Camera review from Train C BTMSPS0 33D Trailing DPU. During this review Investigators identified a possible broken rail on the North side rail of main track 1 that would have preceded the accident train.
