National Transportation Safety Board

RRD24FR007

Group Chair's Factual Report

Location: Decatur, AL
Railroad: Norfolk Southern
Date: January 31, 2024
Time: 4:15 PM
Struck Train: A08AA31
Striking Train: A80AA31

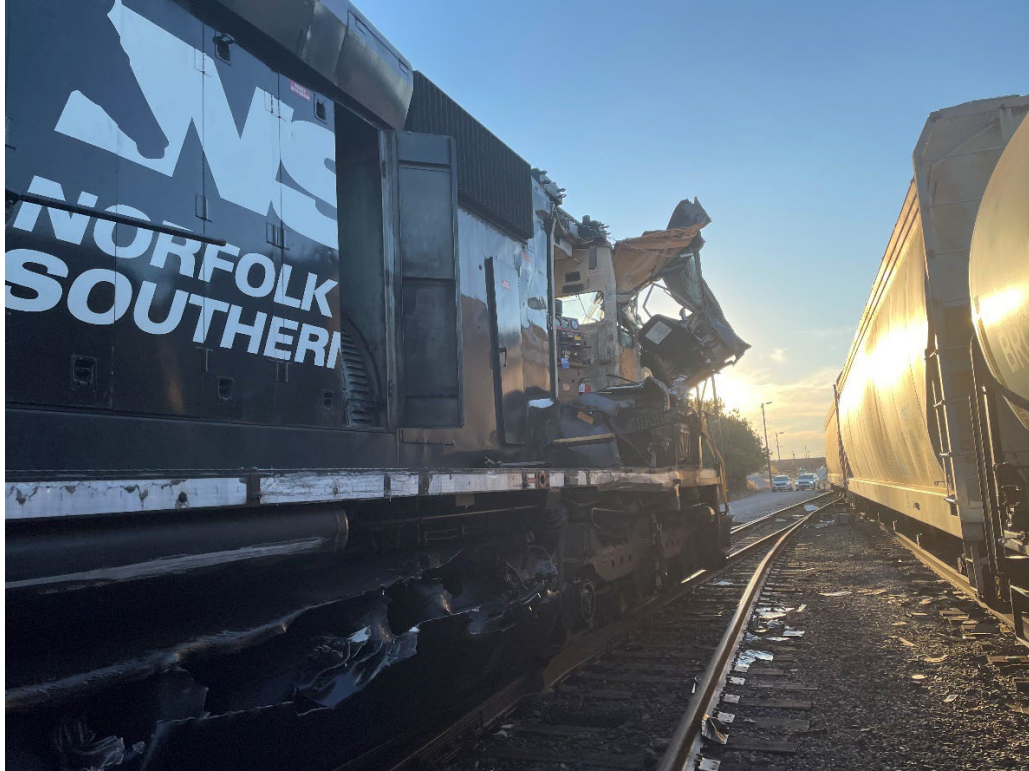
Locomotive NS 1648 was positioned just east of Track CT08 switch on track CT10. The right-side fuel tank was torn open the entire length and the right side of the cab. Locomotive NS 6086 was coupled on the east end of NS 1648 and coupled to 18 mixed manifest freight cars. There was no accident damage to any other equipment on track CT10.

Figure 3 - Locomotive NS 1648 that was struck by the rail cars that rolled from the east end of track CT7.

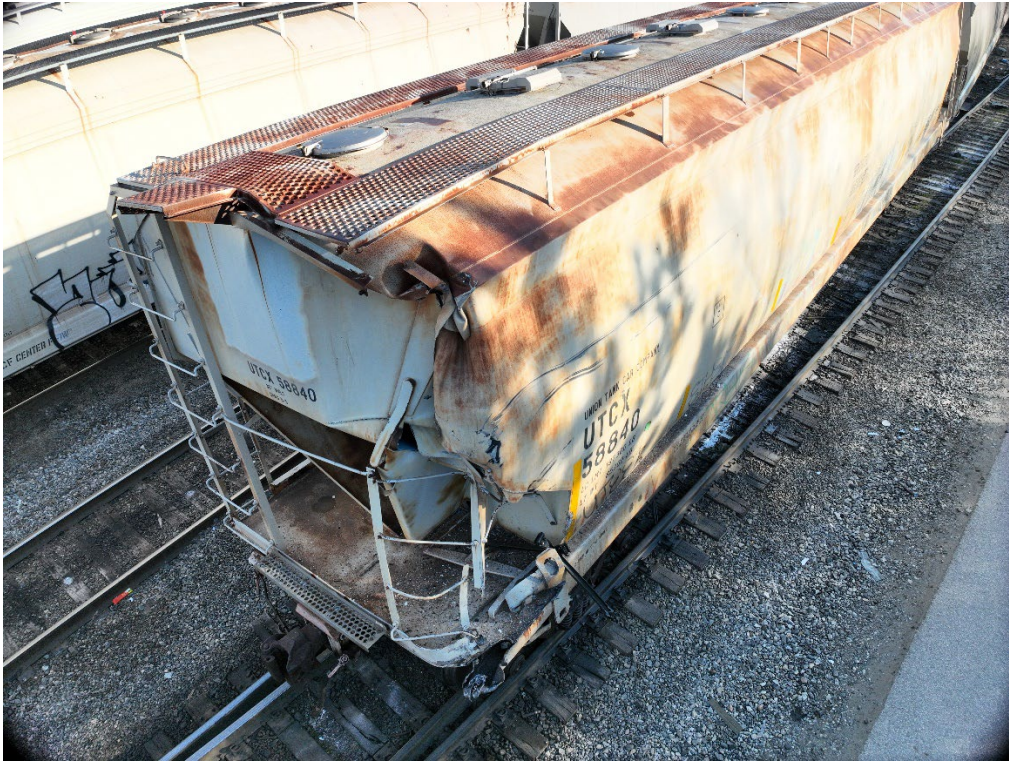
The 35 railcars that rolled west and struck locomotive NS 1648 were positioned at the west end of track CT07, just west of track switch 8. Car UTCX 58840 at the west end of the 35 railcars had damage to the "AL" corner and the "A" end trucks were separated from the carbody.

Figure 4 - The west railcar UTCX 58840 that struck locomotive NS 1648
