Preliminary Report RRD24FR007

Norfolk Southern Railway Employee Fatality

Decatur, Alabama

January 31, 2024

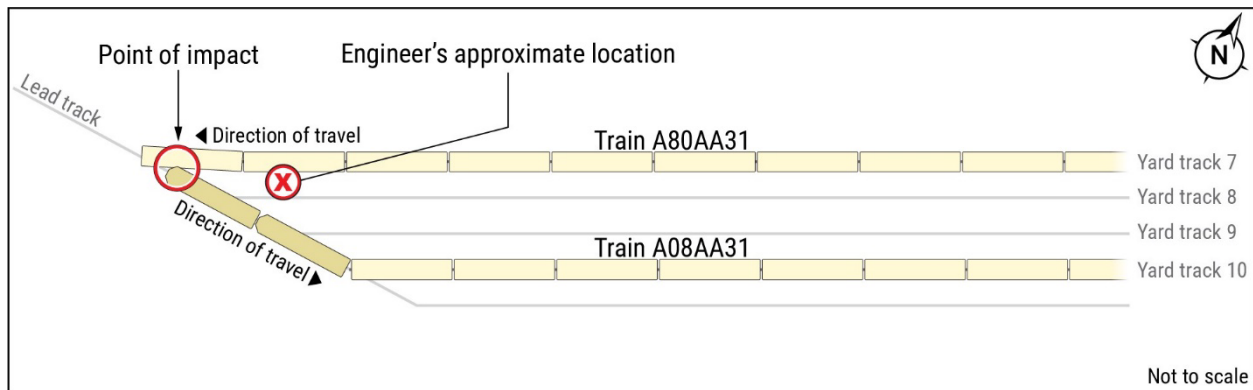
Figure. Overhead diagram of the accident.

The crew of train A80 consisted of an engineer, a conductor, and a conductor trainee. Shortly before the accident, the crew picked up a block of railcars from yard track 7, leaving 35 railcars behind. The crew of train A08 consisted of an engineer, a conductor, and a brakeman. At the time of the accident, the crew of train A08 was using 2 locomotives to shove 18 railcars from the lead track onto yard track 10. Immediately before the accident, the brakeman saw the 35 railcars of train A80 rolling west toward the lead track. The brakeman radioed the engineer to warn him about the rolling block of railcars. The engineer heard the brakeman's warning and continued the shoving movement in an attempt to avoid the approaching railcars, but was unable to clear the lead track. The 35 railcars rolled about 900 feet and struck the lead locomotive about 30 seconds after the brakeman's warning.
